Use Of The Thermo-Hygro Buttons in Tracking The Influence Of Humidity And Temperature On The Deterioration Of The Building Stones Of The Mausoleum Of Imedghassen Batna In Algeria

Abstract. The tomb of Imedghassen is a pre-Roman royal mausoleum located at 420 Km from Algiers. It is dated back to the 3rd century B.C. It is built with building stones. The semi-arid continental climate, of the chosen location, is characterized by strong temperature fluctuations and high evaporation. These two factors have a great influence on the building stones' state of degradation. The infiltration of water in this very rainy region, related to time ,had a serious impact on the monument. To get accurate results about the influence of temperature and humidity, we had controlled the microclimate of the mausoleum using PC Thermo track; thermo-hygro buttons. It allowed us to accurately track the values of the average and higher temperature and humidity, and also the dew point. The results clearly show the relationship between these factors and the origin of the building stone deterioration.

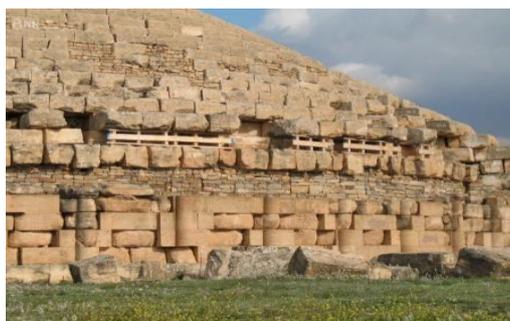
Figure 2. Stone blocks of the Mausoleum

Imedghassen Mausoleum is a monument listed as a national heritage. It is located in the wilaya of Batna, at the altitude of 914 meters (figure 1). The building measures 18.35 m in high and 58.86 m in base diameter. The cylindrical base is embellished with decorative columns. The mausoleum is dated back to the 3rd or 4th century BC. It is entirely built from huge blocks of stones together without mortar, joined by lead studs, and small stones (Figure 2).

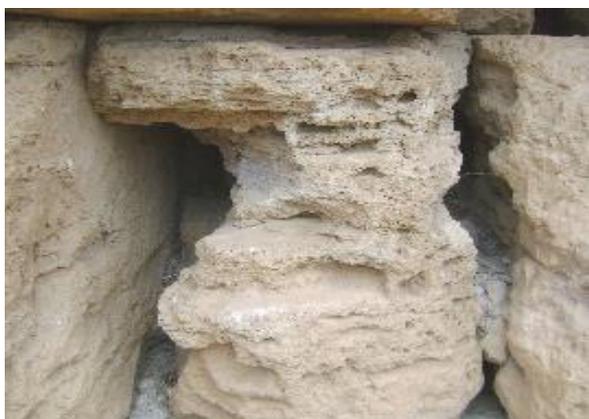
Figure 3. Plant growth

We note the growth of plants of all kinds, in particular between the stones. These plants are abundant in winter because of the availability of water. Over time, these plants have made space between stones, and consequently, the demolition of the walls of the mausoleum as a result.

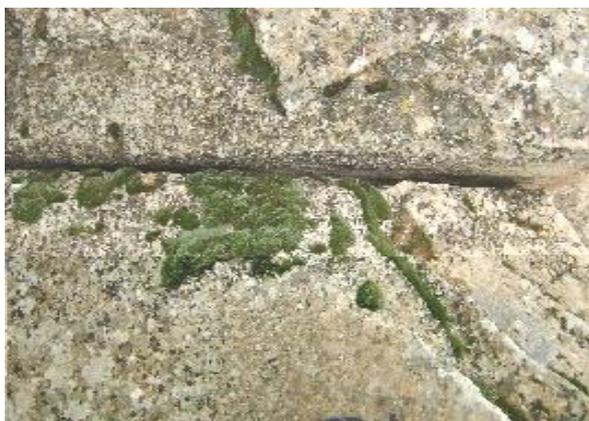
Figure 4. Lichens growth

They are represented by algae and lichens, deployed on many stones of the building. They appear as spots or crust, green, yellow or white, depending on lichens. These plants develop on the outer surface of the stones; this alters the stones and influences the aesthetic side of mausoleum. The density of these algae is particularly enhanced in the spaces between the stones, where there are shade, moisture and water.

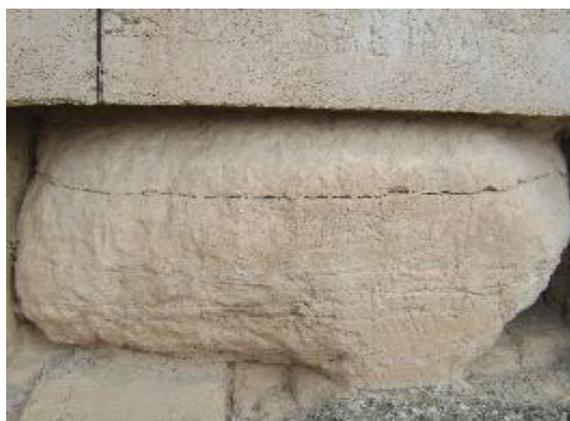
Figure 5. Horizontal cracks

Some stones show visible cracks. We see wide and narrow cracks, vertical and horizontal. The wide variations in temperature and moisture content may be the cause of these cracks. The mechanical pressure of new stones substituted during the restoration, and the presence of plants can also be the cause of these fractures.

After 42 days of recording (from 27 June to 9 August) .The thermo-hygro buttons after reading the results, clearly show the difference of temperature and humidity values between the winter and the summer period with a temperature difference min (9.8 ± 0.5 ° C) and max (15.8 ± 0.5 ° C) and a standard deviation for the Humidity of max (11.86 ± 0.1 %). These large variations in Humidity and temperature may be the main cause of some cracks observed on the mausoleum stones.

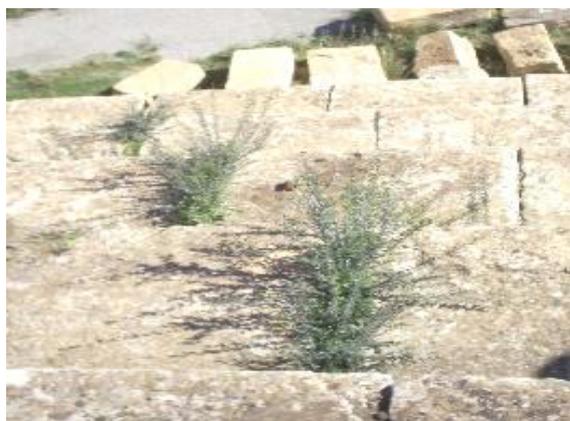
Figure 6. Corrosion stones

The mechanical action combined with rain, wind, sand and time has changed the shape of the stones, decreased their size and a mass loss. The surface corroded stone comes off easily.

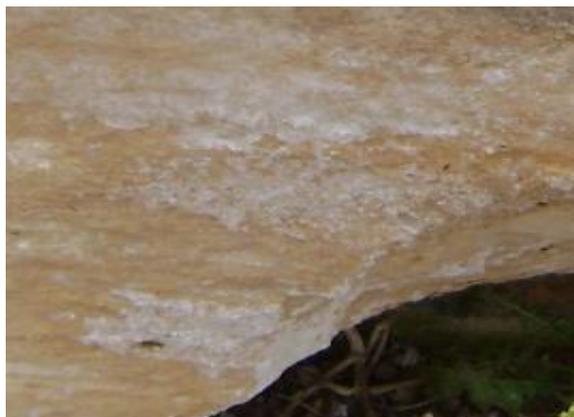
Figure 7. Efflorescence salts

The bottom capillary moisture of the wall of the soil, the dissolution of the salts by water from rain and the evaporation of water at high temperature of the surfaces of the stones, are the main cause of salt crystallization. Mausoleum Imedghassen shows very well this phenomenon. White layers are observed on the first sitting of the monument.

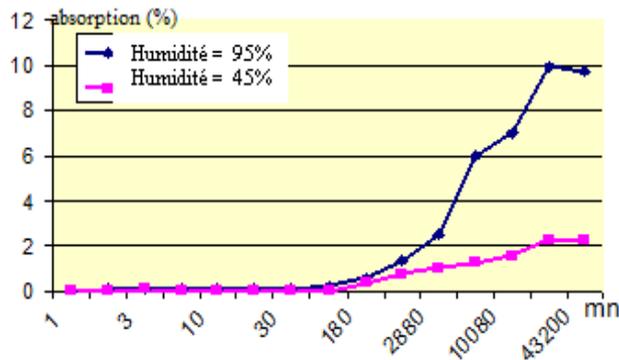
Figure 8. Influence of the H (45% and 95%) on the samples for 30 days

The solutions are prepared in the laboratory to create relative moisture of 45% and 95%. The solutions were placed in desiccators, with perforated partitions, so that the samples are not in contact with the solution. After drying in an oven until a constant weight, they are put into a 45% environment and 95% relative moisture. The masses are weighed after different time (t1, t2, t3.....tn) with tn equal to 30 days. The results are shown by the graphs of Figure 8.

The samples, subjected to a 45% environment and 95% relative humidity for a period of 30 days, showed that the limestone-type samples ,with significant open porosity, absorb moisture from the surrounding .This absorption increases with increase of the amount of moisture, increased porosity and the exposure time of the samples in that environment. This clearly shows the effect of changes in humidity, rain and rising damp on the alteration of building stones. The different types of alterations observed in the site (micro organisms, lichens, efflorescence, weight loss, etc.), are accelerated by the presence of moisture.

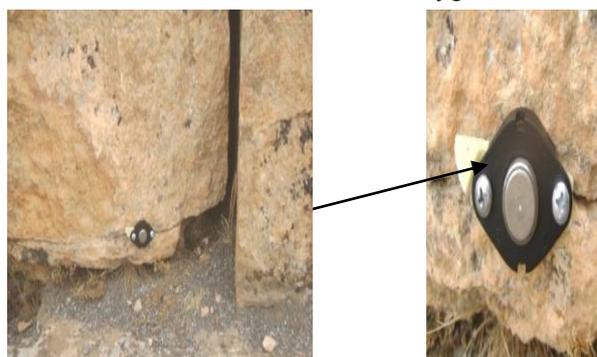
Figure 9. Placement of the thermo-hygro-button

The Thermo-hygro button was placed in the north facade wall, from January 13 to February 12. Figure 9, showing the location of thermo_hygro button in the wall and in Figure. 10, showing the registration of the temperature variation, humidity and dew point during this period. The summary of the recorded mean values are:

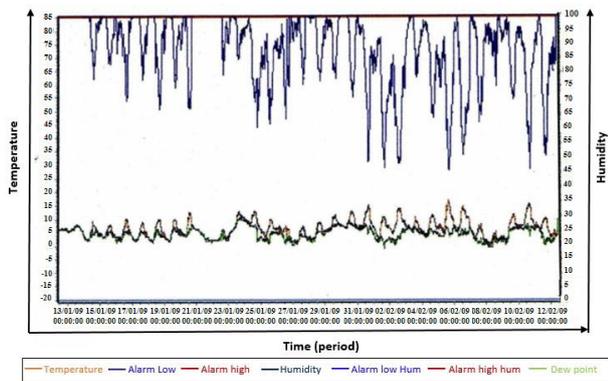
Figure 10. Recording result of H (%) and T°C, the winter period, North façade

H(%) max = 100;H(%) min = 41.8;H(%) Average =85.51
 T(°C) max = 27.9 ;T(°C) min = 0.4 ;T(°C) Average =7.88

After 30 recording days (from January 13 to February 12), we remove the thermo-hygro buttons from the mausoleum walls and reading them, via the PC software Thermo track. The results are shown in the Figure 10 (thermo-hygro1).It shows the variations in temperature and humidity during attempts (30) days .The values do not show large variations between day and night, against the (thermo_hygro2), that shows that the gap is very important between the values of day and night, with large amplitudes during the 30 days of recording The results clearly show the difference in temperature and humidity between the two facades (North and East) .This clearly explains the influence of climatic parameters on the state of degradation of the east façade against the north wall.
