Provisions of Disabled Facilities at The Malaysian Public Transport Stations

Abstract. Public transport stations need to provide access and facilities for people with disabilities (PWD) in fulfilling the requirements of the Malaysian Standard Code of Practice on Access of Disabled Persons (MS). However, most public transport stations in Malaysia are reported as still lacking in terms of providing good designs and facilities for the PWDs. This inaccessible environment affects the PWDs to negatively participate in the social and economic mainstream. The research aims at identifying the compliance of disabled facilities provided at the electronic train service (ETS) railway station in Perak. Two research objectives were established (1) to identify the range of disabled facilities provided at the ETS railway station in Perak and (2) to determine the compliance of the disabled facilities as outlined in the MS. Eight ETS railway stations in Perak were chosen for the case study. Purely qualitative methods were adopted. An observation checklist was developed by conducting document analysis on three main documents. The findings suggest that there are 14 disabled facilities to be provided a

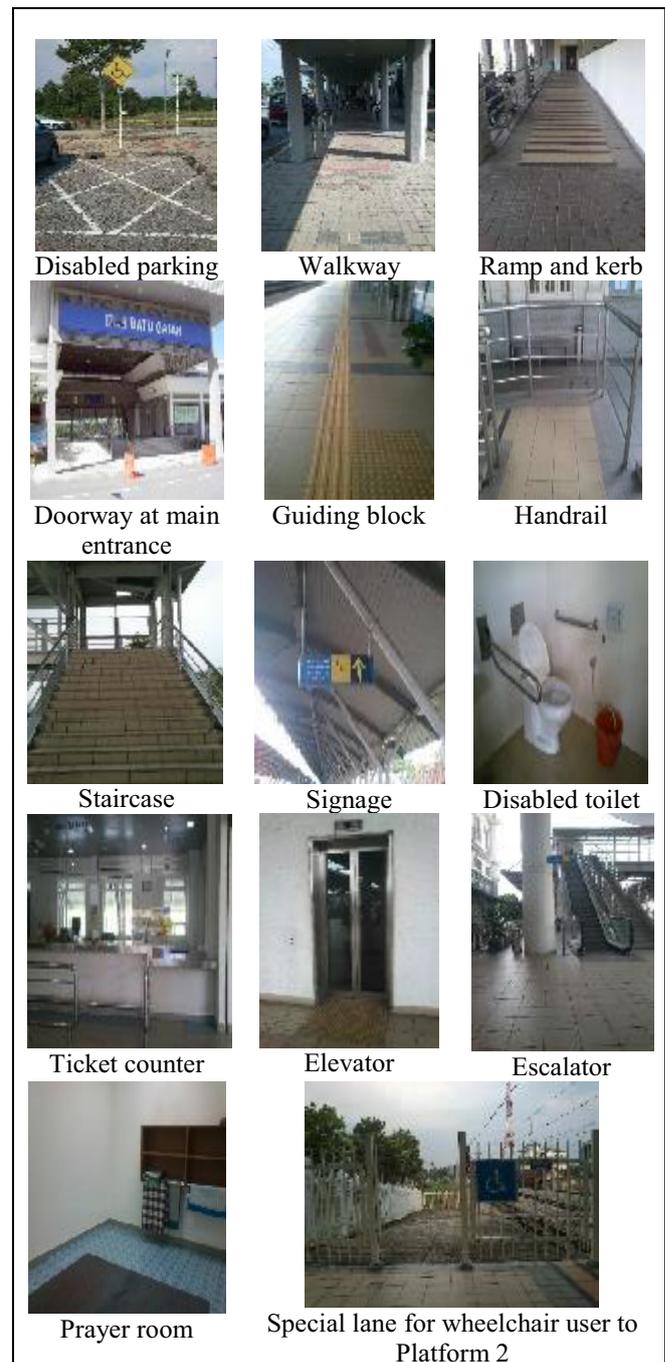
Figure 1. Types of disabled facilities to be provided at ETS railway station

Figure 1 shows the range of types of facilities to be provided at the public railway stations. There are 14 types of disabled facilities to be provided in ETS railway stations namely disabled parking, walkway, ramp and kerb, doorway at main entrance, guiding block, handrail, staircase, signage, disabled toilet, ticket counter and special lane for wheelchair user to Platform 2.

staircase, signage, disabled toilet, ticket counter, elevator, escalator, prayer room and special lane for wheelchair users to Platform 2.

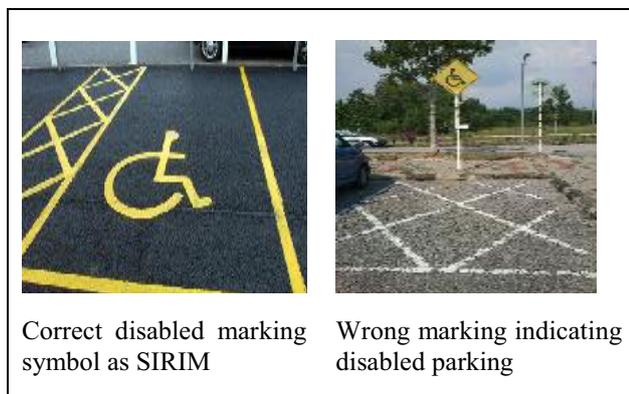
Figure 2. Disabled parking marking symbol

Although all stations have provided disabled parking, only RS3 and RS4 comply with all the standards. However, both stations did not comply with the disabled marking sign as outlined by the Standards and Industrial Research Institute of Malaysia (SIRIM). Instead of using the disabled symbol, it only uses the cross line marking.
