Erosion Corrosion and Protection of Recycle System with Seawater

Abstract. In order to investigate the corrosion of recycle system with seawater in rights of power plant, the erosion behavior and mechanism of erosion corrosion in this system constructed with several corrosion-resistance alloys have been studied and tested in the condition of high speed fluid with a sand particles. Both special protection technologies and results, one designed by high temperature epoxy resin powder coating and another of the associating method of anode protection together with such same coating, have been discussed as well in this case.

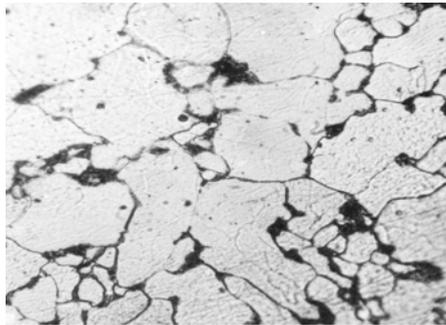
With further inspection of metallographic (Fig 1), it was discovered that crystal grain of that pipe material was bigger than normal and composed by ferrite and pearlite in constitution typically. The pearlite existed in constitution of welding zone was less than that of in matrix (Fig 2), and it was distributed along with the crystal boundaries of ferrite. And there was not any corrosion cracking or SCC existed on the subsurface of welding zone.

Fig 1 The metallographic constitution of pipe ×440

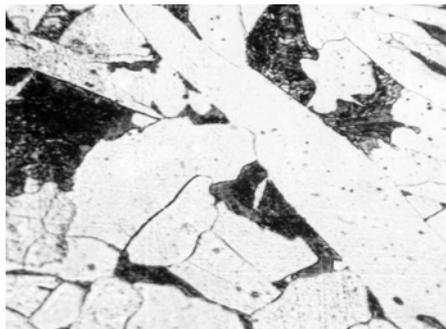
Fig 2 The metallographic constitution near the welding zone×440

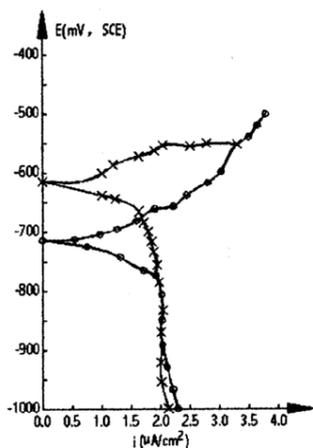
Fig 5 The polarization curves of both materials in static seawater (● A3, × 10CrMoAl)

have been measured and studied in both of static and fluidity seawater as shown in following Fig5 and Fig6

It is viewed that the corrosion resistance of HSLA (10CrMoAl) was a little bit better than that of plain carbon steel (A3 steel) in this system, special in test of static seawater, due to the fact that the electrochemistry behavior for this system was a kind of oxygen adsorption reaction in cathode process with a diffusion control evidently. The limited current density in diffusion process would increase with the increasing of fluid rate of seawater.

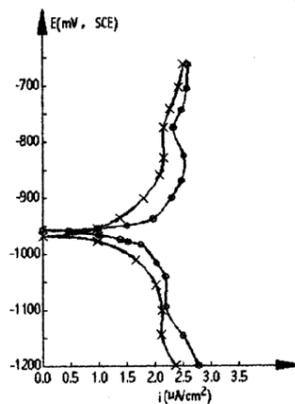
Fig 6 The polarization curves of both materials in fluidity seawater (● A3, × 10CrMoAl)
