Corrosion Damage of Aluminum Alloy in Unsymmetric Dimethyl Hydrazine and Dinitrogen Tetroxide Liquid Propellant

Abstract. The high strength aluminum alloy double cantilever beam (DCB) specimens were corroded under the conditions of different liquid propellant environment. After the stress corrosion exposure, the scanning electron microscopy and energy-dispersal analyses on corrosion damage were carried out. The corrosion damage sensitivity and the stress corrosion character of the LD10 high strength aluminum alloy in N₂O₄, UDMH and 3.5% NaCl corrosion solution were analyzed.

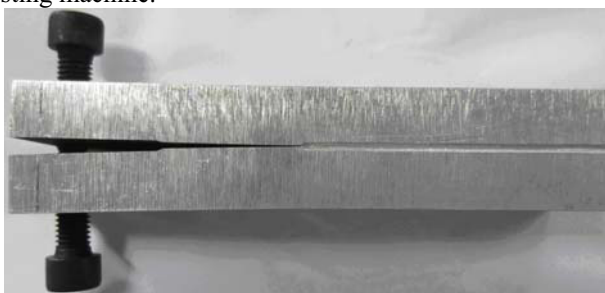
Fig.1 The specimen map

The DCB specimens (shown as Fig.1) which can self load was used in the experiment, and this specimen equipment uses the bolt to provide the loading force. The specimen equipment has the advantage of compact structure and easy to carry out the exposure corrosion experiment in high toxicity liquid propellant environment.

The alclad was machined out from the LD10 aluminum alloy plate, and then the double cantilever beam (DCB) specimens were made and the initial crack was made used the wire discharge machining according to ASTM G47. Fig. 1 shows the specimen equipment. Based on the statistical loading method, the fatigue crack was prefabricated using a closed loop servohydraulic testing machine.

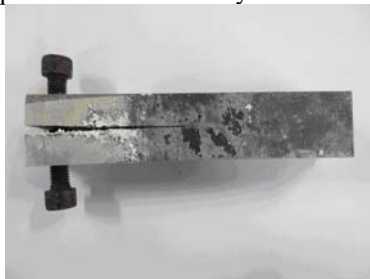
a. Surface corrosion configuration of the specimen in 3.5% NaCl solution

To the specimens in 3.5% NaCl solution, at the surface of the specimen, there are a mount of crystal, and surface layer exfoliating, a great deal of little corrosion pits. To the specimens in N_2O_4 solution, the surface of the specimens covered a layer of hoarfrost, and after cleaning out using distilled water, the specimens surface appear large piece of yellow substance. At part of the surface, there are broken off corrosion production. To the specimens in UDMH solution, the surface of the specimens covered a layer of white corrosion production.

After the SCC experiment, the DCB specimens were taken out from the three components solution, and the corrosion damage configuration and evolution are observed. The corrosion damage configurations of the specimens in the three kinds of solution are shown in Fig.2.

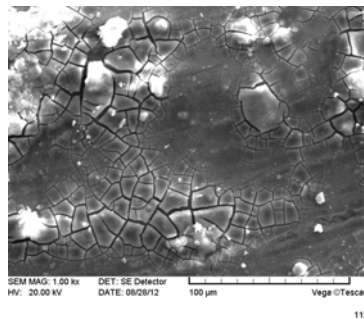
b. Corrosion damage sensitivity of the specimens in N_2O_4 solution

As can be seen in Fig.3, it is different of the surface corrosion damage degree in different solution, the corrosion degree of the specimen in 3.5% NaCl solution is the most serious, it can be seen on the surface that there are chap configuration, corrosion cast, and darker color. To the specimen in N_2O_4 , on the surface, there are little asymmetry yellow speckle, there are chap configuration and corrosion cast in part. To the specimen in UDMH, there are not obvious change on the surface, the color of specimen immersing in UDMH is more shining, it seem as was bashed by oil.
