# Sustainable Shear Behaviour of 2-Span Continuous Reinforced Concrete T-Beams with CFRP Strips

**Abstract.** Reinforced concrete (RC) structures are generally subjected to various load conditions and are susceptible to environmental impact. With time, most of these structures will be subjected to change in their usage. Unexpected increase in load changes may cause severe damage to the structural components, and eventual leading to various types of structural failure. It is noted that shear failure in nature is a sudden failure and should be avoided at all times. To increase its service life due to shear, structures can be strengthened or repaired using CFRP strips wrapped within the shear span ( $a_v$ ) of the beam. Hence, this paper presents an investigation on the sustainable behaviour of two span continuous RC T-beams strengthened and repaired by wrapping Carbon Fibre Reinforced Polymer (CFRP) strips at intervals along the shear span ( $a_v$ ) of the beam. The CFRP strips will be orientated in two directions either at  $0^\circ/90^\circ$  or  $45^\circ/35^\circ$ . Five beams, one control beam, two initially strengthened beams and two precracked and repaired beams were cast and

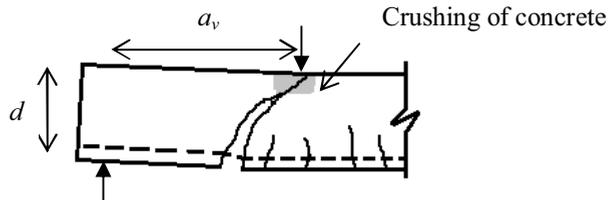
**Fig. 2.** Shear compression failure [2]

Case I: Shear compression failure,  $a_v/d = 1$  to 2.5

From Fig. 1,  $V_{cc}$  is the un-cracked concrete compression zone,  $V_d$  is the dowel action of longitudinal reinforcement and  $V_{ca}$  is the vertical component of the force due to aggregate interlock or interface shear transfer. Effectively, the shear failure mechanism of RC beams are governed by a number of factors such as the compressive strength of concrete ( $f_{cu}$ ), effective depth of the beam ( $d$ ), maximum aggregate size ( $d_a$ ), and shear span to depth ratio ( $a_v/d$ ). It has been reported by Sinha [2] that the behaviour of beams failing in shear can be studied with respect to the different shear span to depth ratio ( $a_v/d$ ). Three common cases of shear failure (Case I, Case II and Case III) with different  $a_v/d$  ratio were outlined by Sinha [2] and are as shown in Fig. 2, Fig. 3 and Fig. 4 respectively.

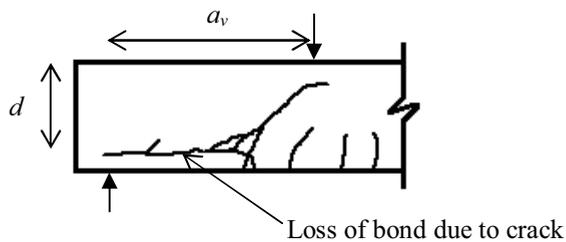
**Fig. 3.** Shear tension failure [2]

Case II: Shear tension failure,  $a_v/d = 1$  to 2.5

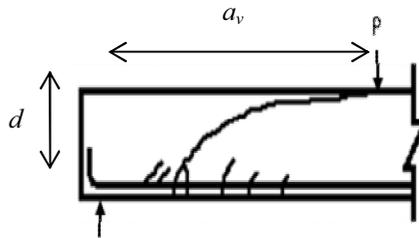
**Fig. 4.** Diagonal tension failure [2]

Case III: Diagonal tension failure,  $a_v/d \geq 2.5$  to 6

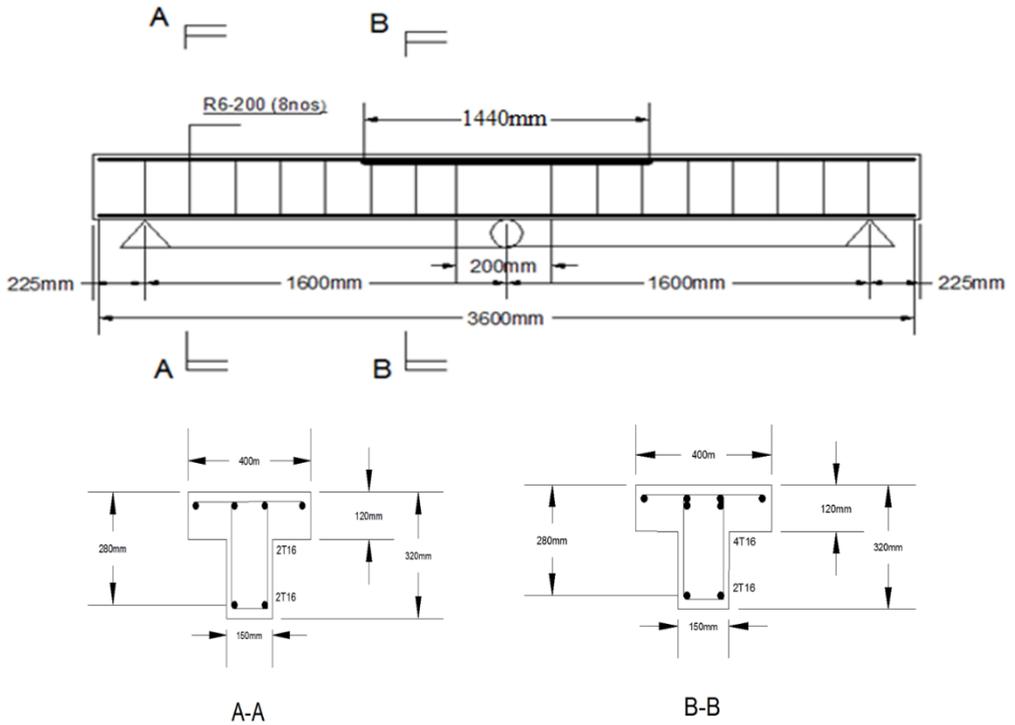
**Fig. 5.** Reinforcement and cross section details

The experimental work consists of testing five 2-span continuous RC T-beams with identical size of 150 mm x 320 mm x 3650 mm, flange width of 400 mm and flange thickness of 120 mm. All T-beams had identical reinforcement detailing, including nominal stirrups and longitudinal reinforcement. Fig. 5 shows the beam size and reinforcement details. All beams were designed to fail in shear and were strengthened and repaired using Carbon Fibre Reinforced Polymer (CFRP) strips from SikaWrap-160 BI C/15 [10], see Fig. 6. The CFRP strips were orientated at, either,  $0^\circ/90^\circ$  (Fig. 7(a)) and  $45^\circ/135^\circ$  (Fig. 7(b)). Due to the limitations of the test frame, the specimens were subjected to a shear span to effective depth ratio ( $a_v/d$ ) of 1.85. The five beam specimens includes one control beam and four reinforced concrete T-beam. All the specimens are labelled as follows: Control Beam (T1.85-C), Beam 1 (T1.85-U-V1), Beam 2 (T1.85-U-V2), Beam 4 (T1.85-U-S) and Beam 4 (T1.85-L-S). Beam 1 and Beam 2 are initially strengthened beams whilst Beam 3 and Beam 4 are precracked and repaired beams. Observed that Beam 1, Beam 3 and Beam 4 were wrapped with a single layer of CFRP strip whilst Beam 2 with two layers. The investigation comprises of its ultimate load and shear capacity, load-deflection profile, its modes of failure and crack pattern of the specimens. All specimens had similar targeted concrete compressive strength of  $30 \text{ N/mm}^2$ , main reinforcement tensile strength of 460

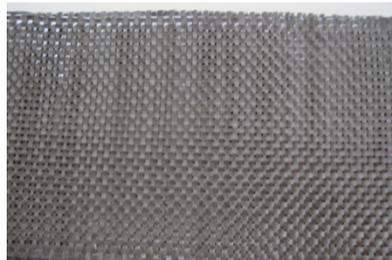
**Fig. 6.** SikaWrap-160 BI C/15

$\text{N/mm}^2$  and stirrups tensile strength of  $250 \text{ N/mm}^2$ . The selected fiber reinforced polymer was a bi-directional CFRP sheet cut at strips of  $80\text{mm}$  in width and were spaced at  $150\text{mm}$  centre to centre (see Fig. 7(a) and 7(b)). Table 1 shows the material properties and its strength for concrete, steel and CFRP. The application of the CFRP strips was conducted by placing a coat of Sikadur-330 epoxy [9] to the concrete surface, see Fig. 8. The CFRP strips were then placed accordingly within the shear span ( $a_v$ ) and allowed to cure for one week before being placed in the testing frame. Note that Beam 3 and Beam 4 (as precracked and repaired beams) were preloaded up to 70% of the ultimate load to create the initial shear cracks of the beams. Upon reaching the 70% load, the beams were unloaded followed by the application of the CFRP strips along the initial shear cracks.

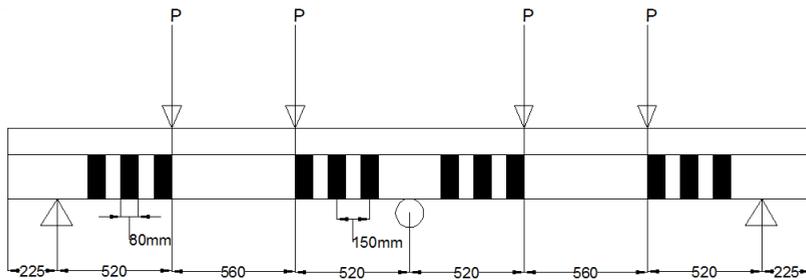
(a) CFRP orientation at 0°/90°

**Fig. 7.** CFRP orientation of 2 span continuous RC T-beams

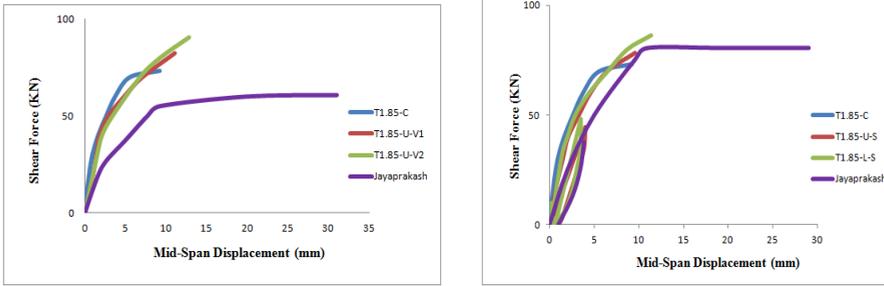
Fig. 9. Load-deflection profile

The load-deflection profiles are shown in Fig. 9(a) for Beam 1, Beam 2 (initially strengthened) and Fig. 9(b) for Beam 3, Beam 4 (precracked and repaired beams). Comparison with deflection profile of the control beam (T1.85-C) and findings from Jayaprakash et al. [11, 12] was made for further clarity. By observation, the deflection profile for initially strengthened beams (Beam 1 and Beam 2) showed stiffer responses compared to Jayaprakash et al. [11, 12]. However, less displacement values were recorded at failure but still shows an improved ductility behavior compared to control beam. Results show that displacement values for Beam 1 and Beam 2 was recorded at 12 mm and 14 mm respectively.

For Beam 3 and Beam 4 (precracked and repaired), similar trends and close proximity of deflection profile was observed with Jayaprakash et al. [11, 12]. By comparison with the control beam, the deflection at failure was slightly higher at 11 mm and 13 mm for Beam 3 and Beam 4 respectively indicating an improve ductile behaviour.

(a) Initially strengthened

(b) Precracked and repaired
