# Post Windstorm Evaluation of Critical Aspects Causing Damage to Rural Houses in the Northern Region of Peninsular Malaysia

**Abstract.** Rural houses are susceptible to roof blown off and severe damage during a windstorm event due to the lack of engineering considerations. The aim of this paper is to conduct a post windstorm evaluation on the damaged rural houses located in the northern region of Peninsula Malaysia. Several activities were involved during the post windstorm survey including site visualization, site measurement and interview. Critical aspects including types of damages, types of houses, gap height, overhang length, roof geometry, roof pitch, roof cladding and terrain category were analysed using a simple bar chart. It is anticipated that the presence of kitchen house influences the overall stability of the rural houses due to the formation of gap height.

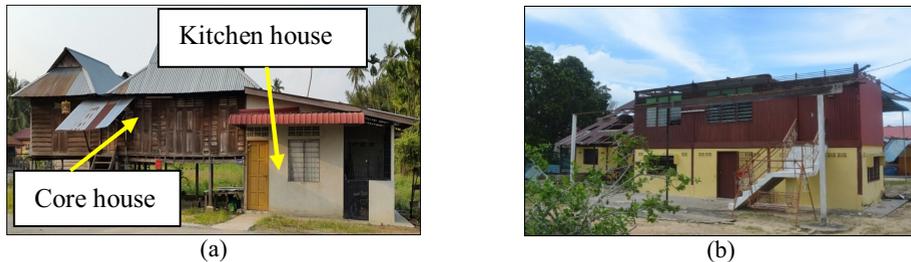
The non-engineered low-rise buildings are defined in various building categories, including residential, institutional, and commercial structures. These types of buildings are most vulnerable to be damaged during windstorm [1, 2, 3]. Typically, they were built with a minimum or no structural engineering design compared to other buildings that use codes and standards [4]. In Malaysia, rural houses are considered as non-engineered building, typically built according to the location and culture. One of the features of the rural houses in Malaysia is the presence of the core house (rumah ibu) and the extension house or kitchen house (rumah dapur) as reported by [5]. Fig. 1(a) shows an example of a rural house comprising a core and kitchen house.

Fig. 1(b) shows a rural house that suffers from roof blown-off and severe damage to the truss system during a windstorm event. Such damages are normally associated to the high uplift pressure generated at the roof of the house. [6-7] concluded that roof is the most damaging and vulnerable part of the house during windstorm as it is always subjected to the largest wind force. Failure of the roofing system is primarily from the weakness of the attachment and roofing material as stated by [8].

**Fig. 1.** (a) Core and kitchen house (b) Severe damage to the roofing system of a rural house.

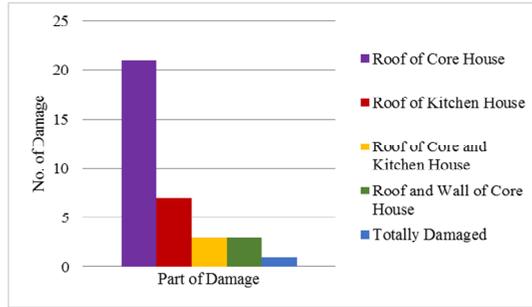
Wind can cause different types of damage to the rural house such as roof blown-off, wall damage and total collapse. The survey data in Fig. 2 shows that 21 houses (60%) experience damage at the roof of the core house only and this number is triple the houses experiencing damage the roof of the kitchen house only. In addition, 3 houses suffer damage at both roofs while another 3 houses suffer damage at the roof and wall of the core house. The survey also recorded 1 house that was totally collapsed due to the windstorm. The results matched the statement provided by [6, 7] where the roof system was found to be the weakest component for a low rise building. It is interesting to note that more number of roof damage was recorded for the core house compared to the kitchen house suggesting that

**Fig. 2.** Types of damages.

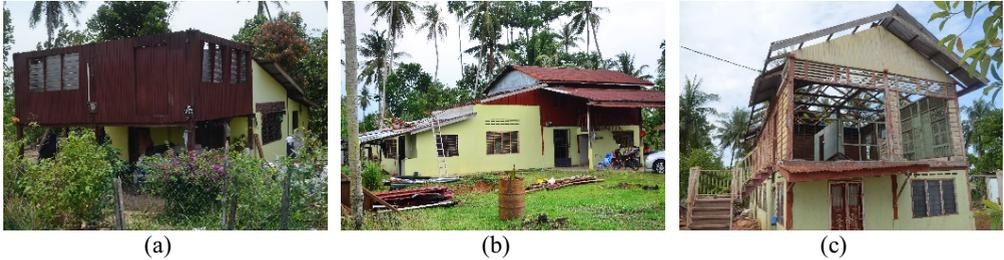
presence of the gap between the two roofs and the orientation of the kitchen house may have influence the wind pressure within the vicinity of the roof area. Fig. 3 shows some examples of the damaged rural houses.

**Fig. 3.** Example of types of damage (a) roof of core house (b) roof of kitchen house (c) roof and wall of core house.

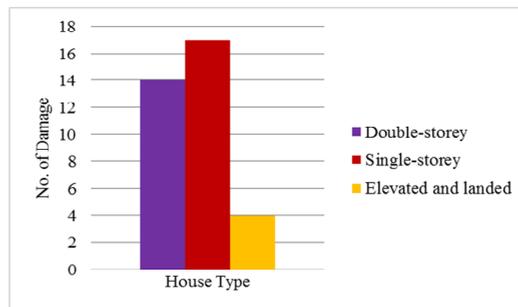
The main frame of rural houses was built using two different types of construction materials namely concrete and timber. Fig. 4 shows that 17 single-storey (concrete), 14 double-storey houses (concrete and timber) and 4 elevated and landed (concrete and timber) houses suffer one form of damage as presented earlier in Fig. 3.

**Fig. 4.** Number of damage according to the types of houses.

It was thought that double-storey and elevated houses would show more number of damages due to the fact that higher structure generally will be exposed to higher wind speed

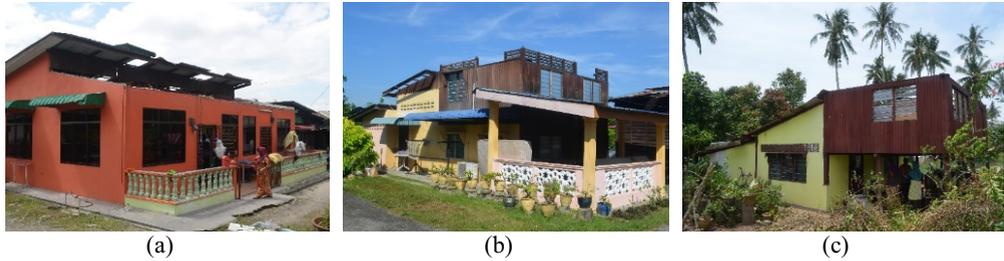
and pressure. However, this contradicting result can be related to the difference in the gap height of between the core and kitchen house. Some typical examples of the houses are shown in Fig. 5. Obviously, the gap height for the single-storey houses were smaller compared to other types of houses in this survey. The construction materials for the main frame were found to be insignificantly influencing the occurrence of damage due to fact that most all damages occurred at roof compared to other parts of the house. However, in general, timber frame is considered to be more susceptible to damage compared to concrete.

**Fig. 5.** Severe damage to the roof of (a) single-storey (b) double-storey (c) landed and elevated rural houses.

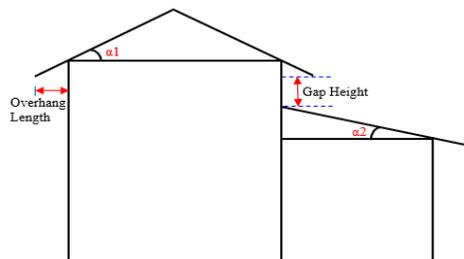
Fig. 6. shows the location of the gap between the roof of the core and kitchen house. Currently, there is very limited information in the open literature explaining the influence of the gap on the distribution of pressure surrounding the roof area.

**Fig. 6.** Schematic diagram showing the location of the gap, the measurement of the gap height between the roof of the core and kitchen house as well as the overhang length.

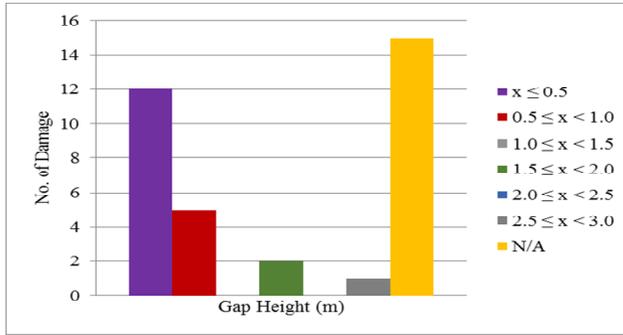
However, the results in Fig. 7 show a significant trend where rural houses with small gap height are prone to damage (mostly to the roof). This statement is particularly true where 12 houses with gap height less than 0.5 m suffered severe damage compared to the larger ones. However, the actual number of these houses with gap height in this category may be affected because no data was made available for another 15 houses due to unforeseen matters. As the gap height increases, the number of damaged houses reduces

significantly. Theoretically, the maximum gap height is achieved when there is no kitchen house being attached to the core house. In this case, the wind force may have directly impinged on the wall of the core house without developing any recirculation zone in the windward direction as shown in the work of [9]. As such, this finding gives an early indication on the sensitivity of the gap height and kitchen house towards the vulnerability of rural houses against windstorm.

Fig. 7. Number of damages affected by the gap height.

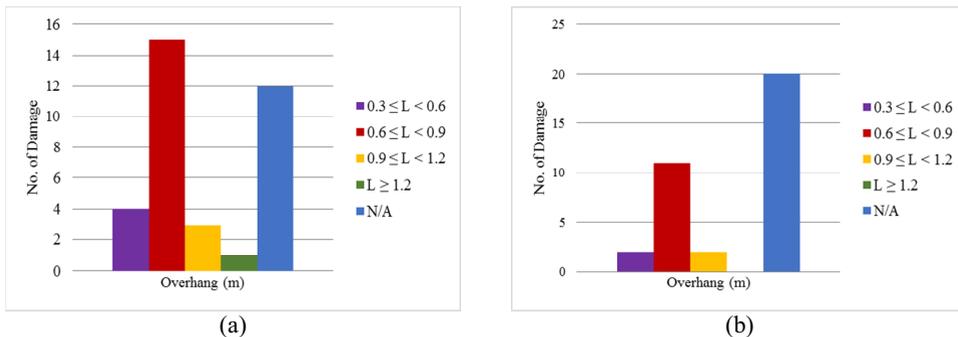
This survey splits the number of damaged houses based on the overhang length of the core and kitchen house as shown in Fig. 8(a) and (b), respectively. To simplify the data, the overhang length is grouped according to the length within a stipulated range. It can be seen that most of the damaged rural houses are built with overhang length in the range of 0.6 to 0.9 m where 15 and 11 houses are affected when considering the overhang length for the core and kitchen house, respectively. The presence of overhang length may create high turbulence and uplift underneath the overhang area. The deflected flow from the windward wall increased the pressure on the lower eave surface while high suction was developed on the upper eave surface immediately after separation had occurred as reported by [10].

Fig. 8. Number of damages associated to the overhang length of (a) core house (b) kitchen house.

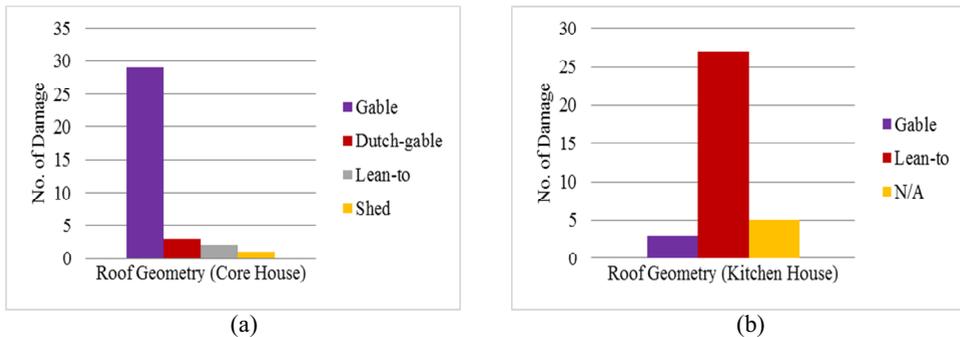
The geometry of the roof may have significant influence on robustness of the roofing system. It is well recognized that roof geometry can change the flow patterns around the house and building [12]. There are four different types of roof geometry that can be commonly found in the rural area namely the gable, dutch-gable, shed and lean-to (skillion) roof as shown in Fig. 9. Based on post windstorm damage survey, 29 core houses were constructed with gable roof geometry. The rest of the roof geometries showed insignificant influence on the damage and less than 3 houses were recorded for each case as shown in Fig. 9(a). [12, 13] proved that gable roof always recorded a high suction on the roof while [14] found that the most critical suction values were observed near the gable end. On the contrary, 27 kitchen houses were constructed with lean-to roof geometry as shown in Fig. 9(b). It is thought that presence of wall at the far end of the roof may developed turbulence and induced uplift underneath the overhang of the roof for the core house. Fig. 10 shows some examples of the roof geometry.

**Fig. 9.** Number of damages caused by roof geometry for (a) core house (b) kitchen house.

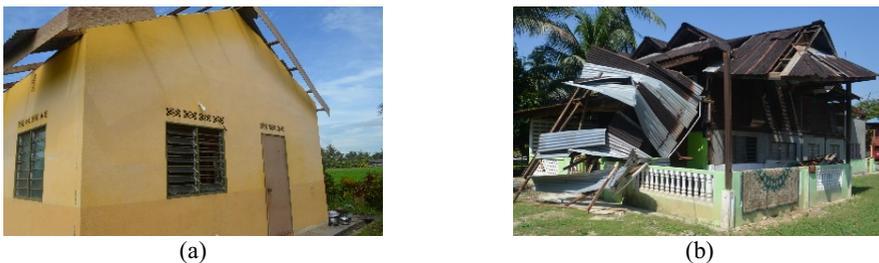
**Fig. 10.** Example of roof geometry (a) gable; (b) dutch-gable.

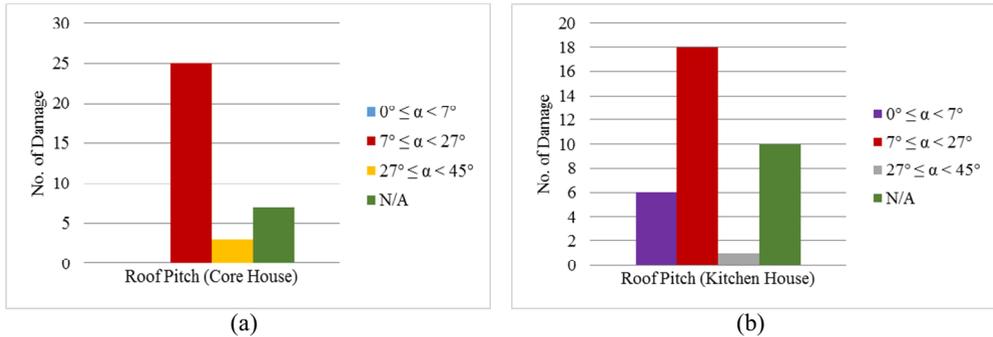
Fig. 11(a) shows that the roof pitch of the core house for 25 damaged houses is located in the intermediate range between  $7^\circ \leq x \leq 27^\circ$ . Similarly, the same range of roof pitch for the kitchen house also exhibits the highest number of damaged as shown in Fig. 11(b). Different roof pitches produced different flow patterns on the roof. For wind flow perpendicular to the ridge for intermediate roof, the flow separated at the leading edge, reattached on the upwind slope of roof, then separated again at the ridge. As stated by [15], this range of roof pitch was able to produce worst results and particularly true for gable roof.

**Fig. 11.** Number of damages with respect to the range of the roof pitch for (a) core house and (b) kitchen house.

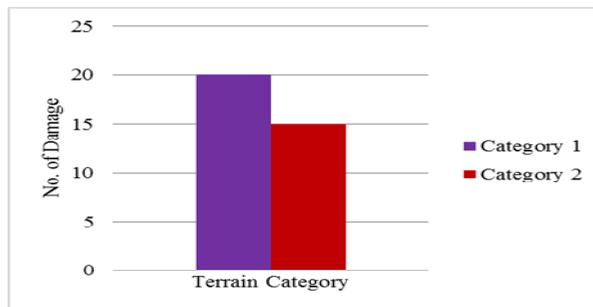
Fig. 12 shows that 20 of the damaged houses are located in an open terrain with no or few obstructions, commonly known as Terrain Category 1. These areas normally cover paddy fields and water surfaces. Such areas can largely be found in the part of the mainland of Penang, Kedah and Perak. On the other hand, the other 15 damaged houses are located in an open area with a few scattered obstructions having height generally from 1.5 m to 10.0 m, commonly known as Terrain Category 2. [16] reported that with increase in the surrounding obstructions, the mean wind pressure acting on the building decreased while unsteady pressure increased. Open terrain can cause a direct attack where the wind will directly impinge on the structures. Topographic features such as hills can also speed-up or slow-down the wind flow [7].

**Fig. 12.** Number of damages based on the surrounding conditions.
