# Analysis of the Causes and Recommendations on Elimination of Biological Damage of Structures During the Repair and Reconstruction of the State Biological Museum in Moscow

**Abstract.** The article presents the results of mycological research on buildings of the State Biological Museum located in Moscow. Over time, the building maintenance conditions have worsened, in particular because of construction of high-rise buildings in the immediate vicinity of the museum, as well as construction of a greenhouse above the underground passage tunnel between buildings 1 and 2. Over the years, the temperature gradients, high humidity, wear and damage of wall waterproofing and foundations have caused leaks in the underpass tunnel and the biological corrosion of stone, wood and metal structures in indoor exhibition halls. In this connection, part of the survey was to determine the types and size of biological lesions in structures, determination of the causes of biological damage, and the development of measures to eliminate the mycological problems during repair and reconstruction works in the museum.

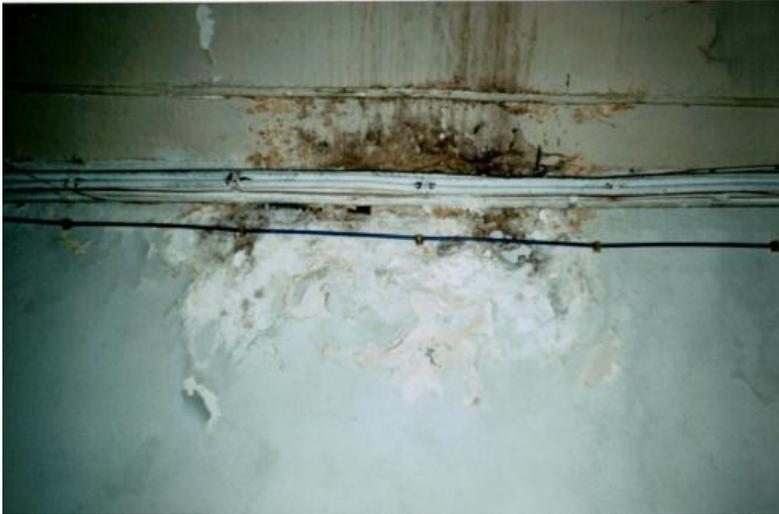
**Fig. 1.** Mould colony in the underground passage

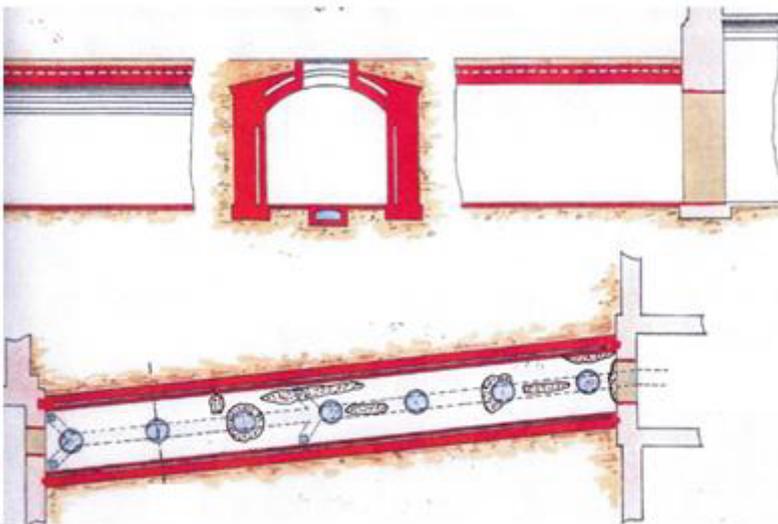
The main exhibition halls of the museum located in the building (building 1) designed by the architect A.E.Erichson in 1898. Until the present time, basements and premises of the 1st and 2nd floors have been used. In the building (Building 2), designed by the architect B.V.Freudenberg, museum administration, research laboratories, restoration workshops, scientific library, shopping service are located. To connect the buildings 1 and 2 the architect A.E.Erichson designed and built an underground passage shown in Fig. 1. Later on, above the tunnel a greenhouse was built for year-round operation with electric lighting, hot and cold water supply, sewerage. The tunnel is equipped with manholes, which are destined for lighting the tunnel interior space with natural light. Over the years, the temperature gradients, high humidity, worn waterproofing caused leakage through the tunnel body. Mould colonies appeared (Fig. 2), which caused the biological corrosion of stone materials in the tunnel [1, 2, 12]

**Fig. 2.** Location of mould colonies in the underground passage between the buildings 1 and 2.

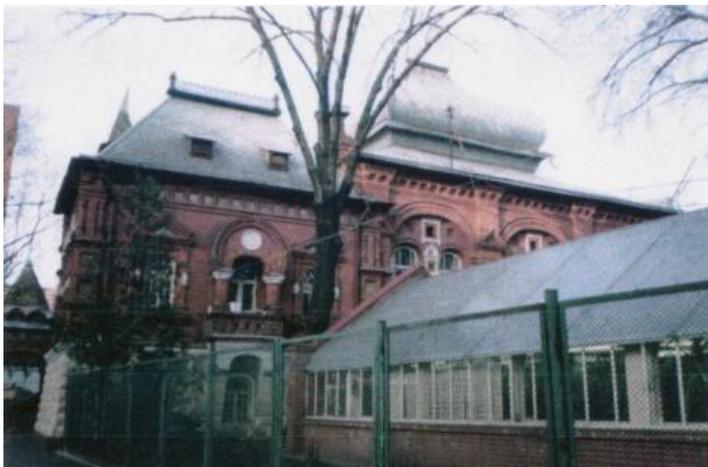
Building 1 has a basement floor and two underground floors and an attic room located in the space. A general view of the structure 1 and a greenhouse on an underground passage between buildings 1 and 2 is presented in Figure 3.

**Fig. 3.** General view of the building 1 and the greenhouse above the underground passage between buildings 1 and 2

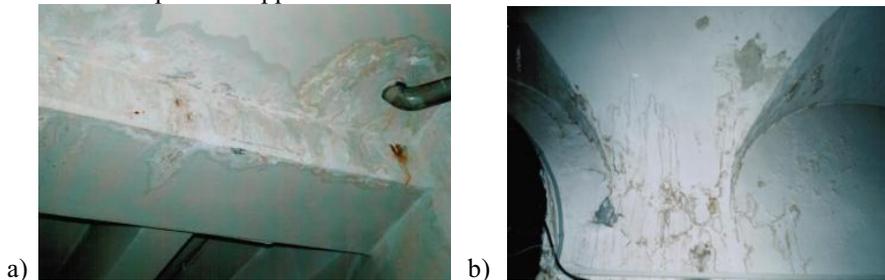
The figure 4 shows colonies of mould fungi in their location places.

The development of fungi is facilitated by poor ventilation of premises. These factors shown are observed in the investigated areas.

Analysis of the places of location of fungal lesions (Fig. 4) showed that in the centers of biocorrosion paint and plaster coatings are mostly destroyed. Additional danger of colonies consists in that they are a background for germinating of the fungus *Serpula Lakrimas*, which damages books and other materials.

**Fig. 4.** Colonies of mould fungi in their location places of the building 2. (a) – on the wall; b) - in the vestibule ceiling).

While developing measures to eliminate mould, you must first remove conditions favorable for their development, i.e. surface humidity of wall materials exceeding 10%. Otherwise, the fungicidal treatment of wall materials will be effective for not longer than 2 years.

2. Remove the plaster coating on the walls in the location area of the colony not less than 1.5 m<sup>2</sup>.
3. After removing the area to be processed with a blowtorch.
4. Bare, after removing the plaster, wall surface to be processed with "Cartocide-compound" diluted with water twice.
5. In the subsequent plastering of the places a concentrated solution "Cartocide-Compound" in the amount 2% of cement weight, has to be added to the plaster solution.

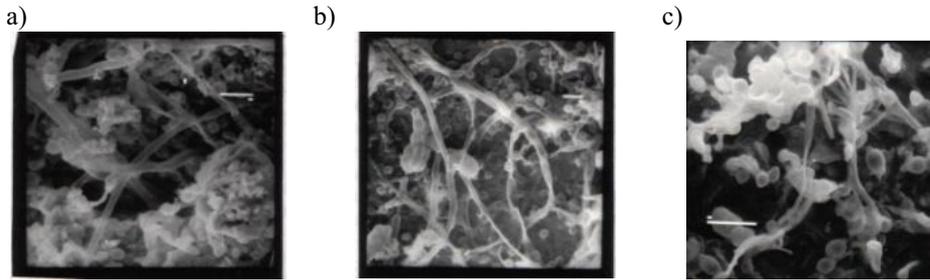
Microscopic analysis of samples taken in different rooms has shown that in this building there are the following types of fungi: white mould (*Penicilium*), green mould (*Aspergillum*), black mould (*Cladosporium*). Mould colonies develop in the specified order. Note that the plastered surfaces in the building are painted with oil paint, which with time forms shrinkage cracks. Spores colonize the cracks, leading to the formation of white mould colonies, which detach oil paint. Afterwards green mould colonies arise that create a breeding ground for black mould.

**Fig. 5.** Dissolved plaster samples with different types of mould. a) white mould; b) green mould, c) black mould

The data (Fig. 5) prove the development activity of fungi lesions (presence of mycelium, punks). In this case, it is necessary to note the increase in density of their biomass, which in itself is a destructive factor. Note that the biocorrosion mainly affects sand-cement compositions (plaster coverings) because a breeding ground for them is calcium hydroxide  $\text{Ca}(\text{OH})_2$ . In addition, the plaster samples taken demonstrated the lowest durability of soluted cement-sand plaster.

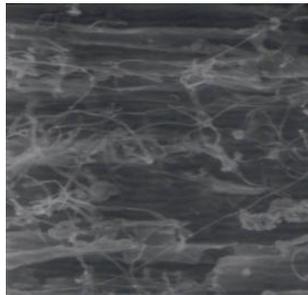
Another timber destroyer - "mine fungus" has spores in the form of filamentary chains, pierced with smooth fibers, binding all in a single unit (Fig. 7).

**Fig. 7.** Thread fungi spores found in wooden walls of the building

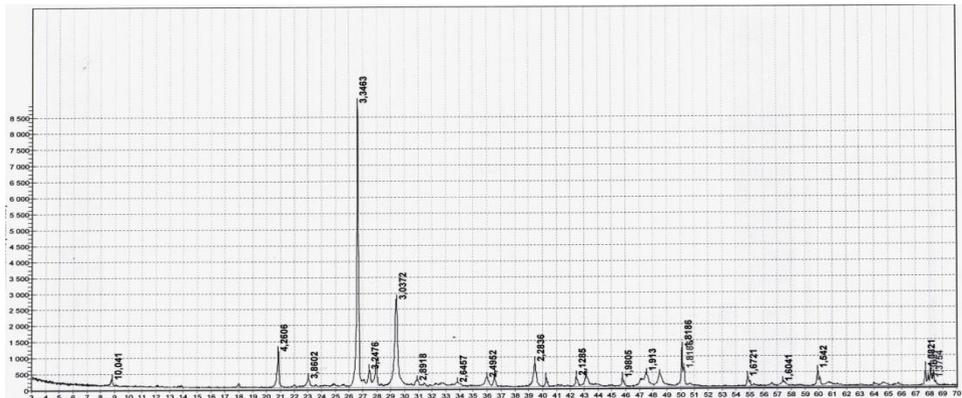
The study of metal structures was conducted using X-ray diffraction method. Figure 8 is an X-rayogram of rust, efflorescence scale and the most damaged portions of steel structures that are complex salts containing NaCl,  $\text{Na}_2\text{CO}_3$ ,  $\text{MgCO}_3$ , and the silica gel  $\text{Si}(\text{OH})_4$ . These include such as  $\text{Fe}_2\text{O}_3 \times \text{CO}_3$ ;  $\text{Fe}_2\text{Si}_2\text{O}_5 (\text{OH})_4 \cdot 2\text{H}_2\text{O}$ ;  $\text{Na}_3\text{Mg} (\text{CO}_3)_2 \text{Cl}$ .

Chlorides of sodium and magnesium metals in combination with the moisture are steel corrosion process activators. They are adsorbed on the surface of structures, displacing oxygen and causing pitting corrosion of steel.

**Fig. 8.** X-rayogram of the microstructure of the most damaged parts of steel structures

$\alpha$  FeO (OH) and  $\gamma$ FeO (OH) - alpha and gamma hydrohematite – the substances having high absorption properties and increasing the initial volume. Thus, neoplasms Fe (HCO<sub>3</sub>),  $\alpha$  FeO (OH) and  $\gamma$ FeO(OH) provoke internal stresses and destroy steel bearing components of the building.
