Some geocological aspects of suffosion danger in the road infrastructure using

Abstract. Danger of emergence and extension of suffosion processes is considered on the example of some objects of the road infrastructure. Need of the analysis and accounting of suffosion risk in construction and operation of highways is proved. The model which is showing the mechanism of suffosion destruction of soils, hidden from direct observation in natural conditions, is given. The results of the experiment which is directed for the studying the features of extension of slope suffosion process near Schmidt Direction Street of Moscow are presented. The possibility of forecasting of emergence and extension of suffosion processes under the influence of natural and technogenic factors, and also determination of the amount of the expected underground and surface suffosion manifestations (zones of destruction, cavities, failures, decreasing, etc.) is shown. Conclusions of the initiating reasons of suffosion processes on objects of road infrastructure and some preliminary recommendations for their prevention are made.

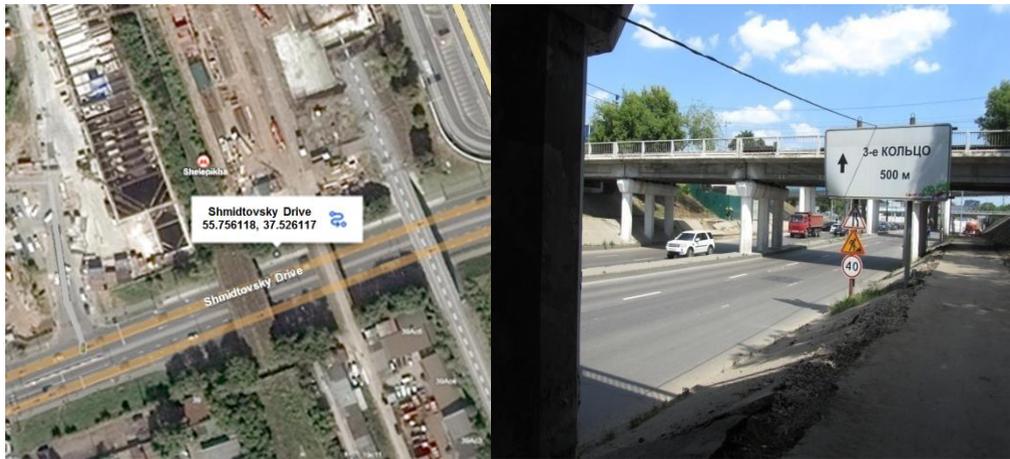
As an object of a research, the section of the highway near Schmidt Direction Street of the house 39 A, 6th building of Moscow (Figure 1) served.

Fig. 1. The place of extension of suffosion and erosive processes on a highway slope near Schmidt Direction Street of the house 39 A, 6th building of Moscow.

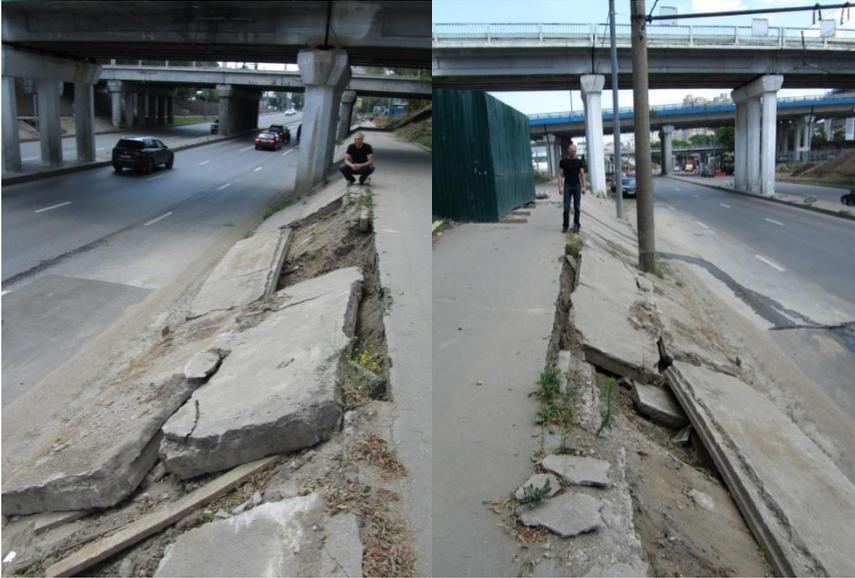
In the middle of June, 2016 authors revealed and recorded destruction and a failure of the plates of a covering of a slope which is adjoining to the lower reinforced concrete grillage dividing the strengthened slope and the carriageway of Schmidt Direction Street. (Figure 2).

Fig. 2. Destruction of concrete plates of a slope of the highway near Schmidt Direction Street of the house 39 A, 6th building of Moscow.

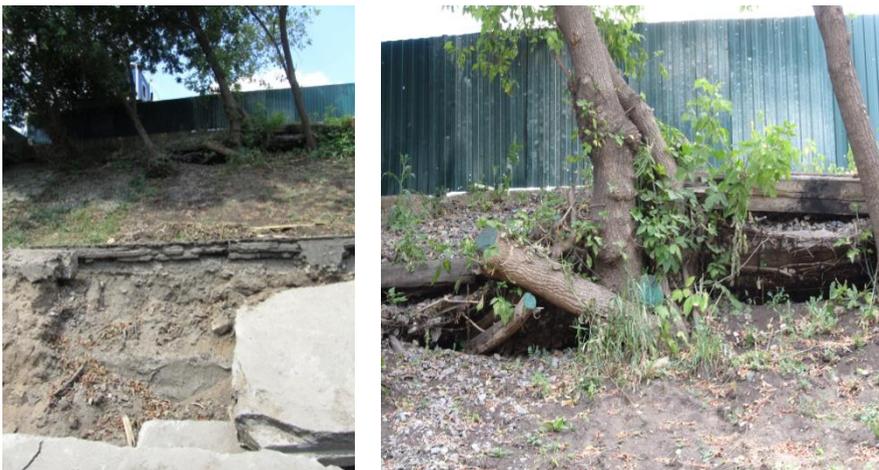
During a survey of the place of deformation of soil as a result of a suffosion, the destruction of concrete plates is visible, and above on a slope the initial stage of erosive washout of its surface (Figure 3) is found. As a result of an erosion of the soil horizon the root system of the trees and bushes growing on this slope is partially naked [2,12].

Fig. 3. Erosive destruction of a surface of a not strengthened slope and an exposure of root system of trees.

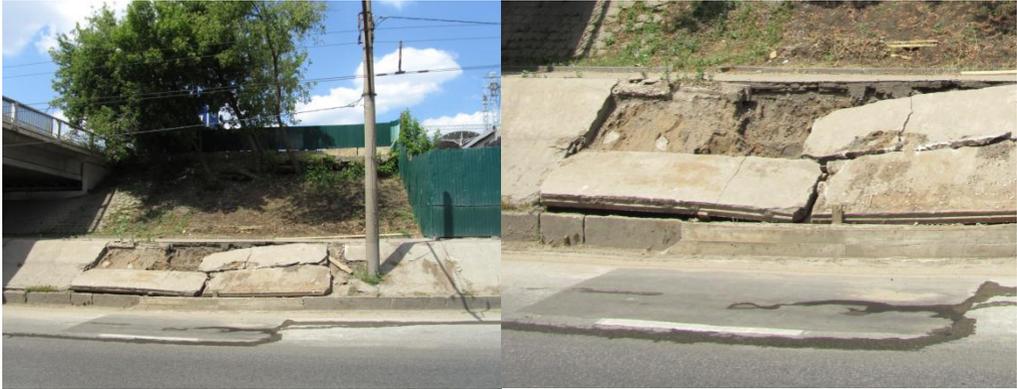
The basis of the slope strengthened by means of concrete plates is put largely and medium-grained sands with inclusion of a gruss and crushed stone that visually illustrates on the Figure 4. The approximate volume of the taken-out soil up to 2.2 m^3 .

Intensive atmospheric precipitation, and uncivilized dumping of surplus of water from the building site which is above on a slope were the prerequisites which provoked a suffosion (Figure 4). The soils of a slope lost the structural durability.

Fig. 4. The destroyed slope plates, the restored tape of a grillage, asphalt «patch».

The direction of carrying out of soil from top to down, under concrete plates of facing of a slope is visible. Extension of the suffosioncourse and the increased hydrodynamic pressure in the lower part of a slope caused carrying out of sandy soil, formation of a suffosion cavity and the subsequent to it a plate failure. During the further inspection of the place of destruction it was established that the reinforced concrete blocks dividing the strengthened slope and the carriageway were dismantled, and instead of them on this place the reinforced tape of a grillage is laid. Asphalt«patch» on the carriageway of the highway, is a consequence of extension of a suffosion. There was a subsidence and the subsequent failure of soil under asphalt covering that presumably initiated the shift and destruction of reinforced concrete blocks and plates of a slope.

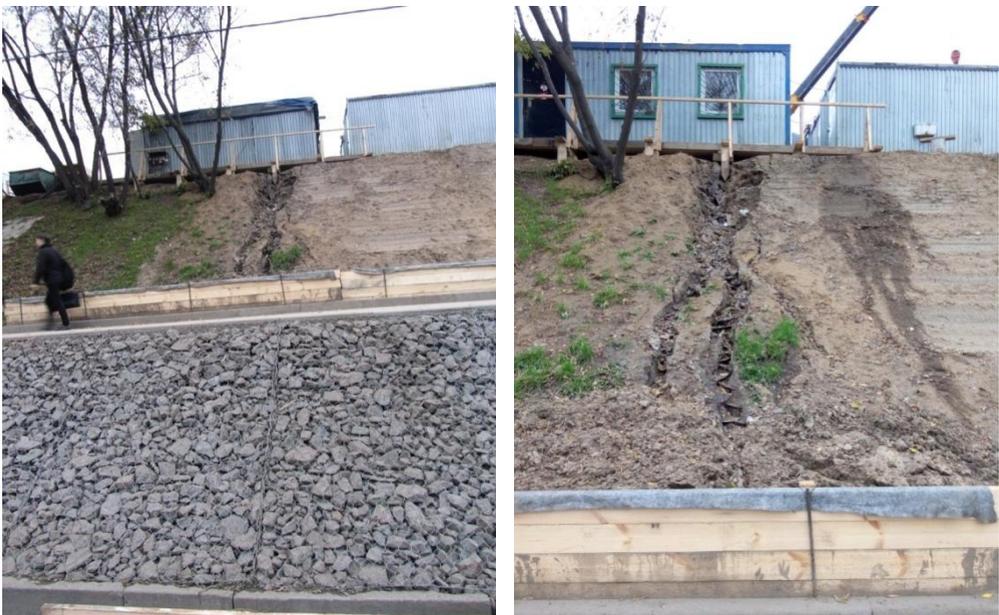
At the beginning of October, 2016, (Figure 5) road services, made dismantle of concrete plates, partial recultivation of slopes and strengthening of the lower part of a slope by a gabion. However incorrectly organized system of a drain from the building site led to emergence and extension of erosive gullies on a slope surface again.

Fig. 5. The slope strengthened by a gabion. A large erosive gully on a slope surface.

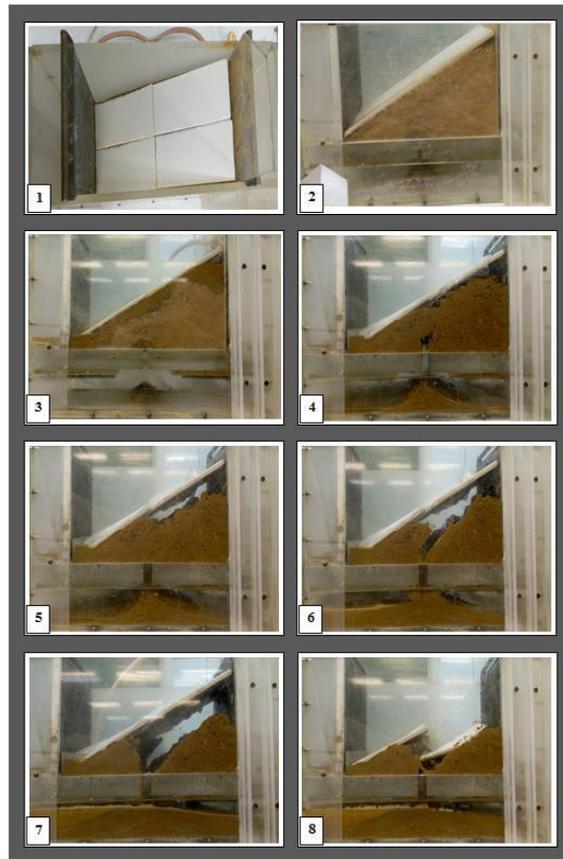
For studying of the mechanism of development of slopesuffosion process on a highway slope near Schmidt Direction Street of the house 39 A, 6th building of Moscow, the authors were carried out its laboratory modeling. A technique of carrying out experiment. Installation for modeling of emergence and extension of suffusion processes represents the rectangular working camera manufactured of plexiglas with transparent walls.

The working camera having the sizes of 32*20*17 cm [2] during the experiment the camera was filled with model material (initial soil) on height of 170 mm, with coefficient of consolidation of k_{com} 0.9 – 0.88 and under the inclination which was imitating a corner of a slope of the highway of the planned steepness - 33°. In continuous impenetrable bottom of foundation of installation was made the cut, which was imitating the suffusion channel. According to the experiment purpose atop obliquely of the located material of model the ceramic granite elements imitating the concrete plates strengthening a slope were laid. Material of model represented mix small, medium and coarse-grained sands with inclusion of a gruss and crushed stone. Working soil was selected and prepared so that the model, reflected structure of the original of material of the slope composing the basis as much as possible objectively. Particle size distribution of soil following: to 15% coarsely clastic, to 45%coarse-grained particles, and filler - particles less than 0.5 mm in size. Material of model has the texture imitating a natural object in which particles of filler have a possibility of free movement between soil skeleton particles under the influence of hydrodynamic forces, and thus, material of model is suffosion unstable. Then water supply, in a zone of its alleged penetration, under the bases of plates in the top point was organized. The sequence of stages of formation of a suffosion failure is shown on the Figure 6.

Fig. 6.Results of an experiment on imitation of formation of a suffosion failure on a highway slope.

Thus, the hypothesis of the suffosion nature of the process which caused destruction and a failure of concrete plates of a slope of the highway near Schmidt Direction Street was confirmed.

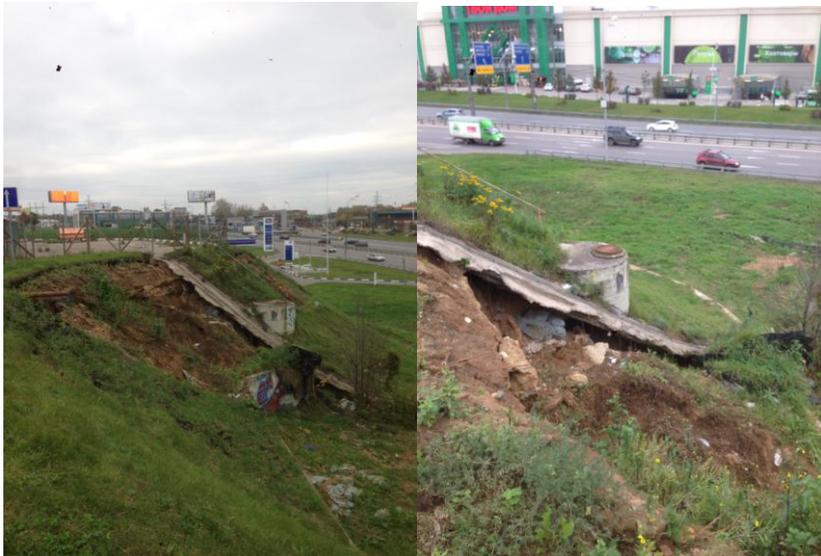
As object of a research the site of a slope of the highway around crossing of OstashkovskoyeShosse highway and MRHW(Moscow ring highway)was used. (Figure 7). As system of water disposal on this section of the road serves the concrete tray (Figure 7) intended for dumping of surplus of water from the carrieway of the highway down to the slope basis.

Fig. 7.The site of a slope of the highway around crossing of OstashkovskoyeShosse highway and MRHW.Reinforced concrete tray of system of water disposal.

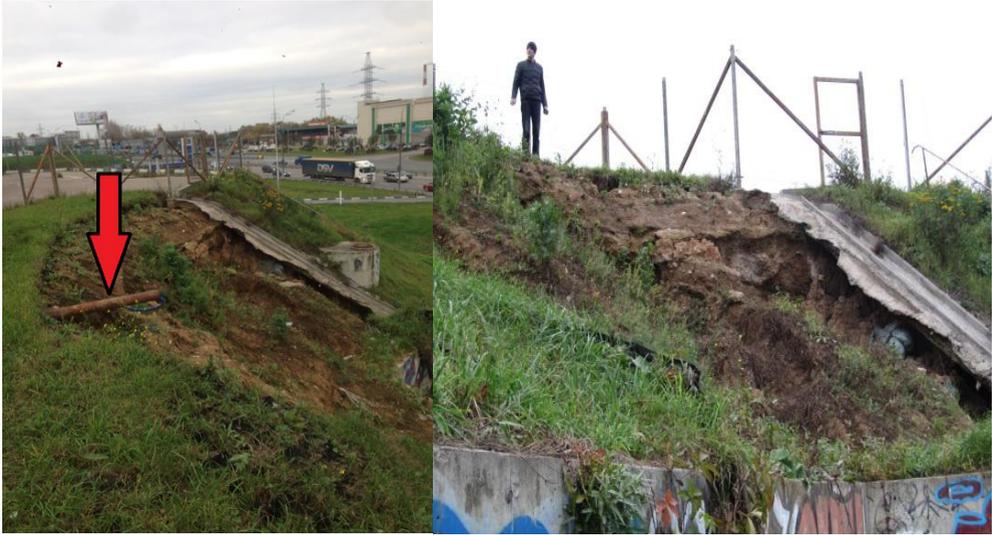
However, because of a possible error of design and the wrong arrangement of a tray, water drainage on this site, actually, was not provided. Besides, during inspection of the adjacent territory, it was found, that there established a supplemental metal pipe of water disposal (at the left, approximately in 17 m from a tray) (Figure 8).

Fig. 8. Supplemental metal pipe of water disposal. A large erosive gully in the tray basis.

As a result of uncivilized dumping of water from the surface of the highway numerous erosive gullies on MRHW slope were created. And also, caused by suffusion processes, destruction of the basis of a tray of system of a drainage system (Figure 8). The approximate volume of the taken-out soil from under a reinforced concrete tray was 11.7 m^3 .

Not acceptance of a complex of the timely actions directed to elimination of consequences of suffusion-erosive destruction of a slope of the highway, and also the organization of civilized dumping surplus of water from the carriageway can also provoke extension of landslide process that will lead to failure of the site of MRHW.

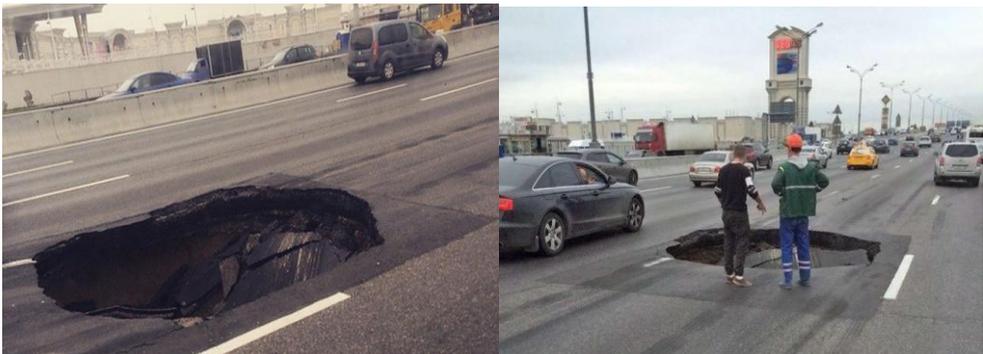
In June, 2015 on 24 km, in the second row of inside of MRHW the failure by the size $3 \times 4.5 \text{ m}$ and more than 2.5 m in depth was created. Asphalt «patch», on the place of a suffusion failure, demonstrates that shortly before this incident, in the same place the similar failure (Figure 9) was liquidated.

Fig. 9. A failure in the second row of inside of MRHW. Asphalt «patch» of the previous failure is visible.

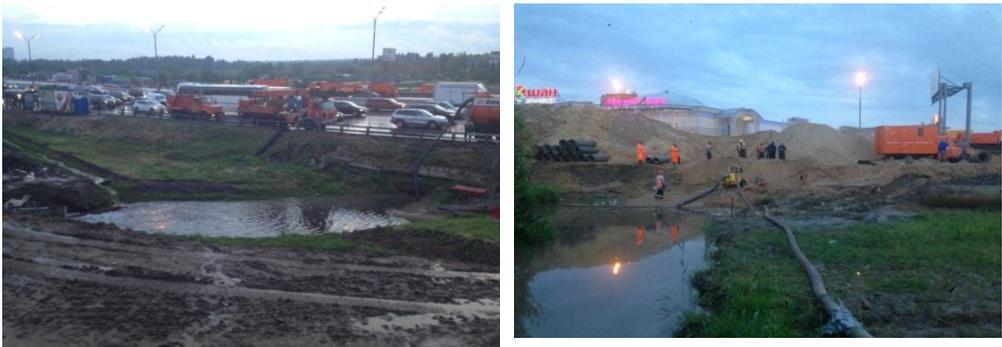
The numerous interviews given by various services, which arrived to the place of accident, came down to the fact that the failure happened because of the construction works connected with reconstruction of KashirskoyeShosse highway in this place. During the studying of a situation, the authors established the true, which caused a failure. At first, emergence of a failure was preceded by plentiful rainfall that led to overflow of the existing collectors and impossibility of short-term dumping of the collected water (fig. 10). Increasing of a pressure head gradient in the place of an exit of a pipe of water disposal from regional shopping center to the highway of a drain in MRHW was the second reason. The third, and the main reason of formation of a cavity under a roadbed, was low quality joining of pipes of the water highway (Fig. 11). During the increasing of the water level, at the expense of a pressure the water began to come to leaky interface of drainage reinforced concrete pipes and whirl took out sandy soil of the basis of an asphalt covering of the highway MRHW.

Fig. 10.Plentiful rainfall led to overflow of the existing collectors and increasing of head gradients pressure.

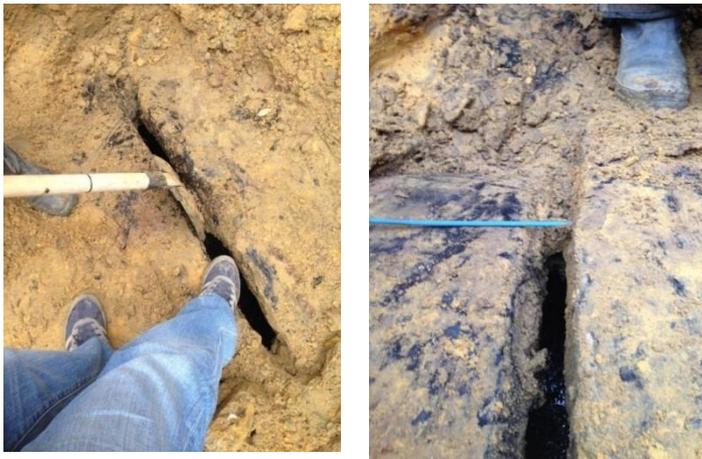
Fig. 11.Leaky joining of pipes of the water highway, width of an opening is 56 mm.

The active option represents the warning actions interfering of development of a suffusion. The careful waterproofing of interfaces of knots of designs and the organization of civilized system of a drainage and water disposal concerns to it.
