Evaluation of the traffic impact on residential building

Abstract. The paper presents an example of evaluation of the traffic impacts on the residential building. Residents noticed numerous damage to the building, which, in their opinion, were caused by the movement of trucks from the nearby transport base of agricultural equipment's. The control seals have been glued on all cracks of the building and elements close to the road, in order to determine the damages propagation. The building and ground vibrations were established during the study. The vibration accelerations in the frequency function at the selected points of building were measured. Taking into account the dynamic impact scales (DIS), the vibration influences on the building were specified. Measurements of accelerations and vibration velocities inside a building were also conducted in order to determine the harmfulness of vibration in relation to the people. As a result of vibration accelerations test in different places of building, it was found that building is located in the first zone of the DIS, which vibrations are classified as imperceptible by the building. The harmfulness of occurring vibrations to the people

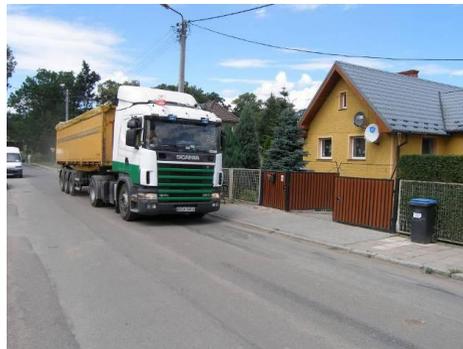
The discussed residential building was built before World War II and is located by a county road. Its 0.65 m thick walls are made of brick. The ceiling structure is made of wood. It is a storey building with no basement. It underwent reconstruction in the 90 s of the 20th century in order to improve its functioning – the floor was then lowered by 0.20 m at the ground level and the wooden ceiling structure over the storey was elevated to reach the minimal height for usable floor space, i.e. 2.20 m for the ground floor and 2.40 for the first floor. Extensions of the building (without basement) are a vestibule on the ground floor and an orangery on the first floor. The building is located at a distance of 12.0 m from the road axis. Fig. 1 shows an overview of the building at the time of a passage of a lorry.

Fig. 1. The residential building at the time of vibration measurements (passage of a HGV).

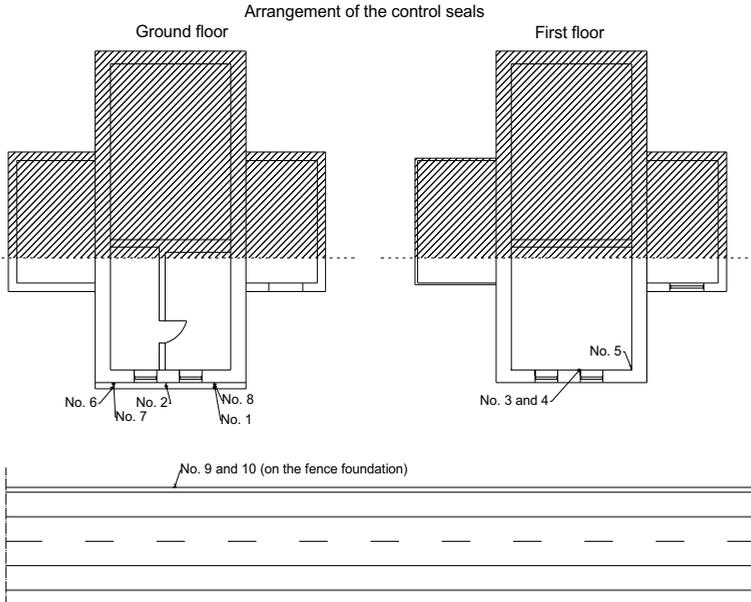
In order to determine the influence of traffic on the building, a detailed inventory of the damage identified in it was undertaken. Fig. 2 shows schematic distribution of control seals on identified cracks on the building. A total number of ten control seals were attached to the damages (cracks) of the building and on elements in the proximity of the road (fence foundation), the aim of which was to determine possible propagation of damages. The control stripes (seals) of plaster were 80×30 mm and 5 mm thick. The seals were secured with a transparent glass slab, at least as big as the seals. The cracks were generally classified as short and therefore the seals (1 or 2) were symmetrically fixed at the 1/3 and 2/3 of the crack height. Monitoring of the seals condition was held once a week over the period of two months. Fig. 3 shows example control seals on the building.

Within the period of monitoring of the seals condition, it was revealed, that the damages identified in the residential building were of non-structural nature, i.e. cracks and scratches of the coatings and plasters, relaxation of door and window mountings in the walls. These sorts of damages were observed on the first floor on the wall on the road side. Cracks on the fence foundation and the concrete floor around the building were observed too. Their dimension did not exceed 1.5 mm. Over the period of two months of monitoring of the seals no propagation of the cracks was observed on the floor of the building while the seals

attached outside the building (the fence foundation, the concrete floor around the building) show a minor tendency of the cracks to increase (of no more than 2 mm).

Fig. 2. Schematic distribution of control seals.

4. The damages found in the residential building were classified as non-structural, i.e. scratches and cracks in plasters and coatings. Monitoring of propagation of cracks held within the period of two months did not prove the damages would have a tendency to develop. The road pavement condition was classified at warning level in line with GDPRaM directives [8]. Numerous cases of surface roughness, cavities in pavement, collapsed drainage and sewage wells were observed.

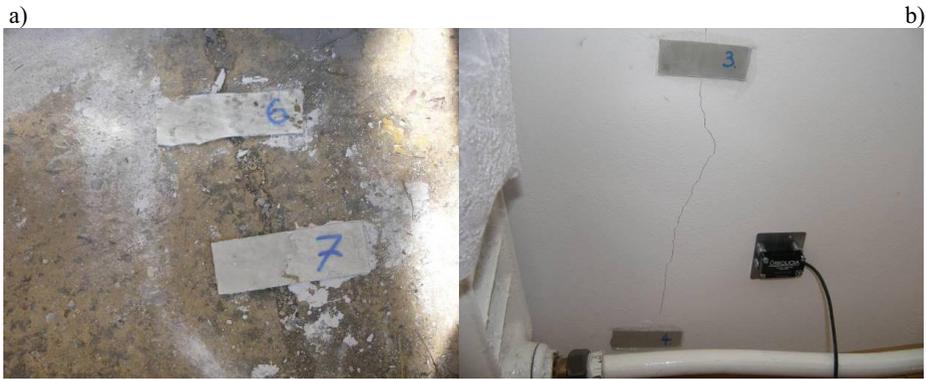
Fig. 3. The sight of control seals a) nos. 6 and 7 on concrete floor around the building (at ground level) and b) nos. 3 and 4 (in a room on the first floor of the building). The sensor to measure vibrations, located on the wall, is also visible.

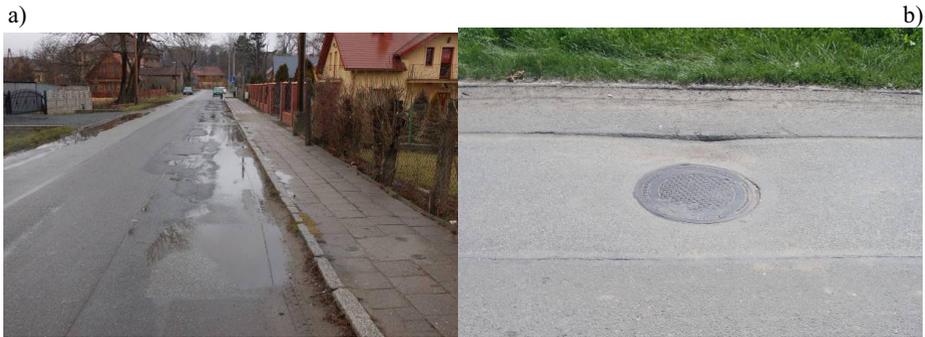
In order to determine the impact of traffic upon the residential building, an inventory of damages on the road in the vicinity of the building was held (ones with potential to increase dynamic impact on the building at the time of passage of vehicles). As a result numerous examples of damage and uneven asphalt layer (caused by previous minor maintenance repairs) were identified. Fig. 4 shows typical damage and uneven surface of the considered road.

At the time of inspection of the road the following were found: (i) a number of cases of uneven surface all along the road, (ii) cavities of the surface, (iii) collapse drainage and sewage wells, (iv) lots of pollutants (sand, gravel) and vegetation near pedestrian sidewalks that hindered drainage of the road, (v) lack of cross and longitudinal slopes of roadway (or being insufficient).

Fig. 4. Damages of the road pavement: a) cavities in asphalt filled with water (poor drainage), b) a collapsed drain.

The condition of the roadway was classified in accordance with GDPRaM (General Directorate of Public Roads and Motorways) directives [8] as at warning level - class C – unsatisfactory condition i.e. roadway with major damages requiring renovation. The warning level defines a condition requiring at least a detailed examination in order to improve the condition of the roadway.

As a result, it was found that the cavities and uneven surface of the considered road as well as damages to the wells could cause increased dynamic impact. Therefore additional passages of vehicles along the damaged areas were planned.

5. It is recommended that the considered road is renovated, with special attention to drainage and sewage wells and cavities in the asphalt pavement, and with modelling of relevant cross and longitudinal downgrades. In the light of tests and analyses, it does not seem to be advisable to limit load of vehicles moving along the road. Moreover, it is suggested to undertake tests of noise level which probably causes poor psychophysical sensations in the residents.

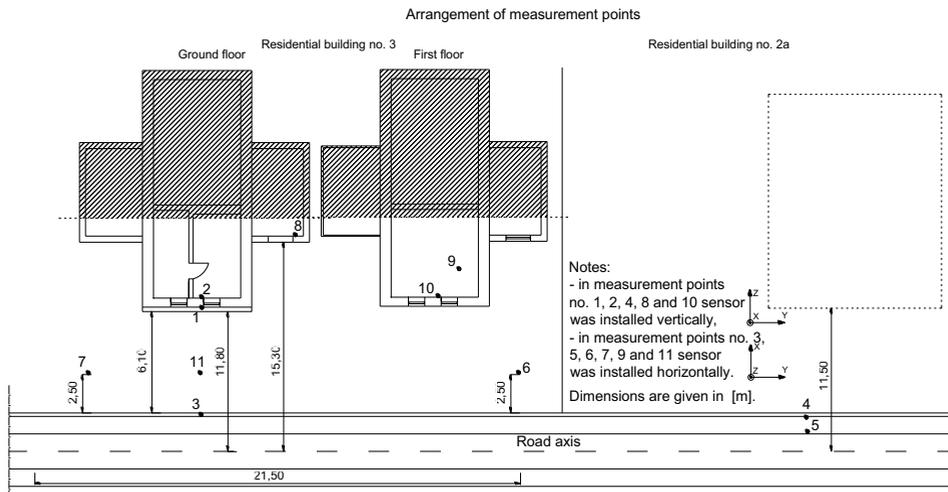
Fig. 5. Distribution of measurement points.

The measurements were held in the following test points (Fig. 5):

- a) inside the building:

- on the bearing wall at ground level (on external facade of the building - Fig. 6a) measurement point No. 1,
 - on the bearing wall at ground level (inside the building from the side of the source of vibrations – measurement points nos. 2 and 8,
 - on the first floor on the bearing wall (measurement point No. 10) and on the floor (measurement point No. 9) – tests related to determining the impact of vibrations on the people staying in the building,
- b) on elements outside the building on the way of the wave from the source of vibrations to the entry point (the building):
- on the fence foundation (measurement points 3 and 4),
 - on the pavement (measurement point no. 5) at number 2a house,
 - on a special tripod embedded in the ground (measurement points nos. 6, 7 and 11) – Fig 6b.

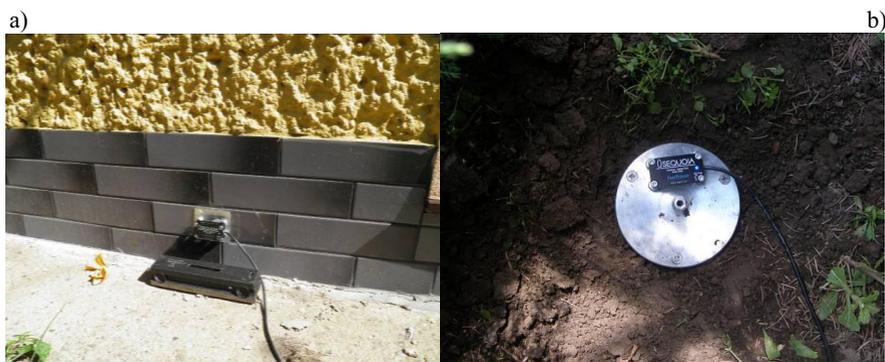
Fig. 6. Measurement points: a) no. 1 located on the wall, b) no. 6 in ground.

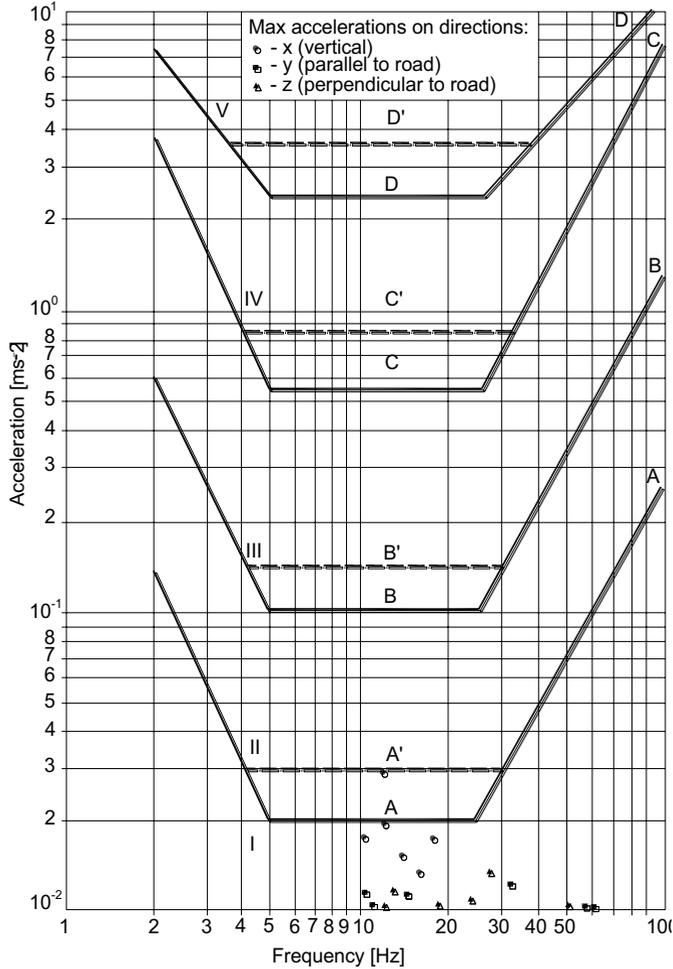
According with the PN-85 B-02170 [11], the DIS scales contain five zones limited with four limit lines (A, B, C and D). The lines have been shown in Fig. 7 within the coordinate system of vibration frequency (f) and acceleration (a). The coordinate values need to be determined from measurement in the points located on the structure at ground level. The following criteria were adopted for division into the zones of detrimental effect:

Fig. 7. Dynamic impact scales with measurement results (vibrations of the building).

- a) zone I – vibrations not perceived by the structure (limit A – a lower limit for reception of vibrations by a building and a lower limit for considering dynamic impact. In case of vibrations below this limit, dynamic impact does not need to be considered).

- b) zone II – vibrations perceptible for the building but of no harm to the structure; advanced wear of the building, first cracks in plaster and coatings etc. (limit B – the limit of the building stiffness, the lower limit for cracking and scratches in structural elements).

- c) zone III – vibrations harmful to the building, they cause local scratches and cracks and therefore weaken the structure of the building and lower its load carry capacity as well as its resistance to further dynamic impact; coatings and plasters may fall off (limit C – the strength limit of individual elements of the building, the lower limit of severe construction damages).

- d) zone IV – vibrations highly detrimental for the building, hazardous for people. Numerous cracks, local cases of destruction of walls and individual elements of the building are observed. Hanging objects may fall down, ceiling coating may peel off, ceiling beams may slide out from bearings etc. A possibly immediate removal of vibration source or reduction of their impact is required (limit D – the limit of a

structure stability, a lower limit of the whole structure collapse; vibrations exceeding this limit can cause construction disasters and hazards to human safety and life).

- e) zone V – vibrations cause breakdown through collapse of walls, falling off ceilings etc.; total hazard to human life and safety; in case of possibility for such vibrations to appear, buildings of this type must not be used.

Zone limits have been presented in two variations, according to evaluation of the building condition, type of ground and type of vibrations. To classify a case within a specific category, a prevailing number of relevant characteristics specified in the Norm is taken into account [11].

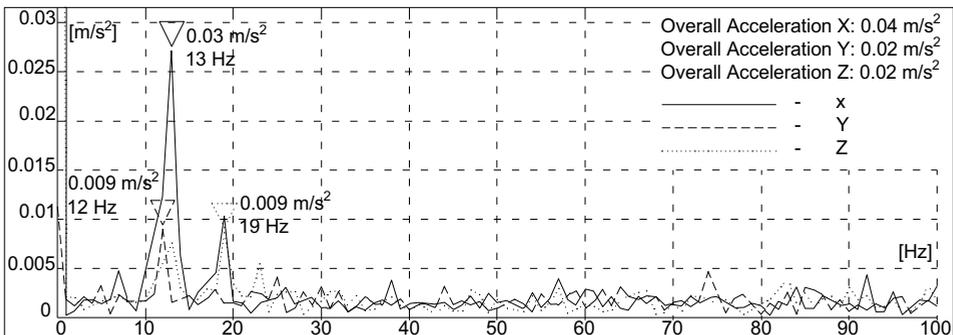
Due to very low values of vibration acceleration of the building structure measured in experiments, only the maximum courses of vibration acceleration were presented. In order to illustrate the level of vibrations in the building caused by passages of different vehicles, the obtained maximum acceleration results have been presented in Fig. 7 showing scales of dynamic impact (DIS). Whereas Fig. 8 shows a chosen course of vibration acceleration in the function of frequency and considers vibrations caused by a passage of a vehicle of 41.2 t of weight at the speed of 35-40 km/h (measurement point no. 1).

Following analysis of test results it can be noticed that the signal is dominated by components of frequency ranging from 10–25 Hz (Table 1), and the highest amplitude of acceleration from horizontal directions (Y, Z) amounts at 0.009 m/s². It was registered at the time of passage of a HGV of 41.2 t of weight at the speed of 35-40 km/h. The impact of other vehicles was at a considerably lower level i.e. acceleration did not exceed 0.003 m/s². In line with the PN-85/B-02170 [11] and Fig. 7, the examined building is located within

Fig. 8. Vibration accelerations course at measurement point no. 1 (foundation of the house).

zone I of the DIS-I scale, meaning the vibrations are not perceptible to the structure. Limit A means the lower limit of vibration perceptibility for the building. Dynamic impact can be neglected when vibrations fall below this limit. However it needs to be underlined that the analysis did not consider measurement from the vertical direction, because residential buildings are designed for vertical loads (dead load, snow load, service load).

1. As a result of examination of vibration acceleration in different parts of the residential building, it was found that the building falls within zone I of the DIS-I scale, which

means that vibrations are classified as unnoticeable for the structure (in line with Polish Norm PN-85/B-02170 [11]). It needs to be mentioned that the extreme values of vibrations were observed during passage of a loaded HGV of 41.2 t of total weight. Passages of other cars and heavy vehicles caused smaller values of vibrations.

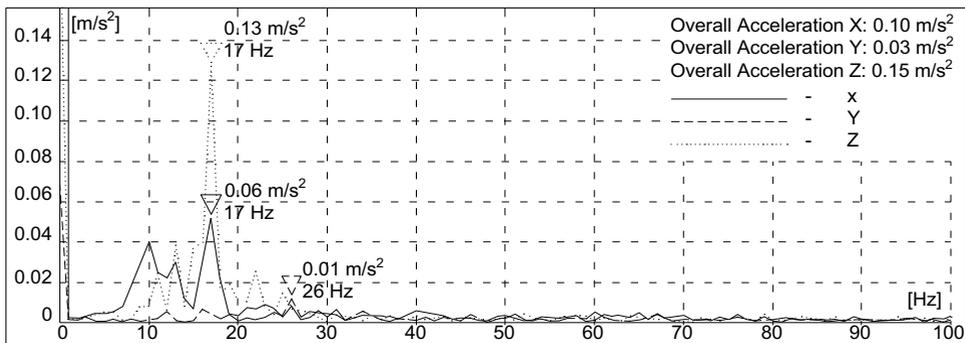
Figs 9-10 show extreme courses of vibration acceleration at points located outside the residential building on the way of the wave from the vibration source to the receipt point of vibration (fence foundation and at ground – see Fig. 5) caused by passage of a HGV of 41.2 t of weight with the speed of 35-40 km/h. The maximum values of vibration acceleration of the measurement points located outside the building have been presented in Fig. 7. Table 2 shows extreme values of vibration acceleration for the three tested dimensions in relation to the vibration source.

Fig. 9. Vibration accelerations course at measurement point no. 4 (foundation of the fence) (axes: Z – direction perpendicular to the carriageway; Y – direction parallel to the carriageway; X – vertical direction).

Acceleration of vibrations of measurement points located on the fence foundation (points 3 and 4) also do not show increased values. However, it needs to be underlined that the foundation structure is not well known and can contain the eigenvalues.

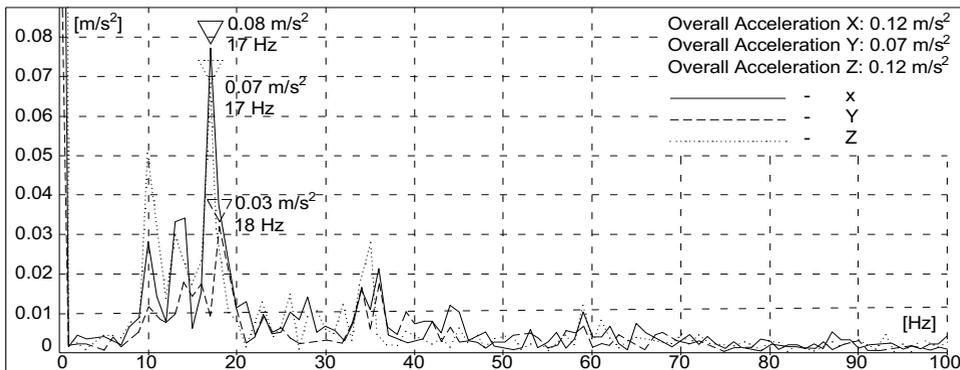
Analysis of graphs showing spectrums of vibration acceleration from points 6, 7 and 11 (located in ground) proves that they represent a very similar level, which means that vibrations propagate in soil in a similar way. This proves that soil in the area of tests is homogeneous. Moreover, in most cases, the obtained horizontal acceleration components of vibrations in ground are smaller than 0.005 g (g – gravitational acceleration). It should be noticed that it is not required to consider loads to a structure from vibrations transmitted through even in case of newly designed buildings.

Fig. 10. Vibration accelerations course at measurement point no. 7 (in ground) (axes: X – direction perpendicular to the carriageway; Y – direction parallel to the carriageway; Z – vertical direction).

2. As a result of additional measurements of vibration acceleration of soil, it was found that the values represent a similar level, which proves homogeneity of soil and therefore similar propagation of vibrations within. The values of vibration acceleration in majority of cases do not exceed 0.005 g, which is a condition for newly designed buildings.

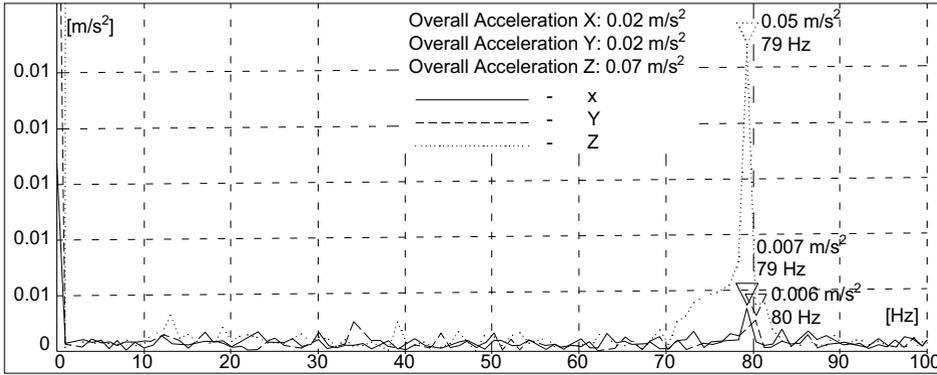
Fig. 11 and Table 3 show maximum vibration acceleration obtained for measurement point no. 9 located on the first floor of the building, on the floor from the vibration source side.

Fig. 11. Vibration accelerations course at measurement point no. 9 (the floor) – passage of a HGV over a collapsed drain.

- for the vertical direction (*Z*) of vibration reception by a man, the corrected allowable vibration acceleration value amounts at $0,16 \text{ m/s}^2$, and is in all cases higher than one received in tests. Similarly the allowable value of vibration velocity being 3.2 mm/s was not exceeded in any of the case of passage of a loading vehicle. It needs to be underlined that a HGV of 41.2 t of weight was used in the tests, which, along with standard passages, did an additional passage over a collapsed drain (constituting a so called impact, i.e. increased dynamic influence).

- for perpendicular and parallel directions (*X* and *Y*) of vibration reception by a man, the corrected allowable value of vibration acceleration amounts at 0.1152 m/s^2 , and is, in all discussed cases, higher than maximum results obtained from tests. The allowable value of vibration velocity of 9.28 mm/s also was not exceeded in any of the considered instances of vehicle passage.

3. No harmful effects of vibrations on people residing in the house by the discussed road have been proved. The obtained values of acceleration and velocity were smaller than permitted ones. It needs to be mentioned that a HGV of 41.2 t of weight was used during the tests. What is more, one of its passages was over a collapsed drain, causing an increased dynamic impact.
