# Impact of corrosion processes in the basement level on the durability of the construction of large-panel buildings

**Abstract.** The paper presents results of research on the assessment of the corrosion progress level in structural elements of buildings made of large-panel technology. The symptoms of corrosion processes and the results of other authors research are presented.

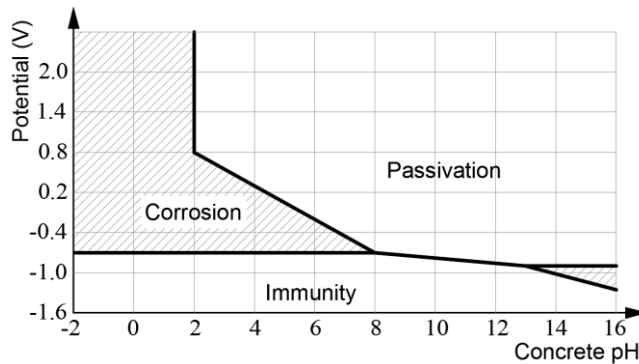
Fig. 1. Steel corrosion vs concrete pH value and potential

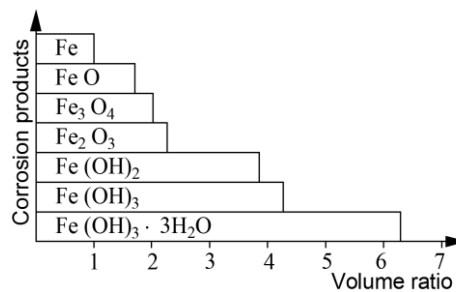
Fig. 2. Relative volume of steel and corrosion products [5]

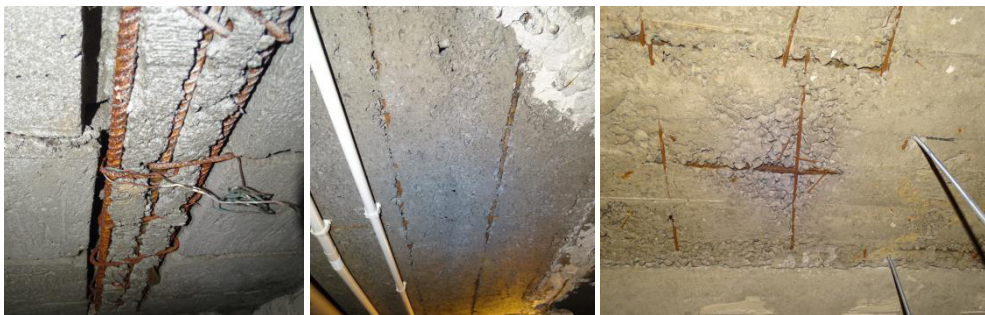
One of the basic processes to be checked during technical inspections is corrosion of steel. The main task of technical inspections is to check the progress of corrosion in the elements of the building, because most often they are components or installations that have been subject to this process from the beginning (e.g. tinplate). Regarding to reinforced concrete elements, cracks control and corrosion symptoms as discoloration and cracking of the reinforcement cover should be observed. Damage points should also be indicated to protect them. Despite the many annual and five-year inspections in most buildings, many of the reinforced concrete elements in cellar level in multi-family buildings remain not protected since construction moment (Figure 3).

**Fig. 3.** Reinforcement not protected since construction moment (photos by Piotr Knyziak, 2016)

There are no symptoms of poor operation of these components, although the reinforcement steel has no corrosion protection on site and the requirements for the transmission of stresses between steel and concrete are not met. In most of the cases they

were small fragments ceilings made of monolithic construction or parts of basement walls (elements using a low bearing capacity). In a few cases it was possible to find a precast elements with improperly made reinforcement cover - visible abnormal thickening of concrete around the bar located just off the surface of the element, or even less frequently, bars visible on the surface of the precast elements.

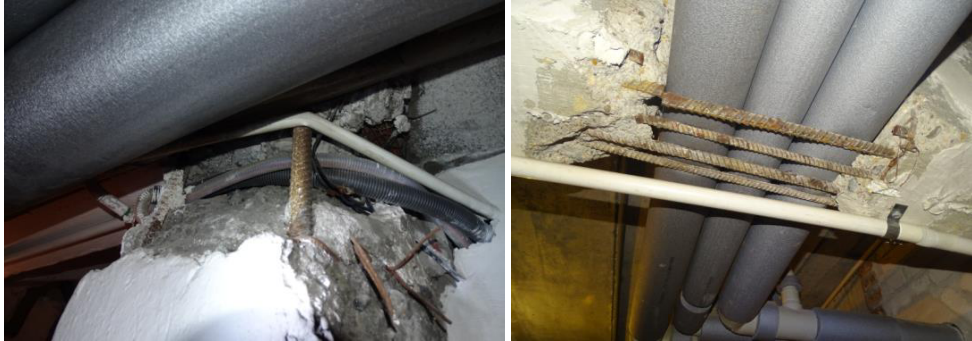
**Fig. 4.** Reinforcement exposed during installation work and not secured (Piotr Knyziak, 2016)

In many cases, installers performing upgrades made breakthrough of reinforced concrete elements, including exposing the reinforcing bars and the cutting of the bars (Figure 4). Mostly damaged are the external parts of the walls in the basement corridors and the lintel sections of the prefabricated sections with a communication hole. In some cases, the damage is covered with new mortar or putty, probably lacking the protective properties in relation to steel. In four of the tested buildings the basement ceilings were insulated (Figure 5), which prevented the cracks and corrosion control of the slabs. They have also been recorded cases of white paint on the basement, but paint with the addition of gypsum.

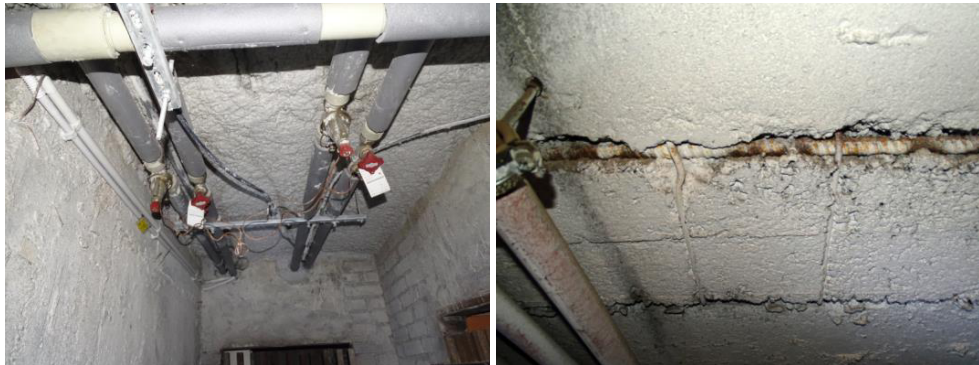
**Fig. 5.** Insulation of ceiling and ceiling with exposed reinforcement painted with the addition of gypsum (photos by Piotr Knyziak, 2016)

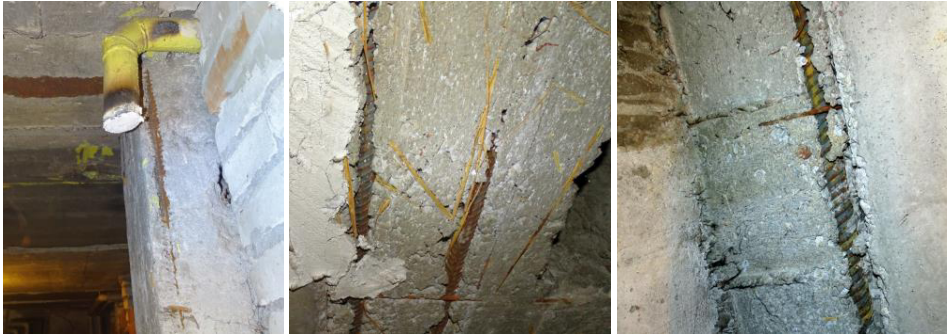
During the inspection of buildings were observed a low level of corrosion of the most parts of the exposed reinforcement and other steel elements. Bars not concreted during construction found in the basement level in concrete elements made on site, in almost all cases, were covered only with a thin corrosion coating, and often on a part of the surface of the rod there was no corrosive attack at all (Figure 6).

**Fig. 6.** No corrosion on reinforcement surface (photos by Piotr Knyziak, 2016)

Basement conditions can be considered as unfavorable to the development of corrosion, due to the low humidity of the air, which is heated practically throughout the year by hot water circuits and in winter also by central heating. In many buildings there are incidental flooding of cellars from the rain water installation, after the downpour, but not little impact on the progress of corrosion in the current period of use.

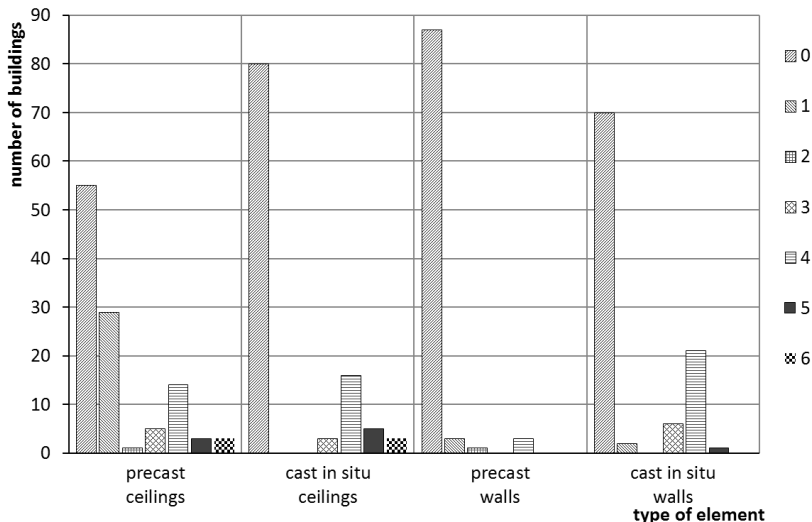
During the technical inspections of 110 prefabricated buildings particular attention was paid to the correctness of prefabrication, the occurrence of symptoms of too thin cover of reinforcement bars, the level of corrosion of visible sections of reinforcing bars. The results of the technical inspections are summarized (Figure 7) by the following indications: 0 - elements without symptoms of poorly made cover and without symptoms of low thickness of the cover, 1 - symptoms of low thickness of reinforcement cover in the elements, 2 - symptoms of corrosion of reinforcement under the cover, 3 - cover partial deficiencies, bars partially corroded, 4 - cover partial deficiencies, rods coated by low corrosion, 4 - cover partial deficiencies, rods coated by high corrosion, 6 - insulation of elements that do not determine the level of corrosion.

**Fig. 7.** Shortcomings and corrosion ratio in elements (data collected by Piotr Knyziak)

Results of technical inspections indicate that in most of the reviewed buildings, no cases of improperly constructed prefabricated or monolithic elements were found. In most cases, there are also no signs of corrosion under the concrete cover.
