Problems in Carrying Out Construction Projects in Large Urban Agglomerations on the Example of the Construction of the Axis and High5ive Office Buildings in Krakow

Abstract. The paper discusses problems in the carrying out of construction projects in large urban agglomerations on the example of two structures located in Krakow. The location and the specifics of the work that had to be performed generated numerous technological and organisational problems. The manner of solving them, in addition to propositions of guidelines for similar projects are discussed in the paper.

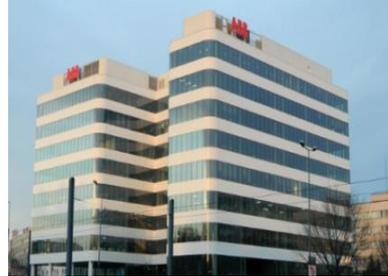
The Axis building (fig.1) is an office building with services on the ground floor. The construction of a part of the structure of the Axis office building began in 2014 and took 22 months to complete. The office surface area of the building amounts to 19 298 m², while retail and service areas amount to 1183 m². The building has 9 storeys above ground and three underground levels with parking lots. The building is a class A office building [14]. The load-bearing structure is composed of monolithic and prefabricated reinforced concrete elements. The subterranean levels were constructed as entirely monolithic, while those above ground used prefabricated reinforced concrete pillars, beams, staircases and FILIGRAN-type floor slabs, in addition to monolithic shafts and landings [15].

Fig. 1 View of the finished Axis building. Original photograph.

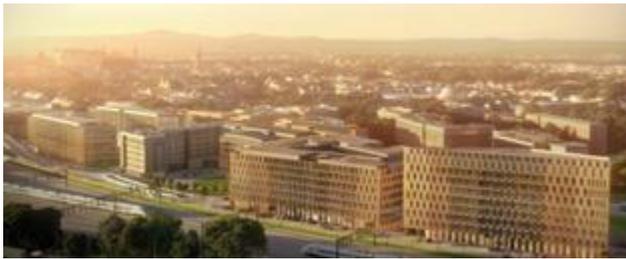
Fig.2 Visualisation of the High5ive buildings [16]

The High5ive office building complex (fig.2) is being built in Krakow near Pawia street. The surface area of two of the buildings from among the five-building complex amounts to around 23 500 m². Both of the buildings have six storeys and have subterranean levels with parking lots (building D – one underground level, building E – two underground levels). They are class A buildings. The load-bearing structure of both buildings is a spatial post and slab structural system with monolithic shafts that provide rigidity.

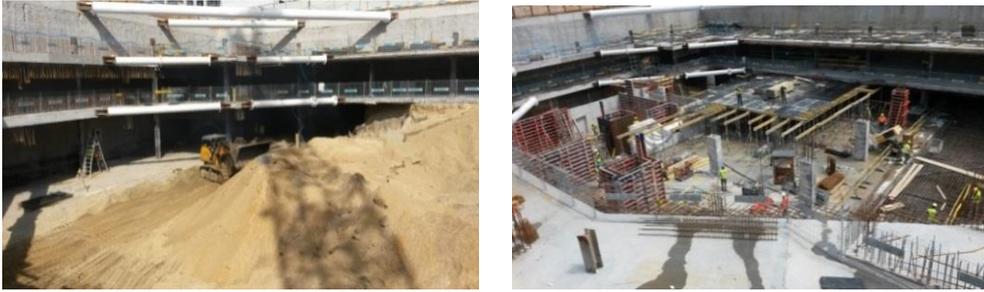
Fig. 4 The construction of the underground levels of the AXIS office building using the top and down method. Original photograph.

The Axis office and service building is located in the central part of the city of Krakow in the area of Rondo Mogilskie. The building's surroundings include a hotel, a green square and some of Krakow's largest and most important streets. The area designated for the construction of the second building - the High5ive office and service building complex is located in the strict city centre of Krakow. The immediate vicinity includes a shopping gallery and hotels. The construction site is adjacent to the main train station and a street with a tram line that is partially on the surface and partially in a tunnel. A part of the site is located over an existing road tunnel. Such a site (fig. 3) generates serious difficulties and limitations in construction work and influences their duration. In the case of a construction project carried out in a dense built environment, the preparatory and design phases are particularly crucial, including: a comprehensive identification of soil and water conditions both underneath the designed structure, as well as in its zone of influence on surrounding buildings, determining the functional and spatial solutions of the underground section, a selection of the support and construction method of the underground part of the designed building and the monitoring of the condition of adjacent structures [8,18].

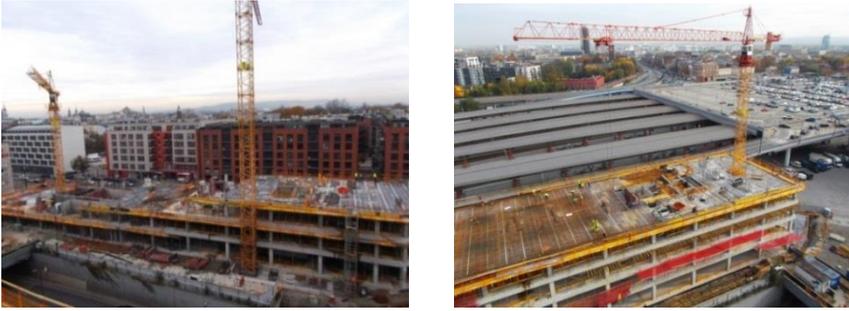
Fig. 5 A view of the limitations associated with the location of buildings E and D of the High5ive complex (a dense built environment, lack of a storage area, the train station platforms, the parking lot of the shopping gallery). Original photograph.

In urban agglomerations, internal on-site circulation is often a problem. In both of the analysed cases, expensive parcels in the city centre have been completely developed with the constructed buildings in mind, at the same time limiting storage area to a minimum (fig. 5). The newly built levels, the work of tower cranes and the quick pace of work, in addition to the simultaneous presence of several hundred people at the construction site required the establishment of a separate logistics department. Delivery deadlines and locations in the case of such a location and the difficulties that had been encountered had to be met in accordance with a strict schedule that were given by construction supervisors to the logistics department. A common practice in the event of having limited space at a site is transport and assembly without storage. This method has been used in the projects that are discussed. This was a very important matter in the case of the construction of the Axis building. The delivered elements needed to be assembled and incorporated into the structure in an established sequence, which is why transport delays, alterations in the sequence of the arrival of trucks with material or the wrong orientation of an element on a truck would cause delays. The small storage area resulted in limited capabilities of ordering elements that were supposed to be installed ahead of time (for instance steel rebar was delivered slightly ahead of the assembly time). Due to the lack of space on the site, the site's backrooms had to be located in a place some distance away from it.
