Research on the internal pressure behavior of metal gas distribution pipelines with different types of tubing defects

Abstract. The paper aims to approach an important subject related to natural gas distribution networks which, depending on the expansion of the localities, are composed of intercommunicating pipes, pressure reducing stations and branch connections fittings. The urban networks are the most complex ones and the rural areas networks are the simplest. However, irrespective of their installation, they must meet the safety operating requirements as much as possible. According to standards, all these components must be tight and pressure resistant. In this regard, we intend to approach a very important issue related to the behavior of the tubular steel material showing corrosion and/or material defects, and to the internal stress caused by the gas pressure on the walls of the tubing material.

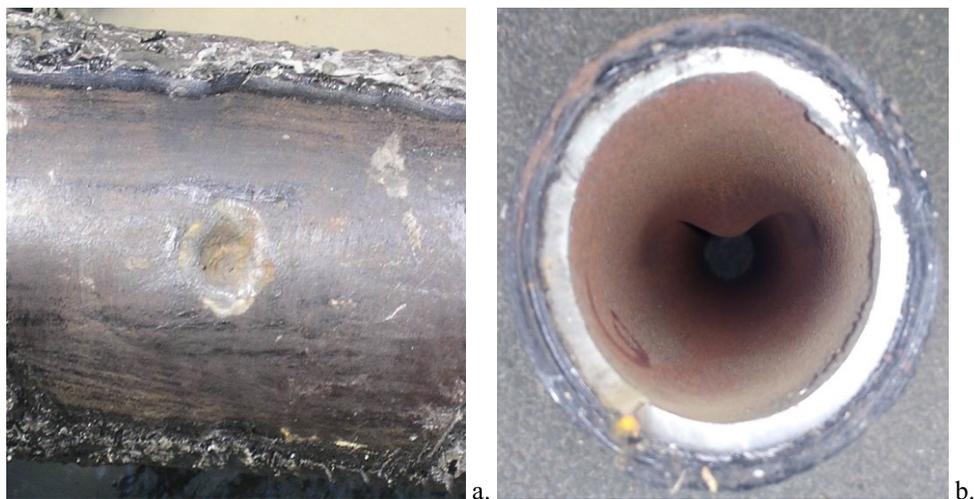
The local deformations (Fig.1.) are less severe defects or imperfections, since they do not modify the pipe wall thickness, producing only local variations in the curvature of its cross section. The local deformations influence the gas flow in the pipes and may cause major difficulties in carrying out cleaning operations and the internal inspection of the pipes, by blocking the advancement of the intelligent control installations.

Fig. 1. Local deformation defects detected on pipes

The gouges consisting of the local plastic deformation of the pipe and the removal of material by cutting effect are high severity defects or imperfections. When material is removed, the upper layer of the gouge is hammer hardened, so that the presence of these imperfections or defects can result in triggering the processes of cracking and brittle fracturing.

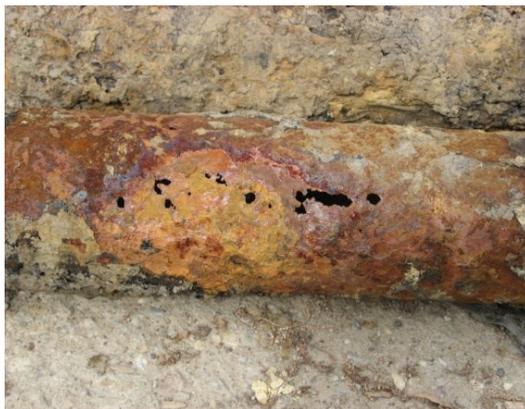
b. metal loss is the imperfection or the defect consisting in the thinning of the pipe wall due to metal loss in the presence or absence of a corrosion process (fig. 2).

Fig. 2. Metal loss defect due to corrosion

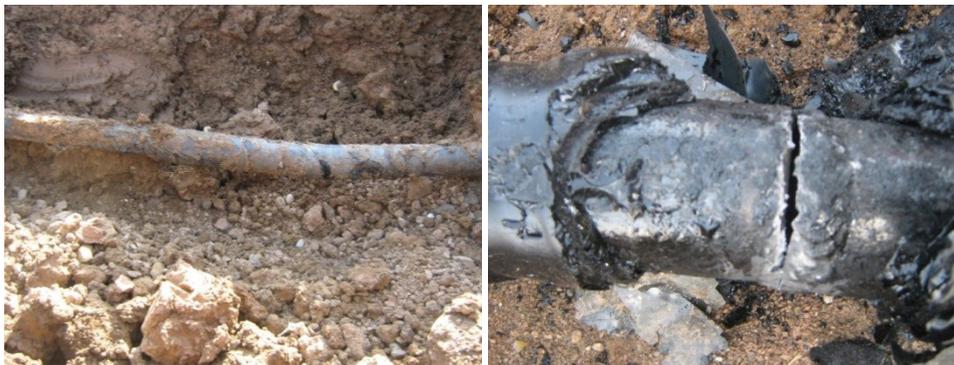
c. fissures and cracks (Fig. 3) are the most harmful defects that cause powerful effects of mechanical stresses concentration and noticeably decreases the bearing capacity of the pipelines. These can be generated during the operation of the pipelines, due to the phenomena of fatigue, stress corrosion, hydrogen embrittlement, etc., or they may be present in the pipe walls since its start-up (cracks and similar defects caused by pipe lamination or cracks in the welded joints).

Fig. 3. Cracking defect caused by landslide

By determining the geometry of the corrosion defect, we tried to simulate the size of a real defect as much as possible (Figure 3), only on the area affected by the pipeline fracture, and not on the entire corroded area. This defect was located on the lower vertical bend which is buried in the ground.

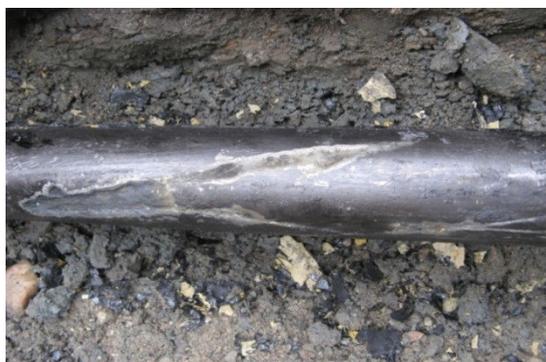
Fig. 4. Metal loss defect detected on a pipeline wall

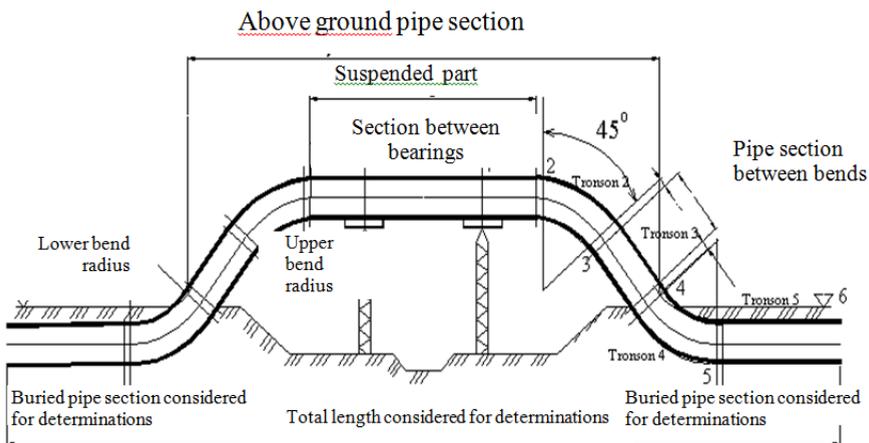
Fig. 5.a. Structure of the pipe subjected to simulation

The determinations were made by the finite element method on a steel pipe, made of type L235GA material, according to STAS 10208, material that is also called 1.0458 or ST 37.0 according to the former standard DIN EN 12007-3, which crosses over a river and has a structure as shown in Figure 5.a.

The design for the assembly for which the calculus was conducted is shown in figure 5.a), where the positions of the welded joints are marked.

We considered useful that the determinations should be simulated on a pipe section that is part of an assembly of a river overpass, on the grounds that all the defects can be simulated on this type of network; which has led to the simulation of the two types of defects: one corrosion defect found in section where the pipe exits from the ground (considered the section most exposed to corrosion) and one material defect, simulated on the upper bend of the overpass. [5]

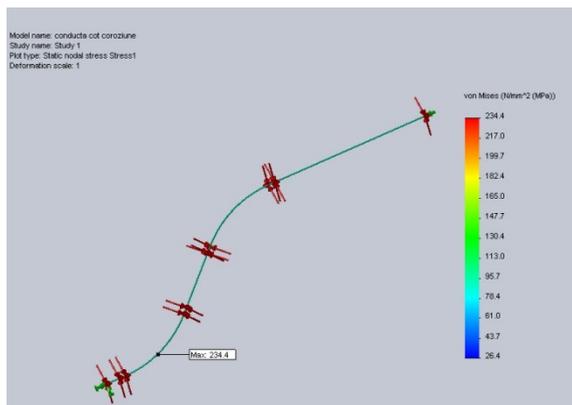
Fig. 5.b. Simulation of a corrosion defect

We considered important to know the behavior to the internal pressure of the pipes that have material and corrosion defects, as shown in figures 5. b) and c). For both types of defects we analyzed the same wall thickness.

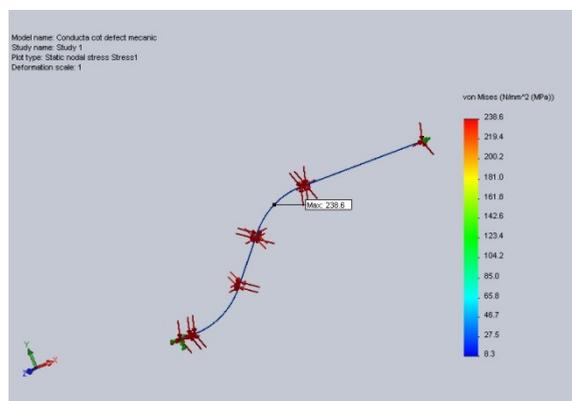
Fig. 5.c. Simulation of a material defect

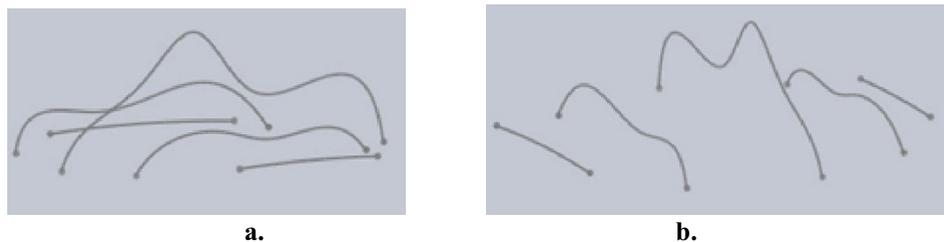
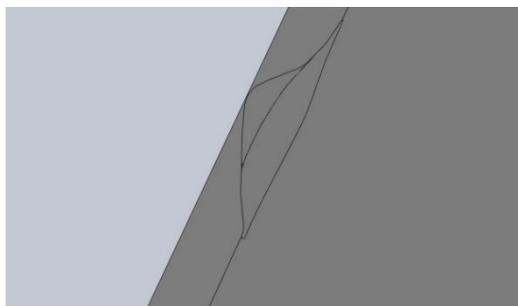
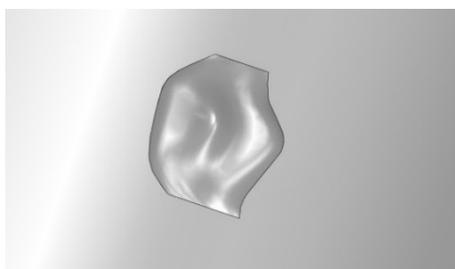
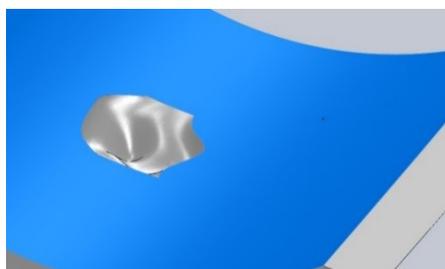
Fig. 6.a. Geometry of the corrosion defect - Curbs defining the defect – side view – a;
longitudinal view – b.

Fig. 6.b. Geometry of the corrosion defect – cross section of the defect in the pipe wall

Fig. 6.c. Geometry of the corrosion defect – front view of the defect

Fig. 6.d. Geometry of the corrosion defect – solid view of the defect

The geometry of the corrosion and material defects is shown in Figures 6 and 7.

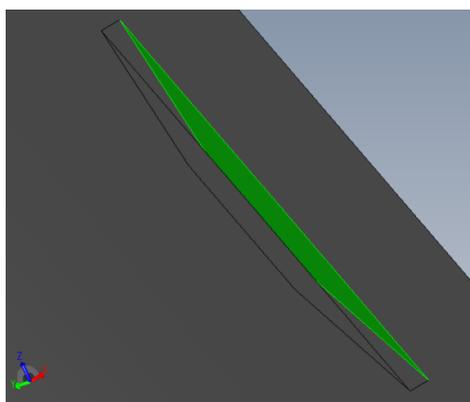
Fig. 7. Image of the material defect

The material defect simulates the damage caused on a pipeline by the tooth of an excavator bucket, not only as a deformation action but as a geometric shape of the blunt body that produces the defect. Assuming that the greatest influence of the operating pressure of the pipeline is in the area of the direction changes, in our case the vertical bends of the overpass, the simulation of the material defect was conducted in this area. [3]

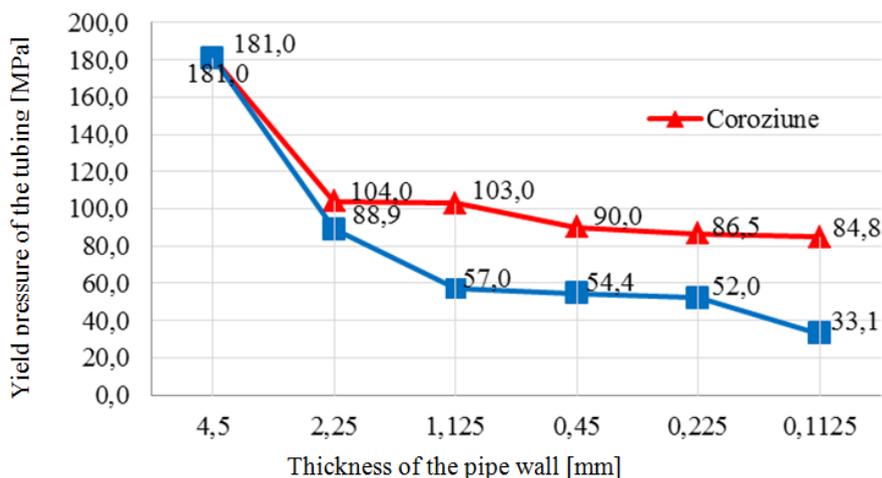
The calculated values of the pressure at which the pipe has yielded in the defect area depending on its depth are shown in Table 1 and the variation graph in Figure 8. [6]

**Fig. 8.** The piercing pressure according to wall thickness

- comparing the behavior of the two types of defects under the influence of the internal pressure of the pipeline, we have deduced that, contrary to the initial considerations, in the case of the corrosion defect, the yield pressure of the tubing is higher, under the same wall thickness conditions. We attribute this to the fact that it is possible that the influence should be due to the defects being simulated on the outer side of the pipe and not on its inner side,

- the maximum yield pressure corresponds to the lack of material and corrosion defects;
- in case there are material or corrosion defects, the effect is felt when the wall thickness has been reduced by half;
- the minimum yield pressure corresponds to the material defects because they have a larger expansion than the corrosion defects and a geometry that determines the concentration of stresses. [7]
- taking into account these conclusions and determinations, we might suggest as effective measures to help and lead to a better and safer operation, an efficient corrosion protection, both from a passive and an active point of view. Also, another very important aspect in this regard is ensuring an optimal handling of the pipes both during transport and installation.
