Investigation of Non-Uniform Rust Distribution and Its Effects on Corrosion Induced Cracking in Reinforced Concrete

Wahyuniarsih Sutrisno^{1,*}, Priyo Suprobo¹, Endah Wahyuni¹, Data Iranata¹

¹Department of Civil Engineering of Institut Teknologi Sepuluh Nopember, ITS Sukolilo Campus Surabaya Indonesia

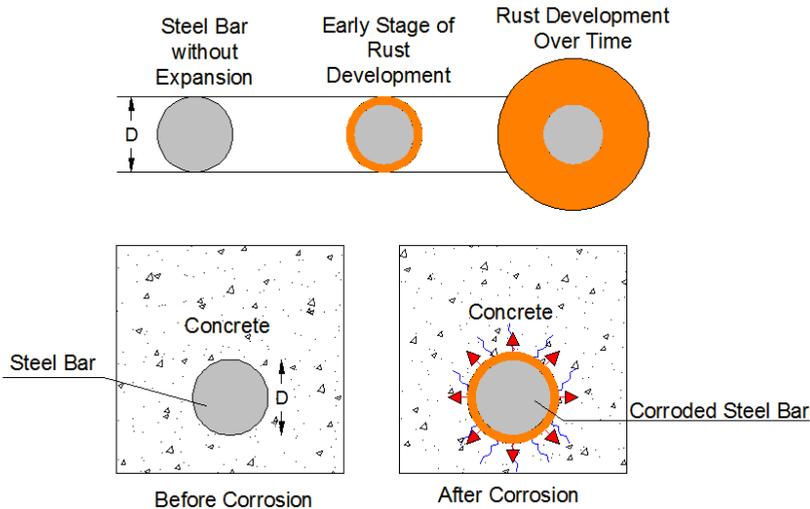
Fig. 1. Illustration of Corroded Steel Bar Induced Concrete Cracking in Reinforced Concrete

Reinforcement corrosion induced by chloride ingress is a major durability problem in reinforced concrete structure. Furthermore, this condition can affect the serviceability and finally leads to damage of the structure. The corrosion process starts with depassivation. Depassivation is a condition when a passive layer of the steel is damage. This process followed with the formation of the rust at the interface between steel bar and concrete. The volume of rust will continue to increase as corrosion processes happen continuously. The volume of the rust can exceed 2-6 times the volume of the original steel, and it can generate outward expansive pressure which causes cracks in the concrete. The overall illustration regarding this process shown in Fig. 1.

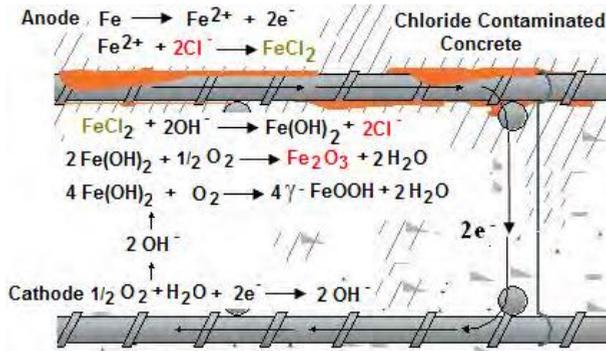
Fig. 2. Chloride Induced Corrosion Process [4]

formation of rust, but this ion help to destruct the passive layer and accelerate the anode process which resulting speed up the corrosion process. The illustration of corrosion process is shown in Fig 2.

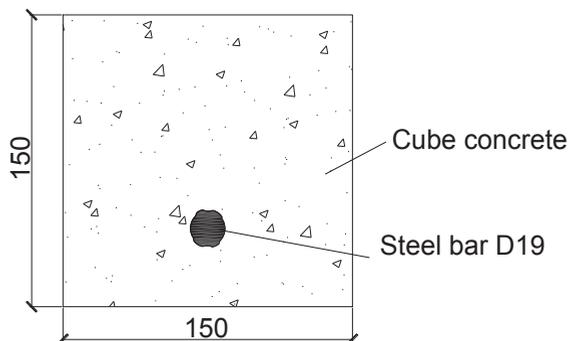
Fig. 3. Cross Section of the Model

The summary of the experimental set up is provided in this section. The sample used in this paper is a concrete cube with dimension 150 x 150 x 150 mm with single reinforcement as shown in Fig. 3. The concrete material used in this experiment is normal concrete with water per cement ratio (w/c) 0.5. Several days before mixing, the coarse and fine aggregate was washed to remove any fine dust which may increase the water demand, and lower the bond strength. The wet aggregate was then placed in a sealed bucket for one day was allowed for absorption. This treatment can stabilize the moisture content of the aggregate and drain the excess water. After one day the aggregate was dried to reach SSD condition.

The concrete was mixed by a mixer machine, and the special mold was prepared to allow the steel reinforcement embedded in the concrete. The concrete was embedded with single steel reinforcement with diameter 19 mm. The reinforcement was embedded 40 mm from the exposed surface. The concrete was demolded after 24 hours, and it was cured under wet burlap and plastic in the concrete lab environment. After 28 days, the accelerated corrosion test was performed.

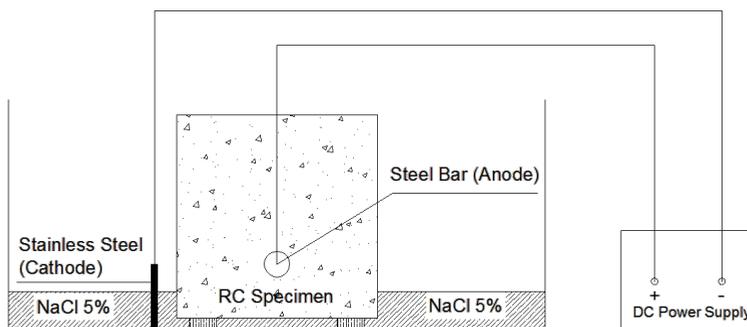
Fig. 4. Accelerated Corrosion Test Set Up

The accelerated corrosion test was carried out to investigate the corrosion induced cracking process in reinforced concrete structures. The corrosion process, rust development, crack initiation and propagation were observed using daily visual observation. The accelerated corrosion process was achieved by applying a constant electrical current to the steel reinforcement by a power supply via a current regulator. The current regulator was used in this experiment to maintain constant current over the time. To generate cracks due to corrosion the accelerated corrosion test used approximately $200 \mu\text{A}/\text{cm}^2$ of electric current. The concrete specimen placed in the 5% NaCl solution. The accelerated corrosion set up is shown in Fig. 4. The steel bar acts as an anode, and the stainless steel plate which submerged in the NaCl solution acts as the cathode. The pore fluid in the concrete is the electrolyte of the reaction. All of the samples were cut into four identical pieces to observed the rust distribution and crack propagation.

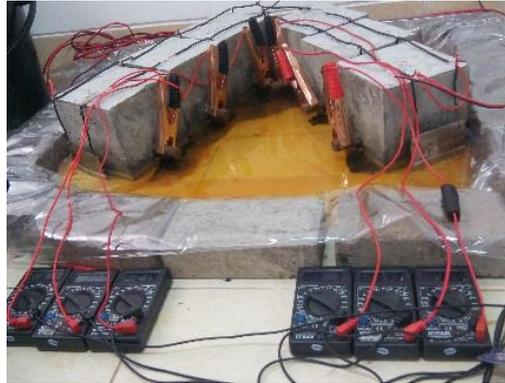
Fig. 5. Discoloration process of NaCl Solution due to Rust Bleeding

An accelerated corrosion test was performed to investigate the corrosion induced cracking process in reinforced concrete structures. The first corrosion and crack initiation at the concrete surface were observed using daily visual observation. The process of corrosion initiation is indicated by discoloration of the steel reinforcement. This process happens just 5 hours after the accelerated corrosion test started. As time passed, the corrosion starts to developed and cause bleeding of the rust. This condition indicated by discoloration of the NaCl solution as shown in Fig. 5.

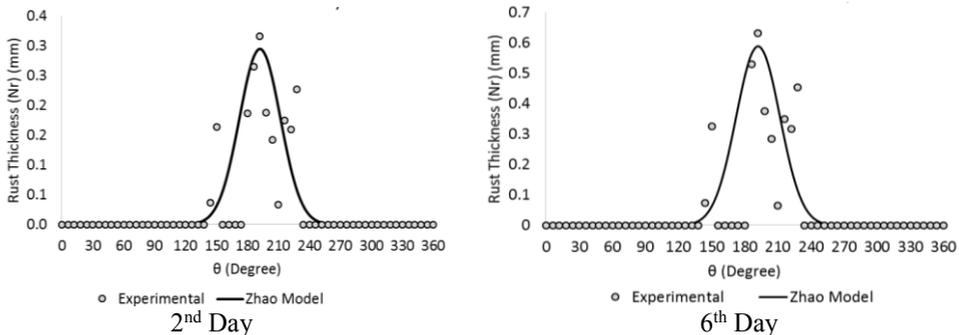
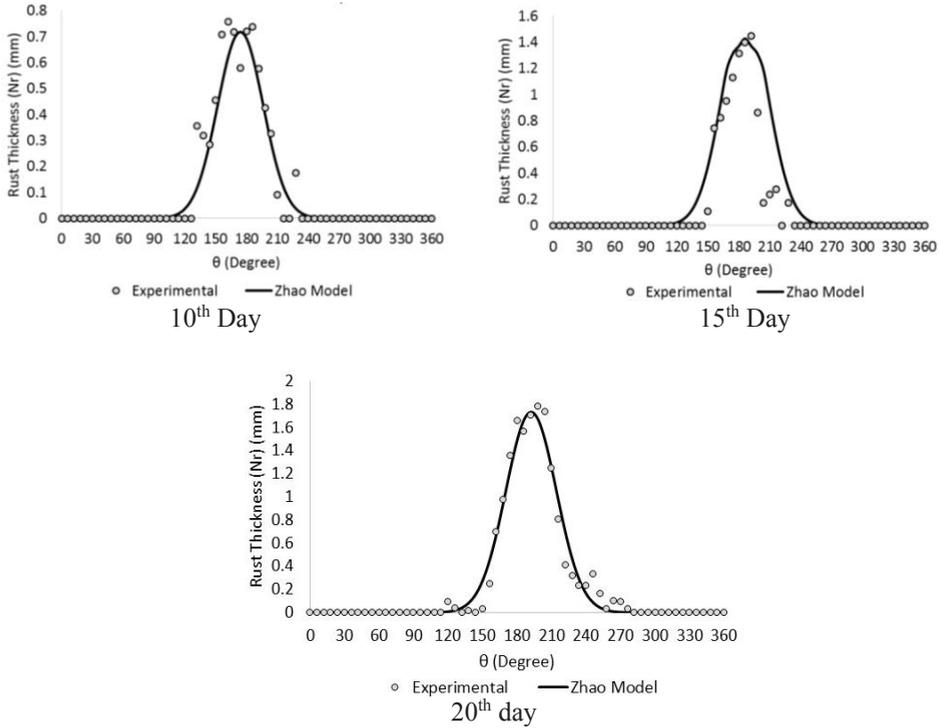
Fig. 6. Rust Distribution Graph from Experimental Result and Its Gaussian Description

As stated at the beginning of this paper, the primary purposed of this paper is to investigate the rust distribution on the circumference of the steel bar and its effect to cracking. Therefore, the thickness of the rust was observed daily and plotted into several graphs as shown in Fig. 6. The perimeter of steel bar is divided into several polar coordinate, and the thickness is measured according to the polar coordinate. The non-uniform thickness indicates as symbol N_r on the graph and the polar coordinate (θ) is measured in degree. The closest part of the exposed surface is assume located at 180° and the furthest part located at $0^\circ/360^\circ$.

In addition to the experimental result, the Gaussian description proposed by Zhao also presented on the Fig. 6. By using the Gaussian function, the non-uniform rust distribution can be idealized. Based on Fig. 6, it can be seen that the thickness of the rust layer is increase as an increase of time. This condition happened because the corrosion process is developed continuously over the time. It is also very clear that the rust distributed non-uniformly along the perimeter of the steel bar. Furthermore, the peak of the curve occurs at the area closest to the exposed surface as expected. This result shows that the area which has the closest distance to the exposed surface is more vulnerable to corrosion because the chloride from outside has faster infiltration to this location than other location.

The curve also showed that the peak of the rust thickness does not always occur at the 180°. The peak of the rust sometimes occurs at 150° or 210°. The reason behind this phenomena is the use of deformed reinforcement. The geometry of the reinforcement affects the distribution of the rust because it has whorl shape which makes it located closer to the exposed surface than the plain part.

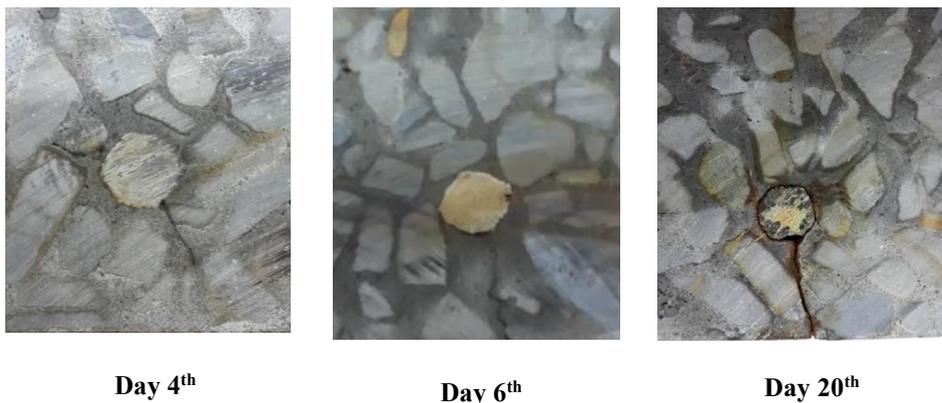
Fig. 7. Crack propagation due to Non-Uniform Corrosion

The non-uniform rust distribution apparently affects the cracking propagation on the concrete. Due to non-uniform thickness of rust, the non-uniform expansive pressure is generated and crack start to initiate. The cracking development due to non-uniform corrosion is shown in Fig. 7.

The non-uniform crack propagation, as shown in Fig. 7, is developed as the effect of non-uniform rust distribution. The crack development shows that even though there are several cracks is formed in the bottom part of the concrete-steel bar interface, but only single crack manage to propagate into the concrete cover. After the crack occurs, the rust infiltrates into the crack tip as shown in Fig. 8.

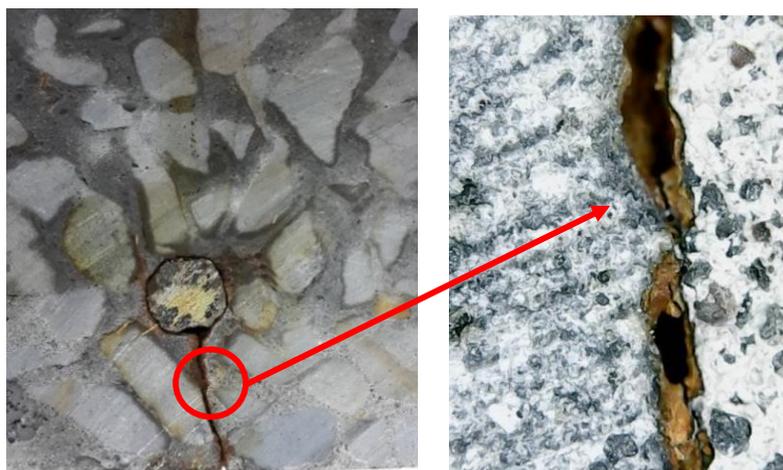
Fig. 8. Rust Distribution at the crack Tip

The Fig. 9 shows stress distribution in the concrete due to expansive internal pressure which reflecting the distribution of the rust. The stress distribution describes the direction of crack propagation in the concrete. Fig. 9a shows that model with non-uniform expansive pressure will lead to a crack which not formed uniformly along the perimeter of the steel bar. This result is contrary to Fig. 9b which indicating crack will form uniformly along the perimeter of the steel bar with uniform expansive pressure. Fig. 9 also illustrate that the stress of the model with non-uniform internal expansive pressure is concentrated in one particular area which indicates the possibility of crack propagation. This result is in good agreement with the experimental result as shown in Fig. 8.

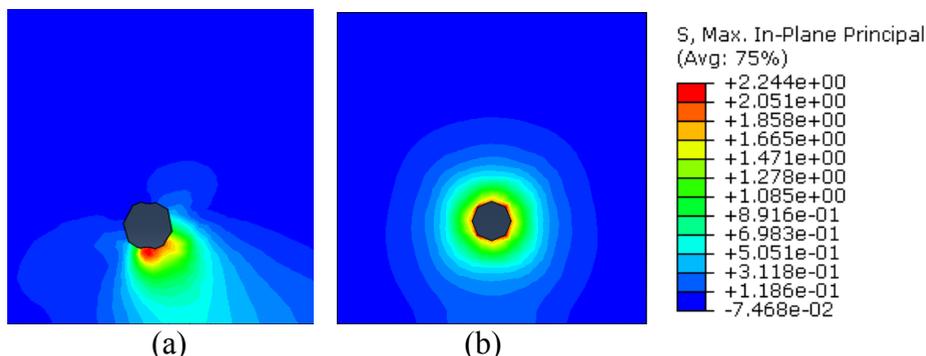
Fig. 9. Finite Element Modeling Result using (a) Non-Uniform and (b) Uniform Rust Distribution Assumption

A finite element simulation is developed to compare the cracking pattern of due to uniform and non-uniform rust distribution. The simulation preformed using the concrete smeared cracking method. The material properties used in this model divided into two categories, elastic and smeared cracking properties. In smeared cracking approach there were three main parameters used to run the analysis such as tension stiffening, failure ratio, and shear retention factor.

The expansive pressure due to uniform and non-uniform corrosion was calculated using the equation proposed by Liu and Weyers [15]. Furthermore, for the non-uniform corrosion, the expansive pressure was calculated by combining the Gaussian model by Zhao and thick walled cylinder based equation by Liu and Wayers [14], [15]. In Liu and Wayers equation, the expansive pressure is affected by the thickness of the corrosion layer.
