Moisture problems of functional joints of wooden windows – causes analysis

Abstract. The article addresses the issue of the humidity regimen of a functional wooden window joint. Current energy-saving trends in the buildings bring secondary effects associated with indoor climate change. Increase of the thermal-technical quantification, non-breathability, and diffusion resistance of the building envelope without the solution of controlled ventilation brings an extreme rise of the interior moisture. The passage of moisture through a functional joint is ensured mainly by exfiltration. The energy standard applicable after the year 2020 assumes buildings with almost zero energy need that cannot be reached without a recuperation system. The concept of the recuperation systems usually works as a pressure system, which increases the likelihood of exfiltration. Measurements done in a large climate chamber show that the diffusion of water vapor can overcome the infiltration flow of the outside air. The passage of moisture results in icing or condensation in the functional joint, which subsequently damages the surface treatment of the wood. Another serious defect is the subsequent mold growth

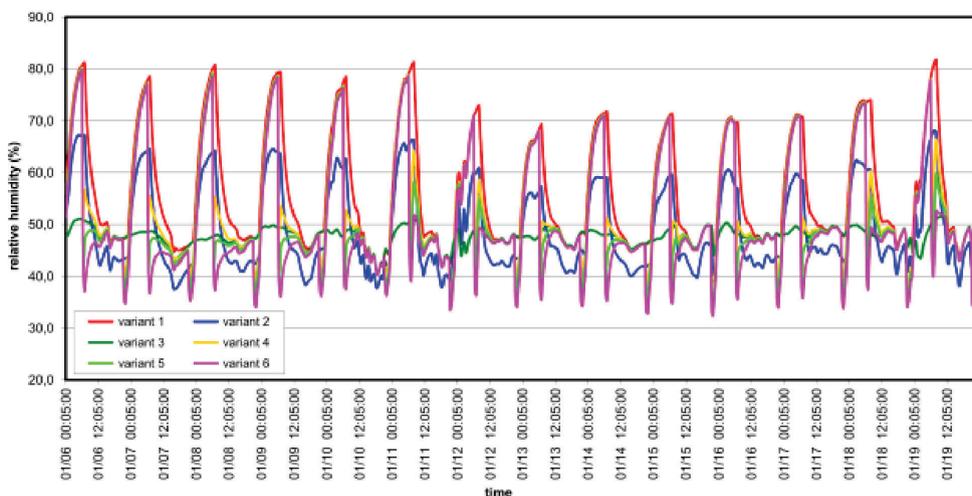
Fig. 1. Graph of relative humidity in the living room during 06.01. - 19.01.

Indoor relative humidity is dependent on a number of factors, such as ventilation, vapour barrier in constructions, the ability to accept and deliver moisture and the source of moisture. Figure 1 shows a relative humidity graph in the living room for six model variants (processed in EnergyPlus). Variant 1 - basic alternative – gap permeability all windows is determined by the value of 0.0002 kg/(s.m.Pa), inner door 0.005 kg/(s.m.Pa) and exterior door 0.001 kg/(s.m.Pa), the evaluation sleeping zone are defined by two people daily from 23:00 to 07:00, the room is tempered to +20.0 °C. Room is oriented to the SW. Variant 2 - difference compared to the original alternative of variant 1 is in doubling the gap permeability of windows to 0.0002 kg/(s.m.Pa). Variant 3 - difference versus the original alternative of variant 1 is to remove, exclude humidity producers - people, model without counting people. Variant 4 - difference versus the original alternative variant 1 is the addition of morning and evening intensive ventilation of the room at the level of air exchange $n = 3.0$ l/h in the duration of 15 minutes, both in the morning and in the evening. Variant 5 - difference versus the original alternative of variant 1 is to complement the morning and evening intensive ventilation of the room at the level of the air exchange $n=3.0$ l/h in a duration of 30 minutes, both morning and evening. Variant 6 - differentiation from the original alternative of variants 1 is the addition of morning and evening intensive ventilation of the room at the level of air exchange $n = 3.0$ l/h in the duration of 60 minutes, both in the morning and in the evening.

Variants describe the real functioning of the existing buildings without the recuperation assembly. The values in the chart were determined to perform laboratory measurements on profile systems. The condensate generation in functional gap (see Figure 2 and Figure 3) is not described neither limited by the standards nor regulations. Seriousness of the problem varies depending on the material base. Considering the wooden window structures the degradation of surface finish occur and its thermal characteristics change.

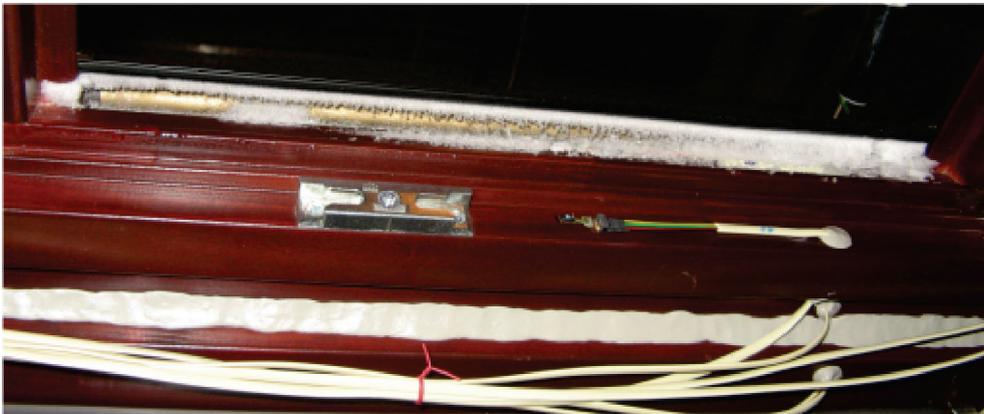
Fig. 2. Demonstration of ice coating and condensation in gap between casement and window frame at exfiltration and 200 Pa pressure difference (lower part).

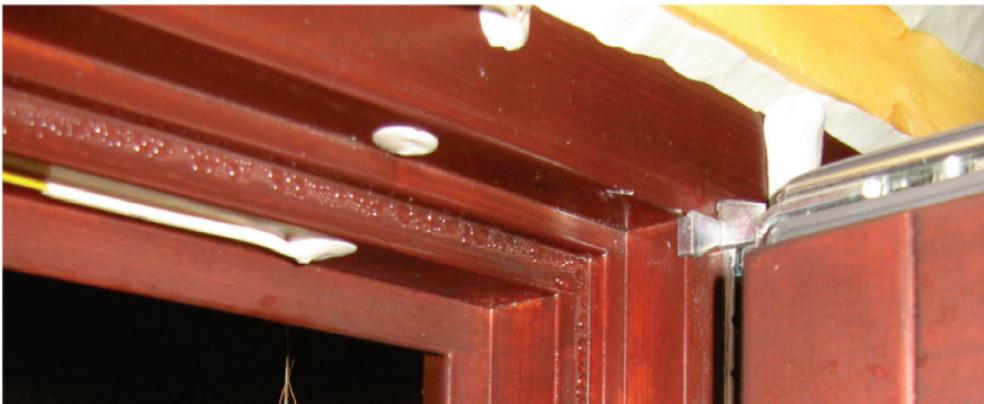
Fig. 3. Demonstration of condensation in gap between casement and window frame at exfiltration and 200 Pa pressure difference (upper part).

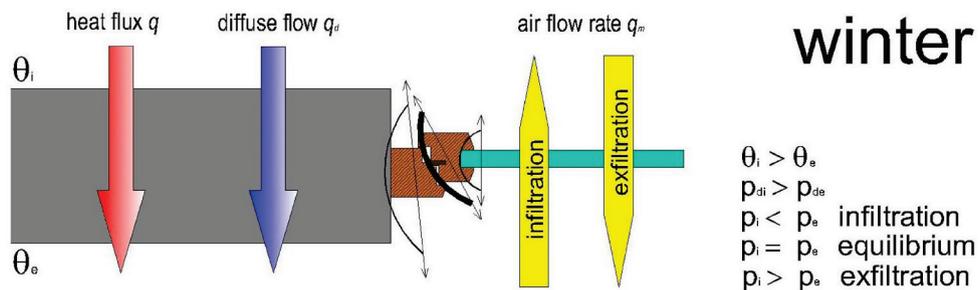
Fig. 4. Schematic representation of heat transmission, diffusion of water vapour and airflow through window structure [7, 8].

The moisture transport through gap between casement and window frame at condensation temperature is the main cause of condensation of water vapour. The transport causes (see Figure 4):

- Air pressure differences (taking water vapour) – infiltration and exfiltration,
- Diffusion of water vapour (different saturation of water vapour in exterior and indoor air).

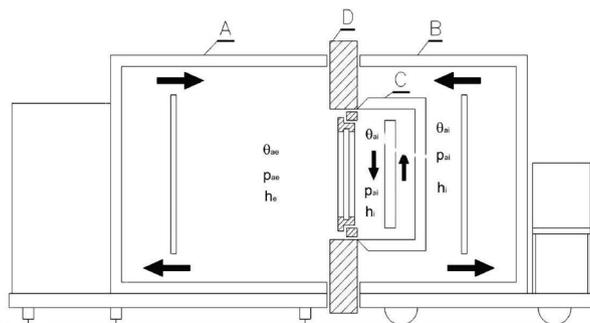
Fig. 5. Scheme of laboratory equipment of big climatic chamber [9].

The experimental measurements were carried out in heat engineering laboratories at the Faculty of Civil Engineering. Measurement models represent real window structures. The big climatic chamber illustrated in Figure 5 was used at measurements. The chamber A represents exterior climate (outdoor temperature -11°C , pressure difference between exterior and interior from 0 to 2000 Pa, heat transfer coefficient $25 \text{ W/m}^2\text{K}$, relative humidity 50%). The chamber B represents balancing chamber for HOT-BOX and simulate the indoor climate (indoor temperature $+20^{\circ}\text{C}$, relative humidity 50%). The HOT-BOX is used for measurement of heat transmission using measured element simulating the indoor conditions (indoor temperature $+20^{\circ}\text{C}$, relative humidity 50%, heat transfer coefficient $7.7 \text{ W/m}^2\text{K}$). Part D is a masking panel, in which the measured window structure is imbedded. In case of our measurement the HOT-BOX was not used as the conditions with infiltration or exfiltration were to be investigated.

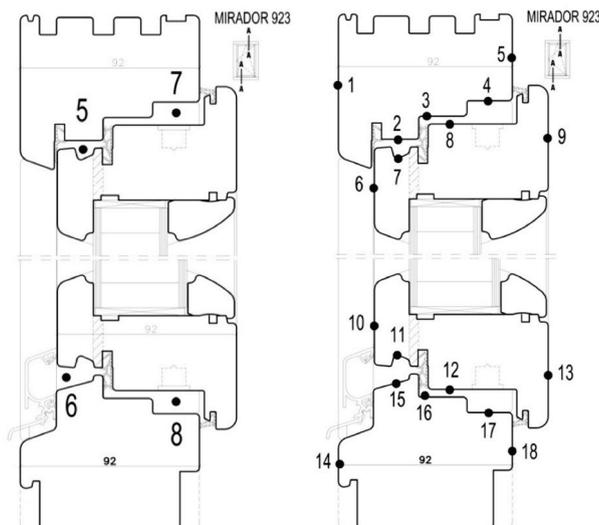
Fig. 6. Geometric parameters of window profiles and placement of measurement sensors.

Measurement sensors are divided into two groups. The first group measures the surface temperatures (PT 100). The second one measures the temperatures and relative air humidity (SHT 75). The sensors distribution is presented in Figure 6.

At experimental measurements in big climatic chamber the occurrence and amount of water vapour and ice coating condensate was found out after each completed measurement phase. The internal surface temperatures and air temperature including relative air humidity in gap measurement points (see Figure 6) belonged into the second valuation data group. The measured values are presented in Figure 7.

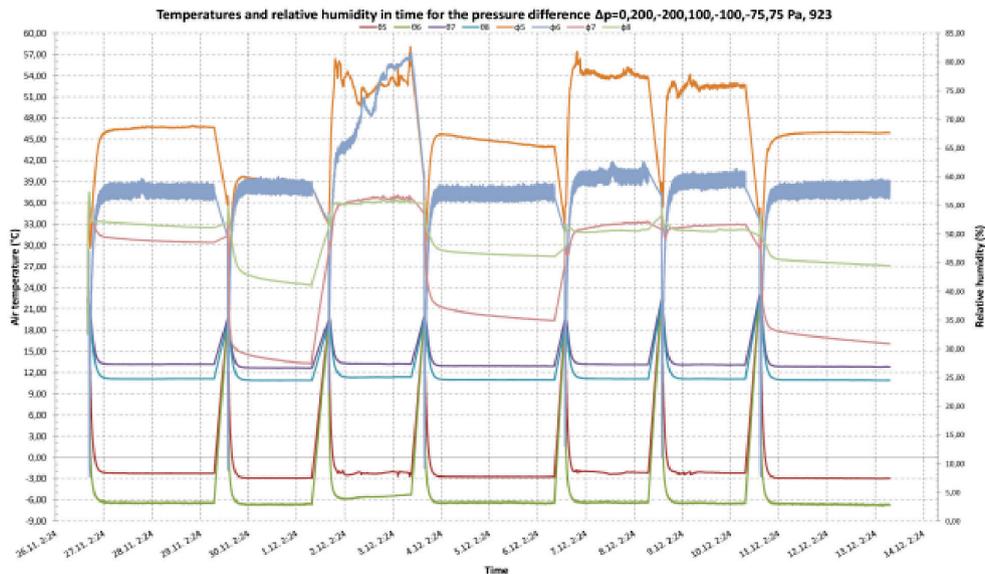
Fig. 7. Graph of temperatures and relative humidity in time for the pressure difference.
