Estimation of cracking of reinforced concrete load-bearing construction structures at the stage of their technical inspection

Abstract. The article describes the process and causes of cracking of bearing reinforced concrete structures, revealed during the inspection of the technical condition of structural elements of buildings at the stage of their erection, at the stage of suspended construction and in the operational stage. The reasons for the appearance of cracks in reinforced concrete structures under force loads and climatic influences are analyzed. Possible reasons for the appearance of cracks in a monolithic reinforced concrete beam ceiling of a multi-storey building of a column structural system and in monolithic walls of an underground cylindrical reservoir, identified by the author of the article when inspecting the technical condition of these structures, are given. The relationship between the appearance of destructive cracks and the design errors of a monolithic reinforced concrete beam ceiling is shown. The complex nature of the causes of the appearance of cracks in the monolithic walls of the underground reservoir is revealed. The article describes the capabilities

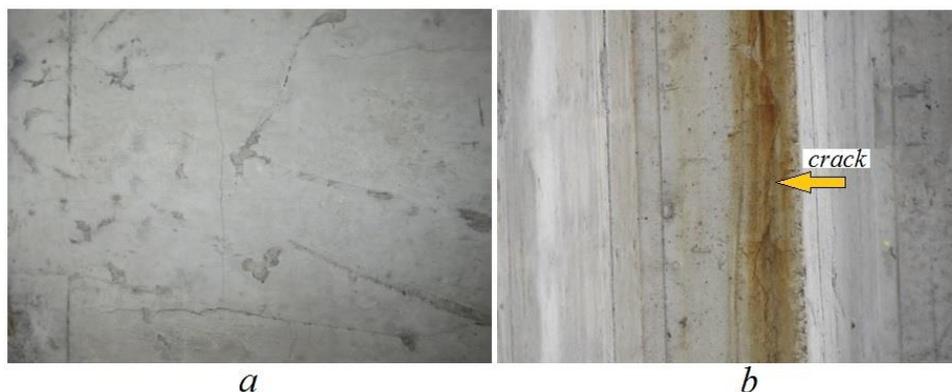
Figure 1a shows the appearance and shrinkage cracks with an opening width of up to 0.2 mm on the surface of the inner bearing wall of a monolithic multi-storey residential building.

Figure 1b shows a vertical crack with an opening width of 0.3 mm on the surface of a reinforced concrete pylon of the basement floor of an unfinished multi-storey monolithic residential building. In this case, we can expect a further increase in the width of the opening of the pylon crack during the continuation of the erection of the building with the further development of the process of corrosion of the longitudinal working reinforcement of the pylon.

Fig.1. Shrink cracks with a width of opening up to 0.2 mm on the surface of the inner monolithic wall of the building (a), a vertical crack on the surface of a reinforced concrete pylon with a width of 0.3 mm opening and manifestations of corrosion of the armature (b)

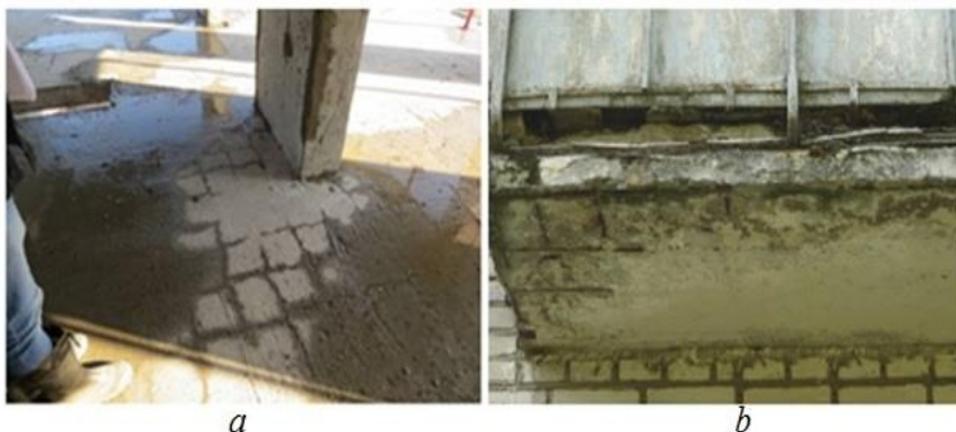
Figure 2a shows the fracture at the upper surface of the monolithic ceiling slab unfinished building. Figure 2b shows the typical defects of the concrete balcony slabs of the operated building.

Fig.2. Destruction of the upper surface of the monolithic ceiling slab of unfinished building (a), typical defects of concrete balcony slabs of operated building (b)

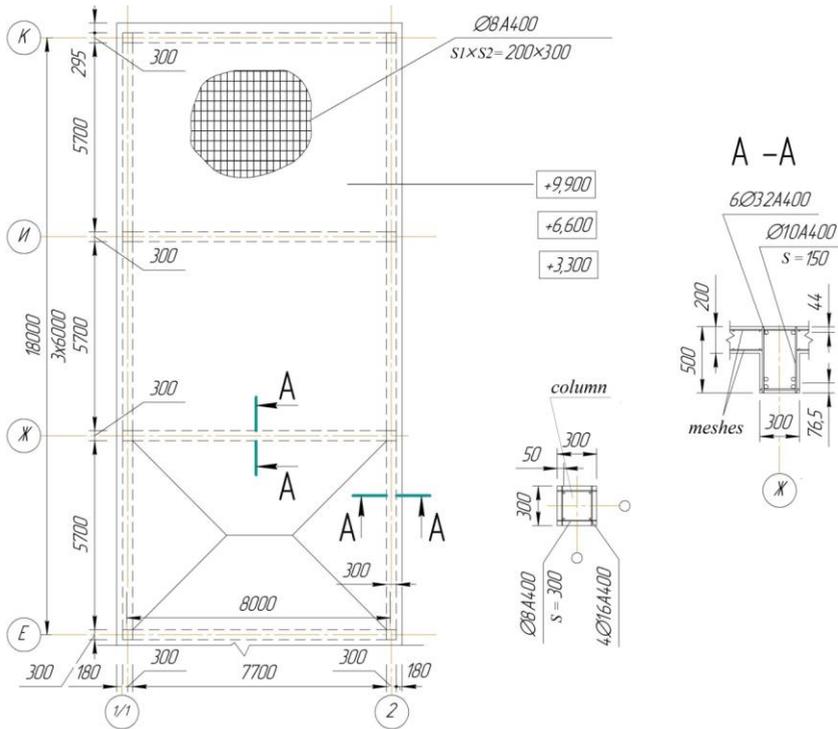
Figure 3 shows the constructive solution of a monolithic beam ceiling of a multi-storey building of a column structural system, during the examination of which cracks in slabs with an inadmissible opening width were detected.

At the same time, the character of the crack formation testified to the insufficient reinforcement of the slab of monolithic ceiling along the long side, although it is known that the rectangular slab, supported on the contour, mainly works on the smaller of the spans.

During the inspection, it was established that the reinforcement from the lower side of the beam ceiling slab was made with a knitted mesh of individual reinforcing bars $\varnothing 8A400$.

Moreover, the reinforcing bars of the knitted mesh running along the short side were installed with a pitch of 200 mm, along a length of 300 mm. Such a projected reinforcement suggested that the slab would work primarily on the smaller of the spans.

When analysing the structural solution of a monolithic beam ceiling, it was established that the principle of assigning cross-sectional dimensions of contour beams, depending on the applied load and the overlapping span, was not realized when designing the beam ceiling. All contoured floor beams had the same cross-sectional dimension 300×500 (h) mm.

Fig.3. Constructive solution of the of the inspected monolithic beam ceiling

The assumed verification of the monolithic beam ceiling showed that the same cross-sectional dimensions of the beams of both directions influenced the work of the monolithic slab under the load: the passing bending moment along the long side of the slab was greater than the moment along its short side, which led to the appearance of defects in the monolithic beam ceiling [11].

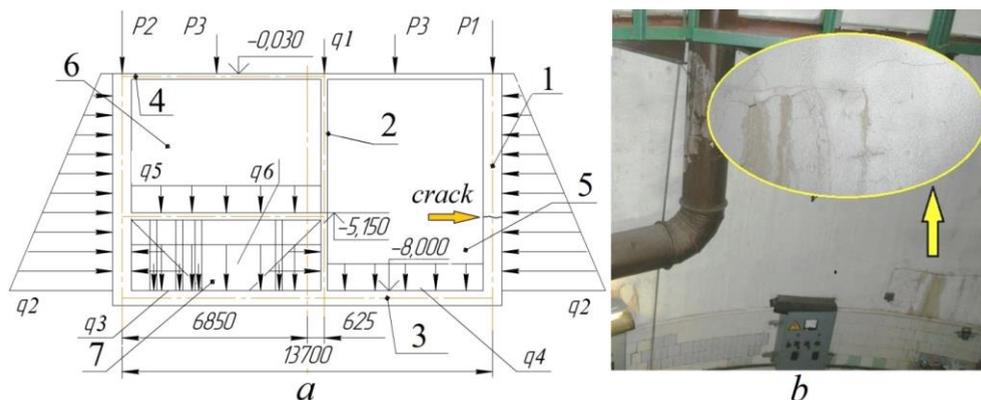
Thus, during the inspection of the technical condition of the underground monolithic reinforced concrete cylindrical tank, damage was found to the exterior wall of the engine room in the form of annular cracks at a distance of about 2.5 m from the floor of the room. Through these cracks in the spring during the thawing of snow, water seeped into the engine room. Opening of the plaster layer allowed to estimate the opening width of annular cracks in the wall of a monolithic well. During the inspection in the summer, it was about 0.2 mm. Figure 4 shows the location of the fracture in the reservoir design scheme, as well as the appearance of the internal surface of the wall with cracks in the engine room of the underground reservoir.

Fig.4. The location of the cracks in the calculated scheme of the underground reservoir (a); the view of an inner wall surface with cracks in the engine room of the reservoir (b): 1 - the outer wall of the reservoir; 2 - inner wall; 3 - bottom; 4 - coating; 5 - engine room, 6 - technical room; 7 - receiving reservoir

Complex analysis of the stressed-deformed state of the reinforced concrete underground reservoir together with the results of its visual and instrumental inspection, as well as the study of the available construction documentation, made it possible to point out possible causes of the appearance of ring cracks located at a height of 2.5 m from the floor of the room of the machine room.

So, the reason for the appearance of ring cracks in the wall of the reservoir and the infiltration of water into the reservoir room during the spring period was probably the coincidence of several factors: poor performance of the technological seam of the concreting in the level of the intermediate overlapping of the reservoir, the location of this seam at the place of the greatest tensile stresses of the inner edge of the wall; the pressure pattern of groundwater filtration during the rapid spring melting of snow [12].

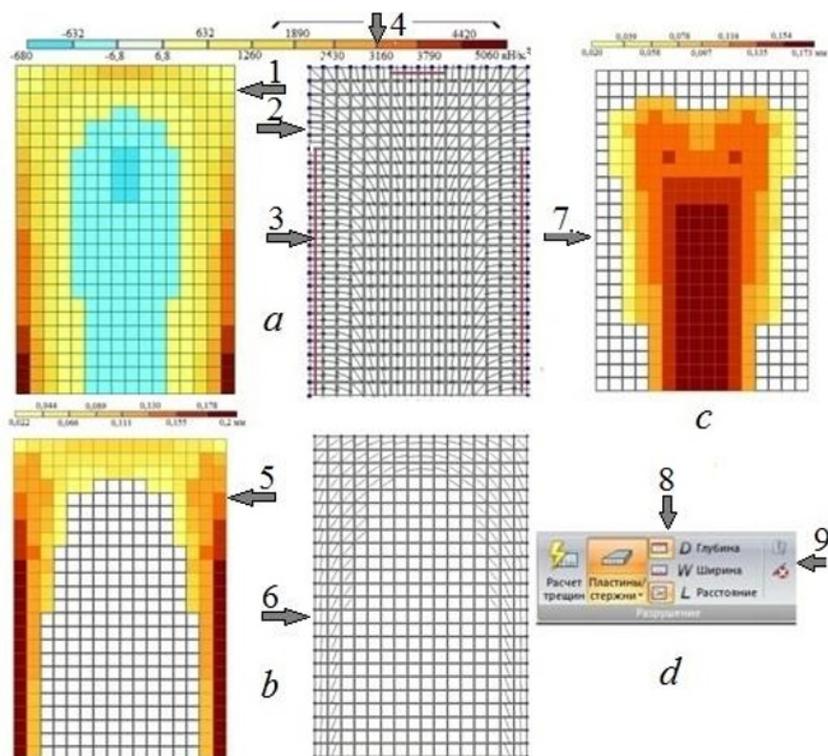
In Fig. 5 shows the results of a computer calculation to determine the pattern of cracking and mosaic of the width of the opening of the force cracks in a rigidly clamped three-sided flat slab with the use of the calculated processor LITERA and the panel-menu command CRACK CALCULATION of the LIRA-CAD program complex [14].

After the basic calculation of the floor slab, additional calculation using the LITER processor becomes available. The pattern of cracking of the structure can be obtained by drawing on the mosaic of the distribution of the principal tensile stresses $N1$, the graphical representation of the directions of the main axes of tensile stresses $N1$ and comparing the values of the principal tensile stresses with the normative value of tensile stresses for the concrete class adopted for the slab. Cracks are formed if $N1 > R_{bt, n}$ (Fig. 5a).

Fig.5. The results of calculation of the slab of the overlap rigidly fixed on three sides using the processor LITERA of LIRA-CAD (a) and the command CRACK CALCULATION of LIRA-CAD (b, c, d): 1 - the mosaic of the main voltages N_1 ; 2 - the direction of the main axes N_1 ; 3 - location of cracks; 4 - cracking stresses (for the top layer of the slab); 5 - mosaic of the opening width; 6 - the direction of the cracks (for the top layer of the slab); 7 - the mosaic of the opening width (for the lower layer of the slab); 8 - the cracking; 9 - the destruction (the buttons on the panel-menu command CRACK CALCULATION)

Another and the main variant of computer fracturing calculations in the LIRA-CAD is the use of the CRACK CALCULATION command (Fig. 5 b, c, d). In addition to the main cracking parameter (crack opening width a_{cr}), additional cracking parameters can be obtained from the calculation using the CRACK CALCULATION command: the depth of crack opening and the cracks spacing l_s .
