Case study of technological problems arising from the use of new material, DOMEX steel sheet, on the components of the mower discs on the example of the production company SaMASZ Sp. Z o. o.

Abstract. The paper describes the improvement of technological process of knife holder production used in disc mowers at SaMASZ Sp. With o.o. The improvement was aimed at eliminating cracks in the press of a 500t crank press press crush that occurred after the Boron 27 starting material was changed to Domex MC 500 high strength steel. The technology of regeneration of claws with identified operational cracks and a stand for fatigue tests was also proposed. Defectoscopy and strength testing methods have been developed to verify that the structure of the regenerated material is free from cracks or micro cracks in the material.

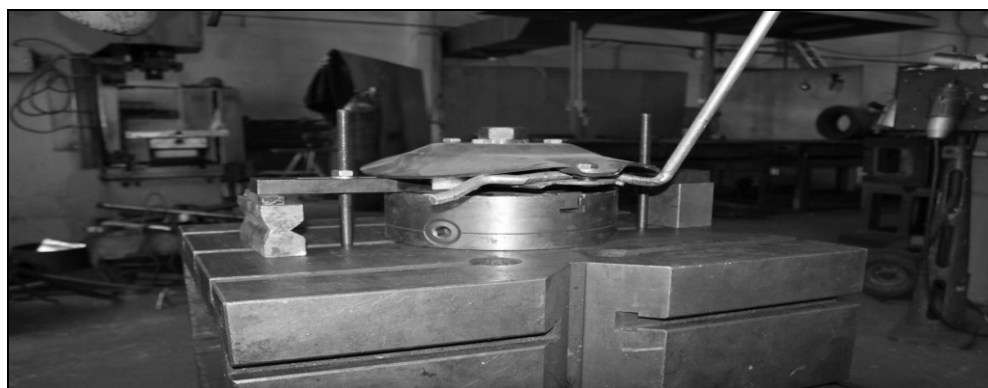
For the technological research of the holders we used 8 samples made in SAMASZ company. Hardened central knife holders with cracks after pressing, were prepared for checking resistance to cyclic bending- real work simulation using a specially shaped key. View of the station and the way of simulation is shown in Figure 9.

Fig. 9. The stand for research of holders resistance at the PB Institute of Innovation

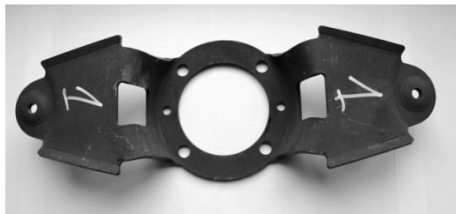
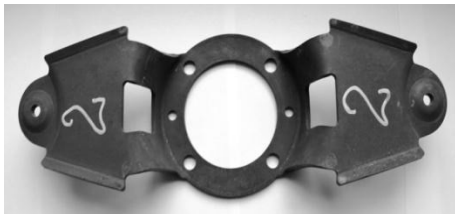
Table 3. Group I - Holders No. 1 and No. 2 – Cracks not visible to 1 mm, not welded

| Sample number | Number of cycles | Conclusions |
|---|---|---|
| I | 200 | Cracks less visible to 1 mm, as at the beginning of the sample test |

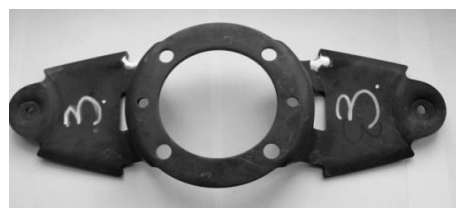
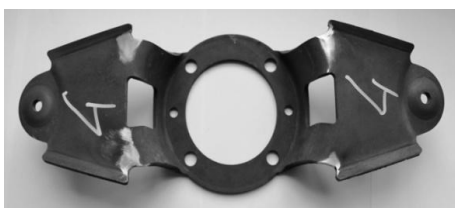
Table 4. II group - holders no 3 and no. 4 - cracks up to 3mm, welded and grinded

| Sample number | Number of cycles | Conclusions |
|---|---|---|
| I | 200 | No visible cracks in material structure |

Defected holders were regenerated by welding cracked places by MAG method. The next step was to grinding welds equally with the holder. To make sure if regenerated holders are ready to use in production, We made bending tests for holders exactly with the side of insert and remove of the holders knife.

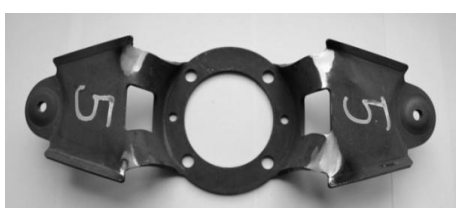
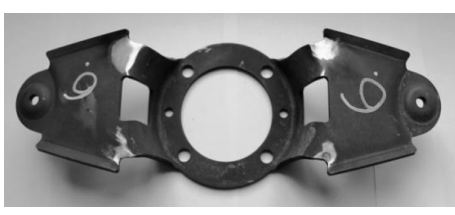
Table 5. Third group - Holders No. 5 and No. 6 - Cracks above 3 mm, welded and grinded

| Example number 5 - crack 7.6 mm | Example number 6 - crack 6.3 mm |

| Sample number | Number of cycles | Conclusions |
|---|---|---|
| I | 200 | No visible cracks in material structure |

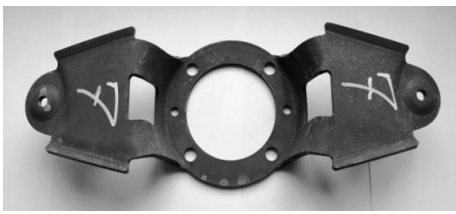
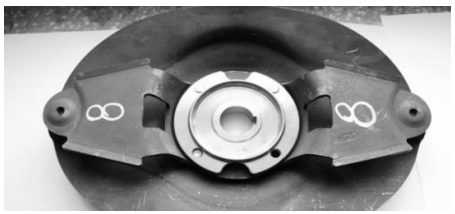
Table 6. IV group - holders No. 7 and No. 8 - no cracks

| Sample number | Number of cycles | Conclusions |
|---|---|---|
| I | 200 | No visible cracks in material structure |

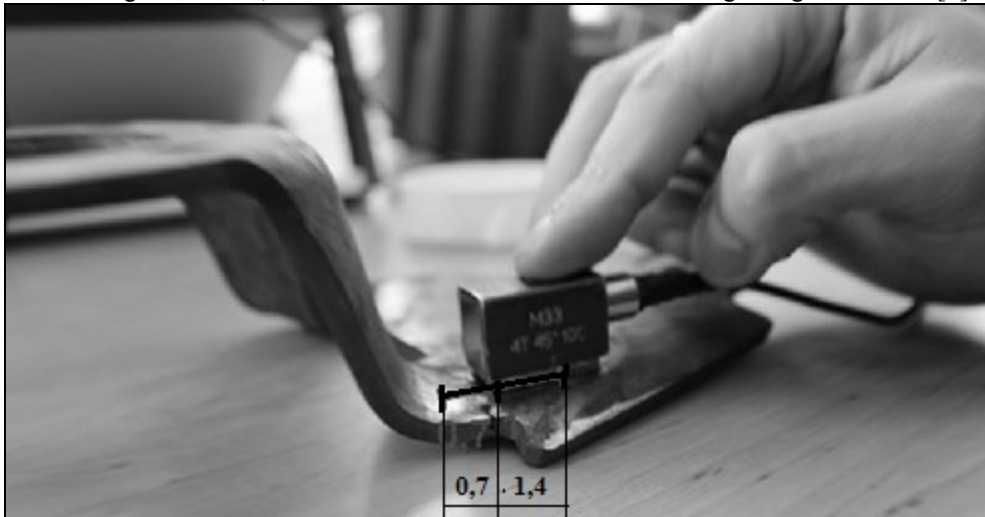
Fig. 11. Location for cracks in knife holder

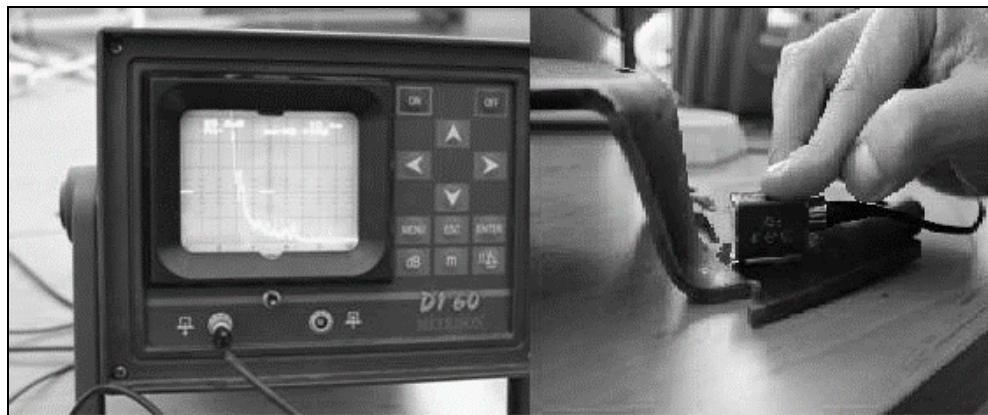
Subsequently, samples subjected to knife replacement simulations were examined. Defectoscopy studies are aimed at detecting and identifying sites of discontinuity [8]. Examination of 8 samples showed no cracks and microcracks in the material structure.

Fig. 12. Defectoscopic examination of 8 samples - no cracks
