Estimate of throughput of bridge transitions and pipe passages built on minor rivers of piedmont areas of Krasnodar Territory- Russia

Abstract. Stability and accident-free operation of engineering road structures including bridge transitions and pipe passages built on mountain rivers mostly depends on a stream regime and lack of obstructions for water flow. Such structures pose a prominent potential hazard being built in piedmont areas of Caucasus Mountains characterized by flash floods and blockage of structures by floating debris, mudflow deposits and wastes of construction. This notwithstanding, the threats caused by these phenomena are poorly studied. The purpose of this study is in estimation of throughput of bridge transitions and pipe passages built on minor rivers of piedmont areas and analysis of hazards caused by floods and obstructions to water flow. The results of calculation of capacities of existing road structures are provided herein. A qualitative assessment of potential emergencies in case of severe flood is also given. A major hazard of possible blockage of waterways that can cause emergency even in regular flood conditions is noted.

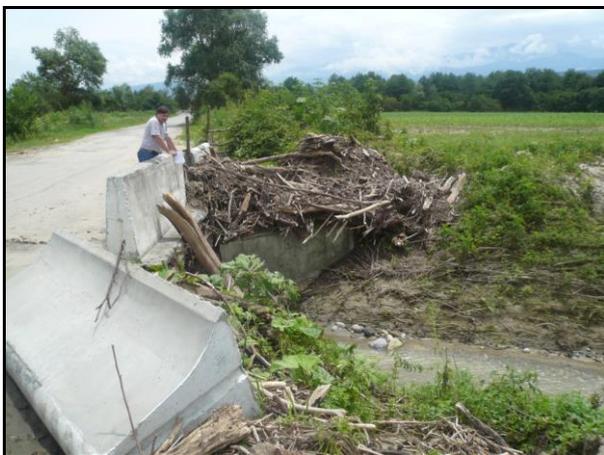
Fig. 1. Floating debris near the bridge transition over watercourse #1 after a flash flood.

In the context of intensive building activities including engineering and construction of roads on the Black Sea Coast of Krasnodar Territory, the man-made hazards of the projects under construction is particularly topical [1]. The floods of mountain rivers and blockage of waterways due to floating debris, mudflow deposits and wastes of construction is one of the sources of both natural and man-made hazards that can cause emergencies [2-4]. An example of the occurrence of the floating debris is shown in Fig. 1.

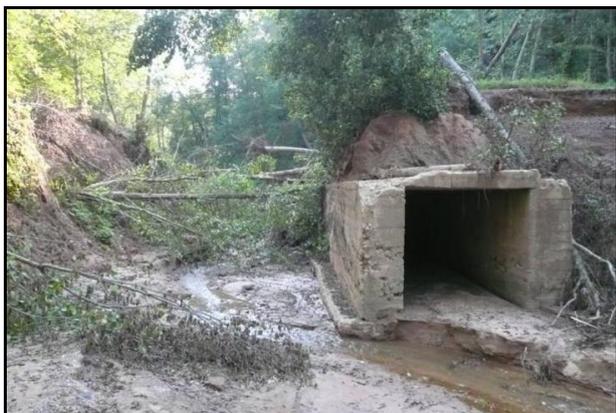
Fig. 2. The destructive impact of floating debris at bridge transition on watercourse # 5.

Based on calculation and passages observation results it was discovered that most of them are not capable to endure discharging the flood of 1 percent exceedance as confirmed by wash-away of bridge transitions and pipe passages as a result of foods in 2002, 2009 and 2010. If it is remembered that waterways are blocked by stems and branches of trees, as well as construction wastes, then it can be said that none of the structure under study is capable to endure discharging a considerable flooding. Examples of the destructive impact of the floating debris are shown in Figs 2 and 3.

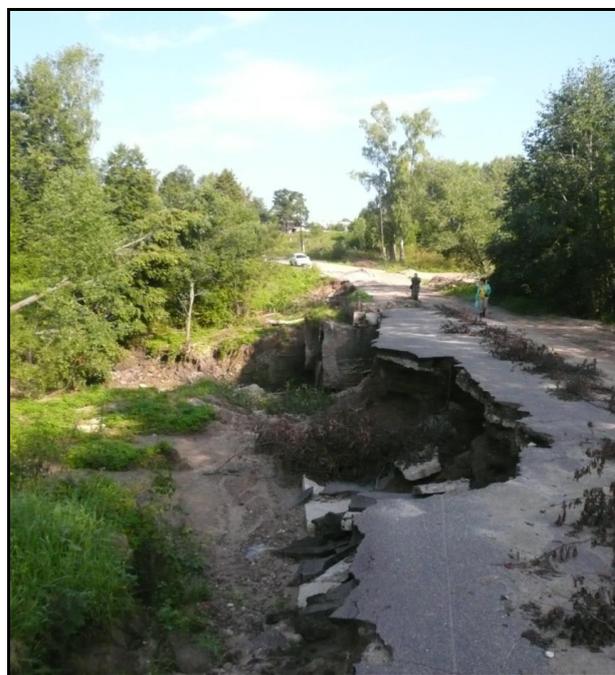
The event of a chain of hanging dams resulted from the blockage of culverts and their further sequential outbreaks can cause disastrous consequences. For example, the bridge transition on watercourse # 9 (see Fig. 3) at a five-time margin of its throughput was completely blocked during a common rain shower. It caused a breakthrough of accumulated flood waters onto the road. It is seen that even at such throughput margin accident-free operation of the bridge cannot be ensured when the flow of floating debris is high.

Fig. 3. Consequences of a flash flood at bridge transition on watercourse # 9.
