Effect of Sandblasting on Low and High-Cycle Fatigue Behaviour after Mechanical Cutting of a Twinning-Induced Plasticity Steel

Antoni Lara^{1,*}, Mercè Roca¹, Sergi Parareda¹, Núria Cuadrado¹, Jessica Calvo² and Daniel Casellas^{1,3}

¹Fundació CTM Centre Tecnològic, Metallic and Ceramic Materials Department, 08243 Manresa, Spain

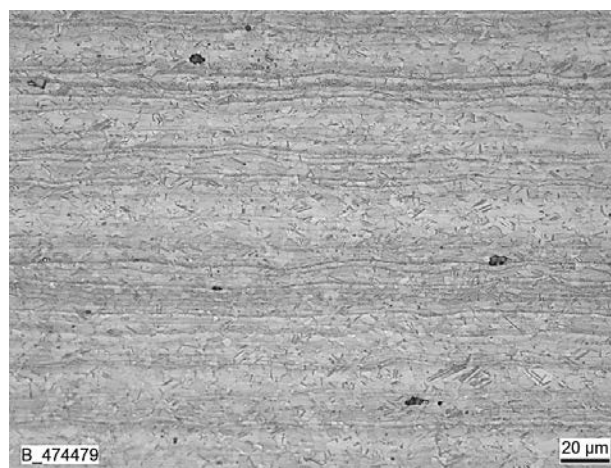
Fig. 1. Microstructure of TWIP1.5 at the centre (Nital etched).

Then, samples of these steels were polished and etched following standard methods. Their microstructures can be seen in figure 1 and figure 2.

As seen in the previous figures the two TWIP steels shows a homogeneous austenite matrix. The grain size is the only notable difference.

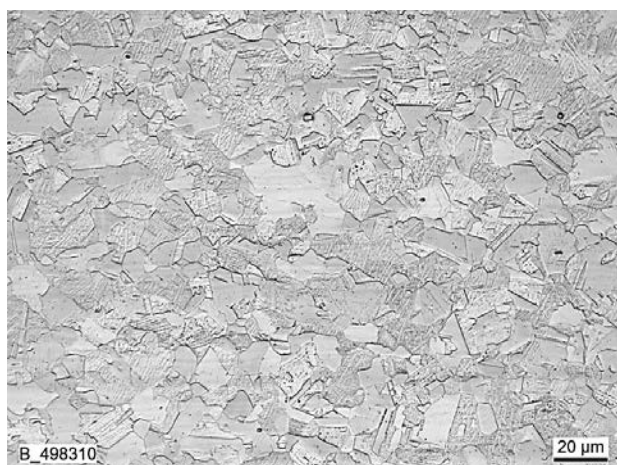
Fig. 2. Microstructure of TWIP3 at the centre (Wallner etched).

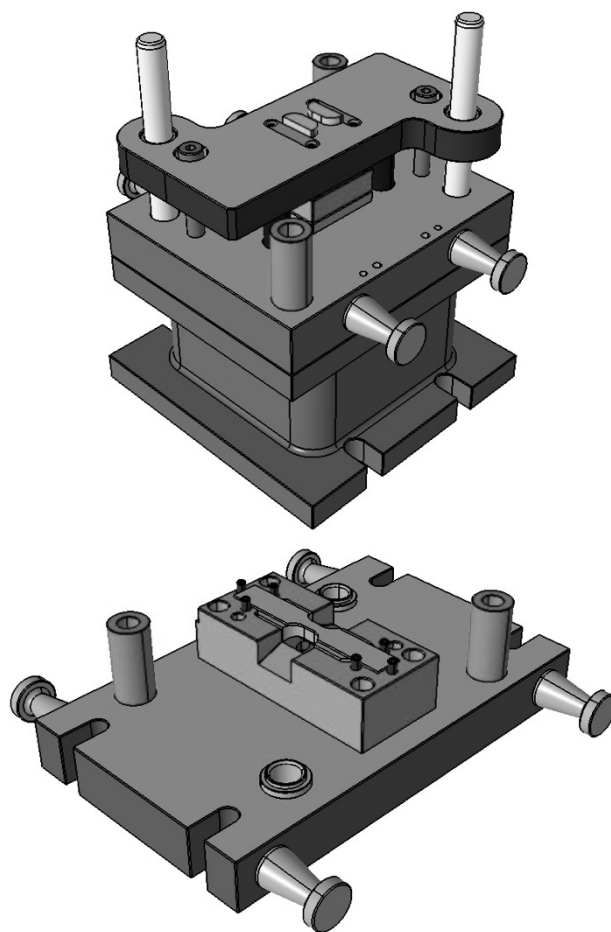
Fig. 3. Tool employed for cutting fatigue specimens.

- Spark erosion (EDM) and polished, with a first grinding and a polishing with two types of abrasive pastes to get clean and shiny surfaces, identified as [REF] condition.
- Shearing using a cutting clearance of 5% of the sheet thickness and a punch radius of 30 microns, identified as [CUT] condition
- Shearing as previously commented and manually blasted using glass microspheres, identified as [SAN] condition.

Figure 3 shows the tool employed for cutting a part of the specimens tested.

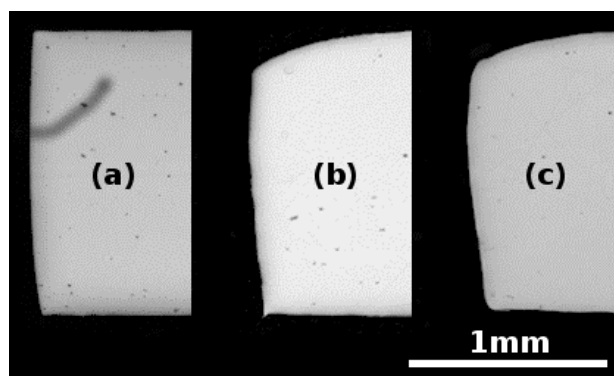
Fig. 4. TWIP1.5 cut edges: (a) REF, (b) CUT and (c) SAN.

The geometry of the edges was evaluated by cutting a specimen of each strategy in cross section and analysing them by optical microscopy, figure 4 and figure 5.

Sheet cut edges present different geometry depending on the cutting methodology employed. As shown in figure 4 and 5, polished samples present rounded edges without asperities, as expected (figure 4(a) and 5(a)). Sheared samples show the typical features of a sheared edge with rollover, smooth, fracture zones and burr in two materials (figure 4(b) and 5(b)). Once samples are submitted to the sandblasting operation, the roughness of the cutting edge is reduced and the burr removed.

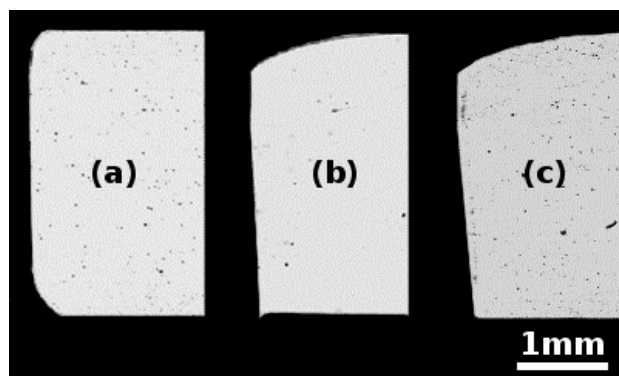
Fig. 5. TWIP3.0 cut edges: (a) REF, (b) CUT and (c) SAN.

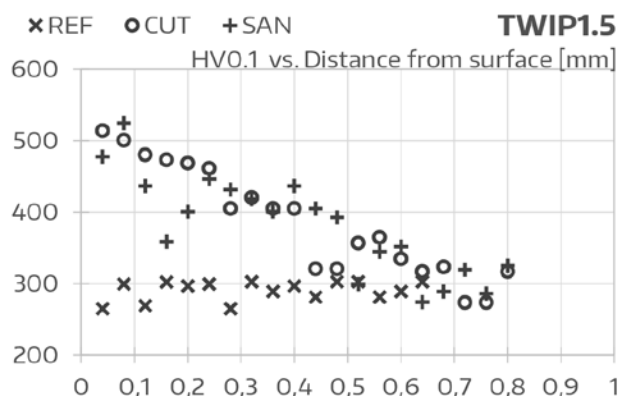
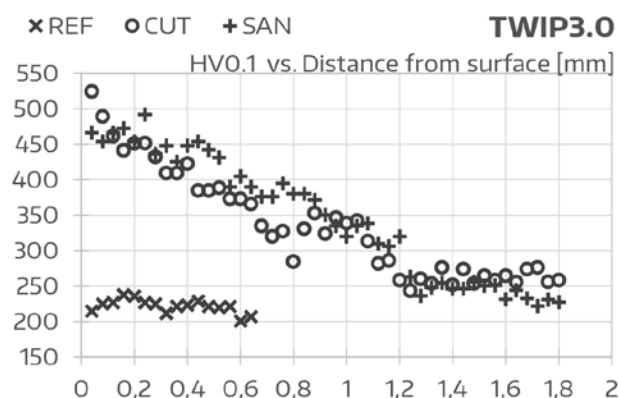
Fig. 6. Micro hardness profiles at the near cut edge.

Vickers micro-hardness profiles were also performed to assess the effect of each cutting methodology and are shown in figure 6.

Micro-hardness profiles shown at figure 6 show that the shearing process increases hardness near the cut edge, an increase that is not observed in polished specimens, for which the cut were done by EDM. The length of the cut-hardened area is deeper in the thicker steel, while no clear differences of hardness are observed between the sheared samples with and without sandblasting treatment.

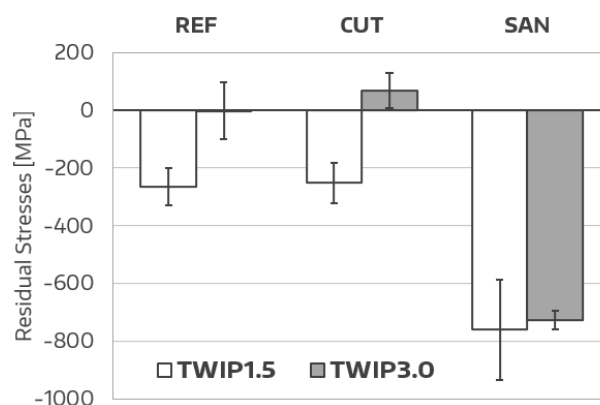
Fig. 7. Residual stresses obtained on the TWIP steels surface.

Residual stresses were also evaluated on the surface of the samples by means of instrumented indentation using the methodology developed by Wang and Bao [15, 16]. In order to perform indentation tests, a Berkovich indenter was used with an applied penetration depth of 10 μm . Results of residual stresses, shown in figure 7, correspond to an average value from at least 20 indentations.

As can be seen in figure 7, sandblasting process induces high compressive stresses measurable even at penetration depth of 10 microns with instrumented indentation. The magnitude of these compressive stresses does not differ much from those reported by other authors that performed shot peening process with different TWIP steels, although the depth of the compressive layer was higher [19], 100 to 300 microns for a shot peening versus 25 to 75 microns for a sandblasting [20].

Differences between polished and sheared samples, and also with sandblasting specimens submitted at high strains or stresses, cannot be explained by differences in residual stresses, since, as observed with nano-indentation in figure 7, they are practically the same. In this case, this change in crack propagation rate has to be motivated by the microstructural change generated by the mechanical cut in the tool. Thus, in the specimens cut by spark erosion and then polished [REF], no deformation was introduced during cutting process, therefore the original microstructure, tougher, more tolerant to the defects and with a high crack propagation resistance is acting. In contrast, there are many works which support that during specimens shearing a high amount of deformation is introduced on the cut edge [11]. Thus, the microstructure in this region does not tolerate much more deformation and behaves like a material with a limited toughness and with a low crack propagation resistance.

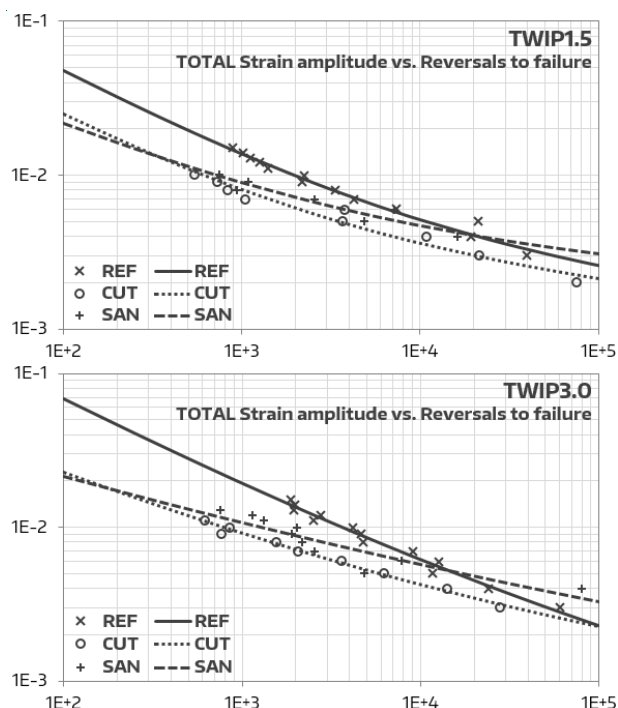
Fig. 8. ϵ N curves obtained with TWIP steels

The main strain and stress-life fatigue results are summarized in figure 8 and 9, defined here as the strain and stress amplitude leading to 50% survival probability (experimental values).

As shown in figure 8 and 9, fatigue performance depends on the cutting strategy employed. At low and high number of cycles (LCF and HCF tests), both strain and stress that can be applied for a given number of cycles, is higher for polished specimens compared with the sheared ones.

Concerning sandblasting specimens, the effect of this surface treatment on the fatigue performance depends on the applied stress level. Thus, the sandblasting process significantly increase the strain and stress-life behaviour when the stress level is low (low strain in LCF tests and low stress in HCF tests). On the contrary, at higher stress levels (high strain in LCF tests and high stress in HCF tests) sandblasting treatment does not introduce any noticeable improvement in the fatigue behaviour of this type of steels, since the fatigue results of sheared specimens are similar with and without sandblasting, at high stress levels.

These results may be explained as follows: sandblasting process to sheared specimens generates a compressive residual stress layer which is expected to influence the fatigue life. At low cyclic stresses, the favourable effects of the compressive residual stress layer results in life enhancement. As the cyclic stress increases, the residual stresses will relax quickly and the extent of life enhancement will decrease, as some authors support [21].

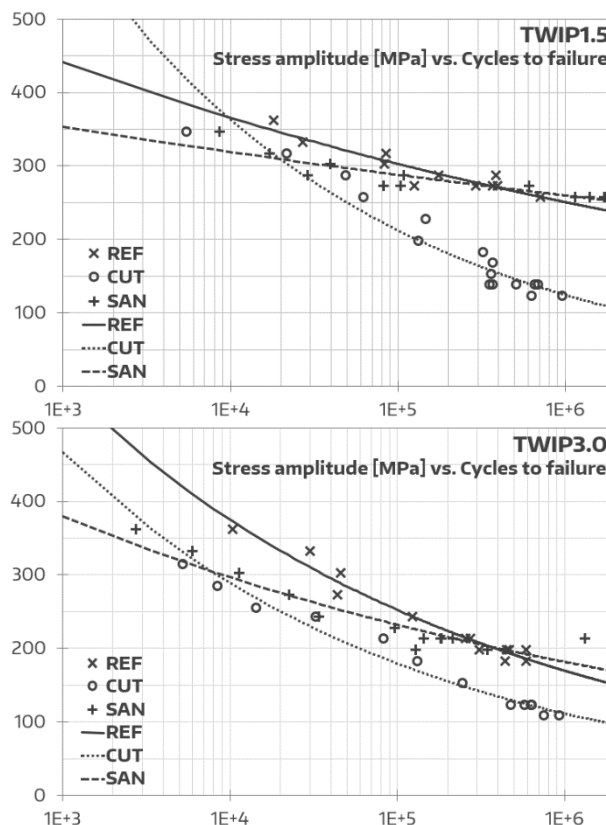
Fig. 9. SN curves obtained with TWIP steels.

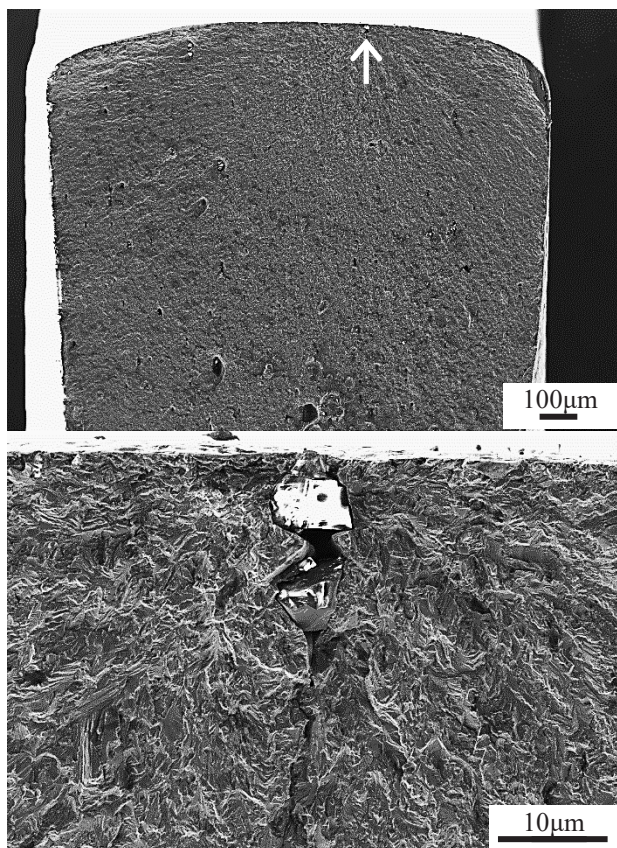
Fig. 10. Fractography of failed TWIP1.5 polished sample, showing the fatigue initiation site.

Thus, to rationalize the origin of failure in each case, a detailed SEM investigation of one specimen of each cutting strategy was done. These SEM fractographies are shown in figures from 10 to 12 for TWIP1.5 and 13 to 15 for TWIP3.0.

The fatigue failure surfaces in most cases show a failure origin independent of the cutting strategy, with no clear differences between the polished, sheared and sandblasted specimens. In most of the surface specimens analysed by SEM, the failure origin occurs in non-metallic inclusions located near the edge of the specimens.

These non-metallic inclusions, responsible for the crack nucleation, are probably the ones that cause that the fatigue performance of these two steels is not as high as expected. To know the nature of these non-metallic precipitates, an EDX analysis was performed, showing that most of them were aluminium nitrides.

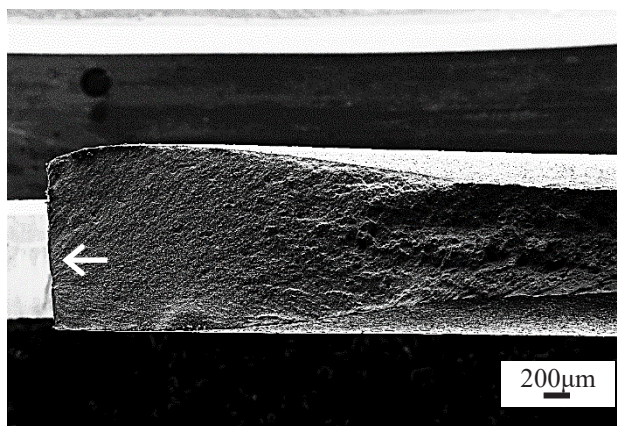
Fig. 11. Fractography of failed TWIP1.5 sheared sample, showing the fatigue initiation site.

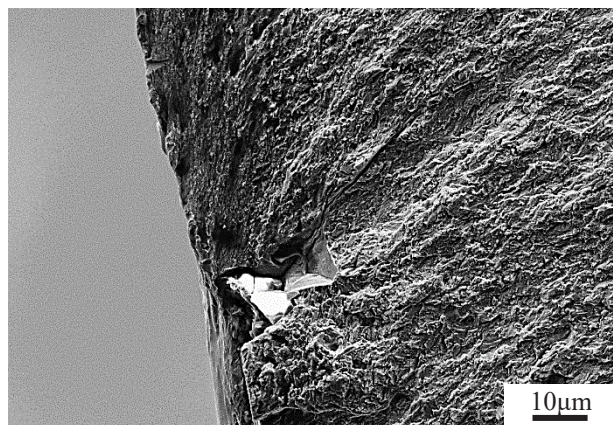
Fig. 12. Fractography of failed TWIP1.5 sheared and sandblasted sample, showing the fatigue initiation site.

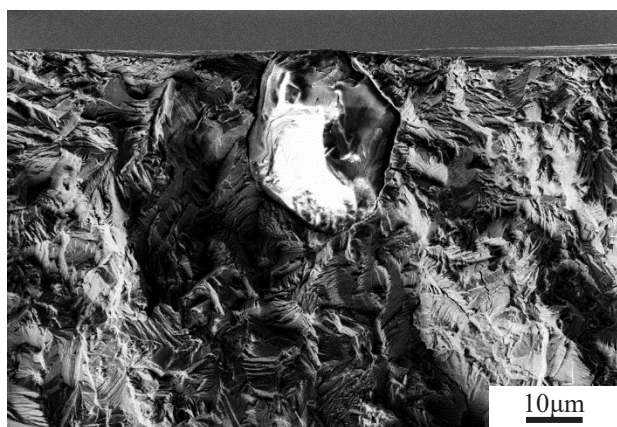
Fig. 13. Fractography of failed TWIP3.0 polished sample, showing the fatigue initiation site.

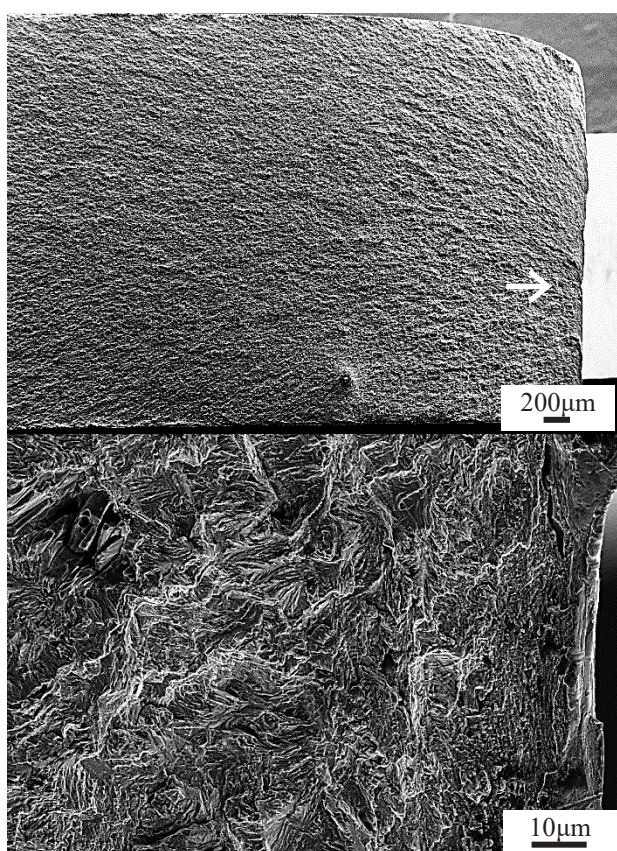
Fig. 14. Fractography of failed TWIP3.0 sheared sample, showing the fatigue initiation site.

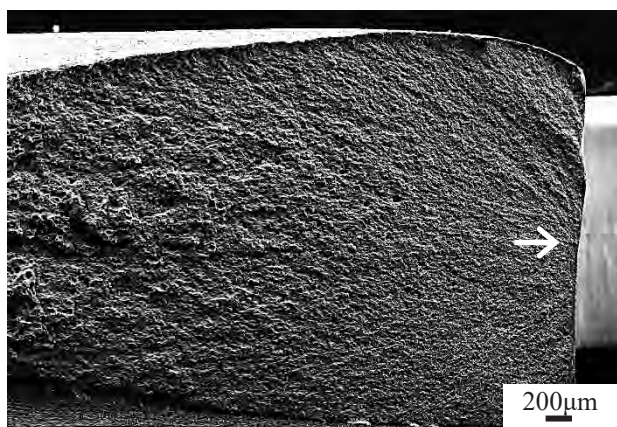
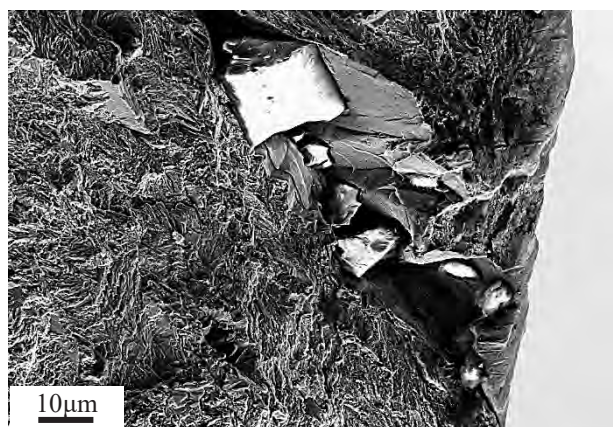
Fig. 15. Fractography of failed TWIP3.0 sheared and sandblasted sample, showing the fatigue initiation site.
