Effects of Elevated Temperatures on Mechanical's concrete specimen behaviour

Abstract. This paper presents an experimental study on the performance of concrete, subjected to high temperatures. Investigation was carried out by using two mixtures: an Ordinary Concrete (OC) and High Performance Concrete (HPC) with 10% of Silica Fume (SF) replaced of cement weight and 1,5% of super plasticizer, the water-binder (w/b) ratio used was 0,5 and 0,32 respectively. The produced concrete specimens are heated at a rate of 7 °C/min up to different temperatures (150, 300, 450, 600 and 900°C). In order to ensure a uniform temperature through the specimen, the temperature is held constant at the temperature stage for one hour before cooling. Mechanical properties at ambient temperature and residual mechanical properties after heating have already been determined. We examined also the effect of high temperature on the aggregate-cement paste interface and aggregate microstructure of the concrete specimens by scanning electron microscopy (SEM) method to reveal changes occurred after the cycle of heating-cooling. The results revealed that relative strength of the concrete specimens decreased as the ex

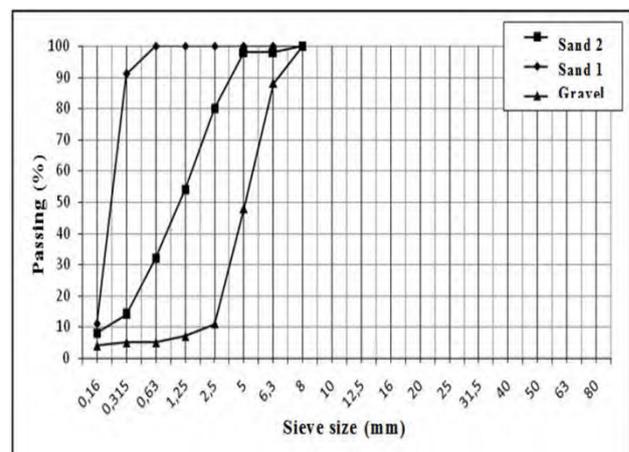
The distribution of coarse aggregate (gravel) in comparison with the sand aggregate are shown in (Fig.1), Tap water at room temperature was used in all mixes.

Fig. 1. Sieve analyses of aggregates.

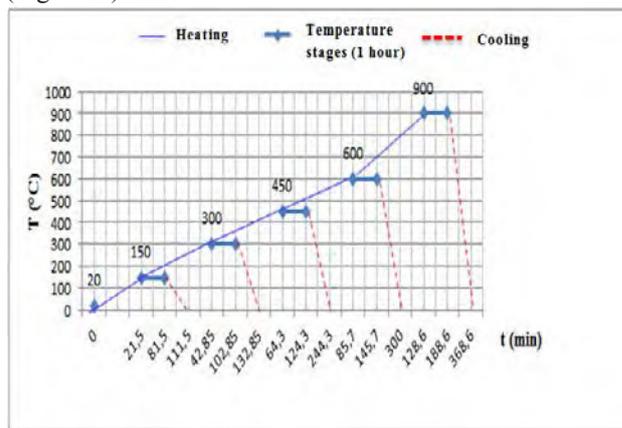
Parallelepipedic specimens (4x4x16 cm) were prepared then cured in lime saturated water at 20 ± 2 °C until the time of the testing. After 28 days the specimens of concrete were placed in an electric oven for performing the fire tests (maximum temperature of 1200 °C). The used furnace (PROETI HD-230) could achieve a high heating rate speed that is somewhat similar to actual fire conditions. The dimensions of the oven hole are of 200 mm · 200 mm · 200 mm, provided with insulator material and the outer body is stiff steel, to safeguard the user in the case of concrete specimen explosion. Specimens are heated to desired temperature of 150, 300, 450, 600 and 900°C (Figure. 2). The heating rate was set at 7°C/min for all cases, which is consistent with RILEM 129-MHT standard recommendation [8, 9] and In order to ensure a uniform temperature through the specimen, this last is held constant at the temperature stage for one

Fig. 2. Heating and cooling cycle.

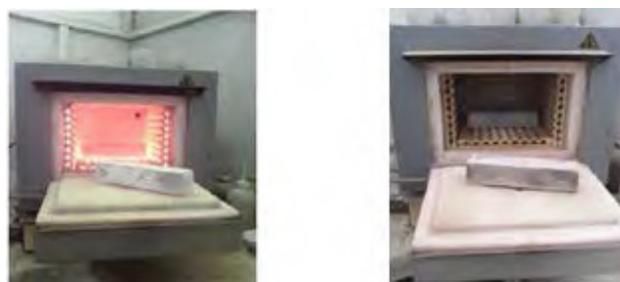
hour before cooling to room temperature at the air (Figure. 3).

Fig. 3. Cooling the test specimens in air.

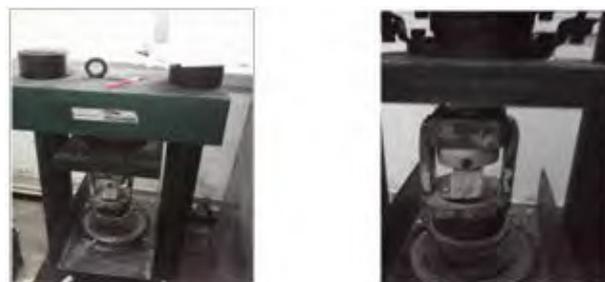
The compressive strength of concrete specimens was measured owing to uniaxial compression instrument (Figure.4) with a capacity of 3000 kN and loading rate was 0.5 MPa/s. The compressive strength tests were carried out on the specimens after exposed to elevated temperatures. Three specimens were used for each temperature and each cooling regimes to perform compressive strength tests. And the average of three measurements of specimens was presented and discussed in the study.

Fig. 4. Compressing test on prismatic specimen.

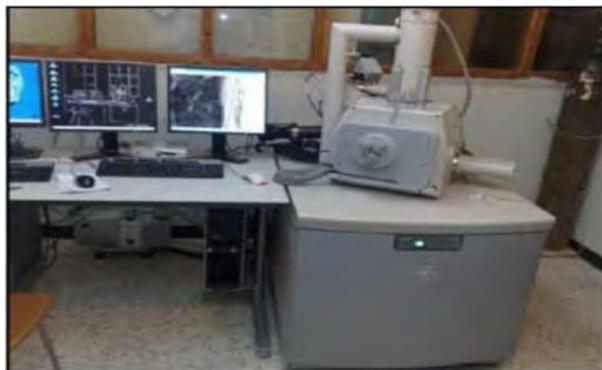
After strength testing, the samples were collected and marked in air tight containers to undergo Scanning Electron Microscopy (SEM) for changes to their microstructure. In this work, microstructural examinations and analyzes were carried out using the Scanning Electron Microscope (SEM - QUANTA 600). The device is equipped with an EDS microanalyzer and can work under conditions of environmental pressure. Figure.5 gives an overview of this installation.

Fig. 5. Scanning Electron Microscope QUANTA 600.

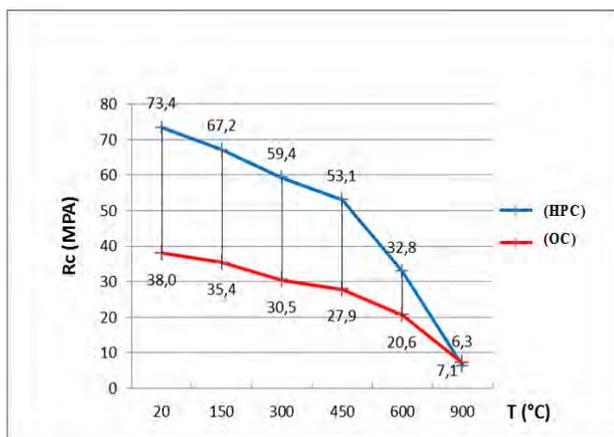
The concrete specimens produced in this study were exposed to the elevated temperatures at 150, 300, 450, 600 and 900°C, then their residual compressive strength values were determined. The residual compressive strengths of concrete specimens are presented in (Fig.6), for ordinary and high performance concrete successively. The residual compressive strength ratios at elevated temperatures as compared to the original strength before heating (20°C) are given in (Fig.7).

Fig. 6. Residual compressive strengths with increasing temperature

There are two concrete behavior zones. In the first zone, which varies from room temperature to 450 ° C, there is a decrease in resistance but in all cases of small magnitude. In the second zone starting from the intermediate limit to 900 ° C, there is a continual decrease in the compressive strength and this regardless of the type of concrete.

It was seen from (Fig.6) that the compressive strength value of high performance concrete decreases significantly with increasing temperature passing from 73.44 MPa at 20°C until reaching an ultimate value of 6.3 MPa at 900°C. It exhibited approximately 91% of the strength value which was measured at room temperature. In comparison with normal concrete who loses about 81% of its initial resistance. As reported in the literature [10, 11]. This decrease in compressive strength may be the occurrence of micro and macro-cracks in concrete because of thermal stress formations resulting from the temperature differences between surface and core high temperature [12].

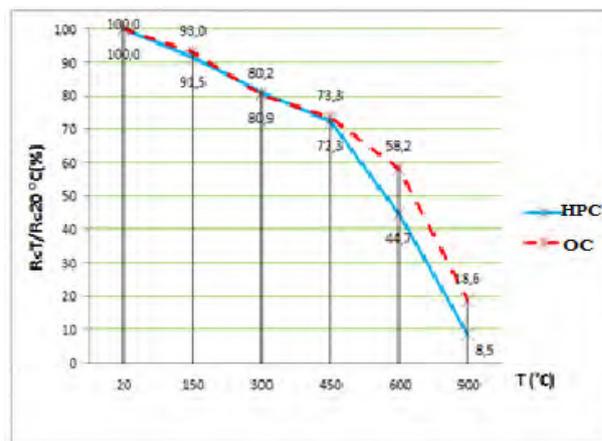
At 150 °C, (HPC) and (OC) mixture was not affected significantly (Fig.7). It exhibited approximately 91.5 % and 93% respectively of the strength value which was measured at room temperature. Referring to [14] the decrease in resistance is due to an increase in the chemical energy of the water, which, by increasing the number of layers adsorbed on the surface of the solids, increases the disjunction pressures between the Different CSH layers.

Fig. 7. Relative compressive strengths with increasing temperature

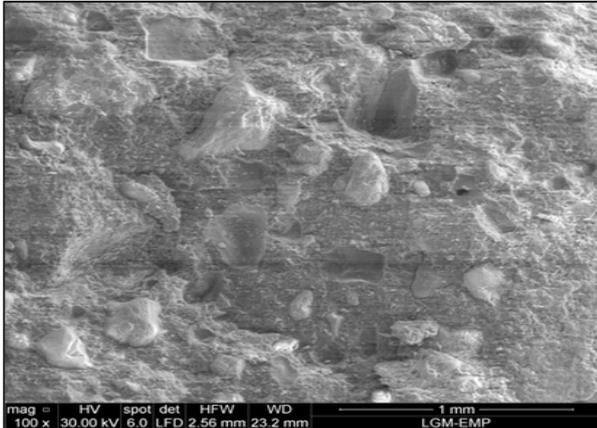
Fig. 8. SEM micrographs of OC sample at 20°C, 100x.

The surface of the ordinary concrete sample that has not been subjected to high temperatures (Fig.8) does not have any facies of alteration and no longer a particular crack. The dense and amorphous structure of (HPC) testifies that this material has not been thermally degraded.

Moreover, we note that the (OC) has a large number of pores or voids that can initially be air bubbles, characterized by black cavities as shown in the micrograph (Fig.8) thus generating a less dense area and more permeable. Unlike that of (HPC) which has an amorphous structure (Fig.9), and much less porous than conventional concrete.

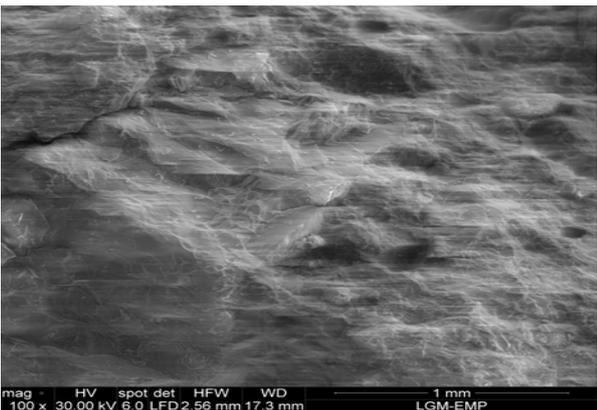
Fig. 9. SEM micrographs of HPC sample at 20°C, 100x.

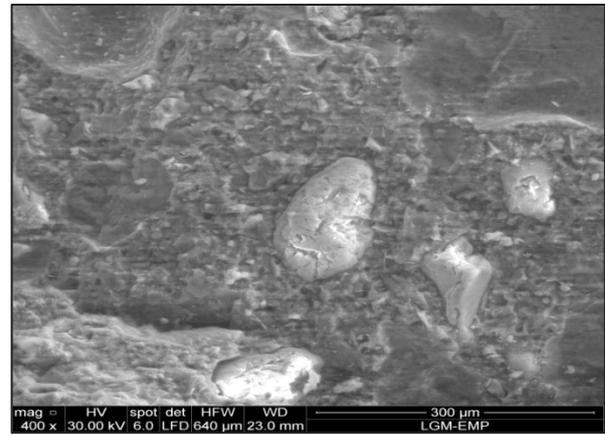
For (HPC) at 20 ° C with an enlargement of 400x. It is noted that there is a very good adhesion to the interface cement -granulate (Fig.11), it is almost perfect compared to that of ordinary concrete, as we can see the stripping (Fig.10) of materials due to the polishing operation, or evaporation of water, or air in the sample (OC). The

Fig. 10. SEM micrographs of OC sample at 20°C, 400x.

In addition the adherence of aggregate and cement matrix of (OC) was observed as quite well (Fig.10). However, the adherence was not the same of specimen exposed to the temperature of 300°C, capillary fissure

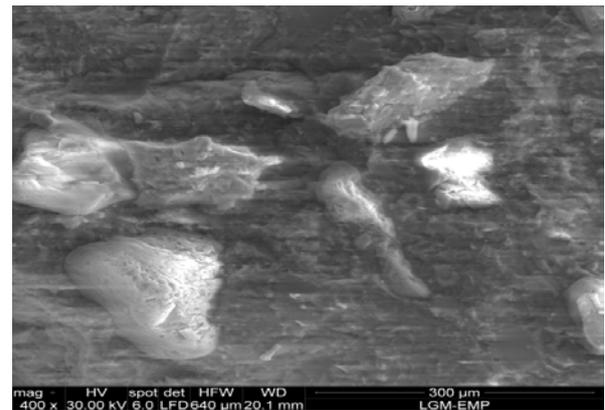
exposed concrete in (Fig.11) containing silica fume has a stronger cohesion and is more compact compared to the BO, the fineness of the silica fume particles allows them to fit between the grains of cement and at the paste aggregate interface by creating additional CSH due to the pozzolanic reaction with portlandite. As a result, a denser paste, a finer porosity and better adhesion with coarse aggregates result.

Fig. 11. SEM micrographs of HPC sample at 20°C, 400x.

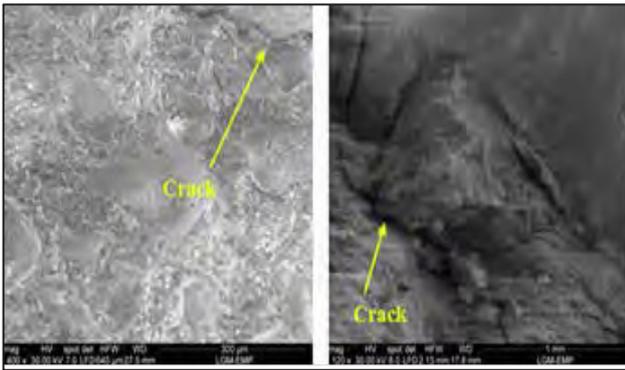
which did not wraparound the aggregate completely was observed at the aggregate–cement matrix inter-faces of some aggregates (Fig. 12).

Fig. 12. SEM micrographs of (OC) sample at 300°C, 400x (*Intergranular cracks*)

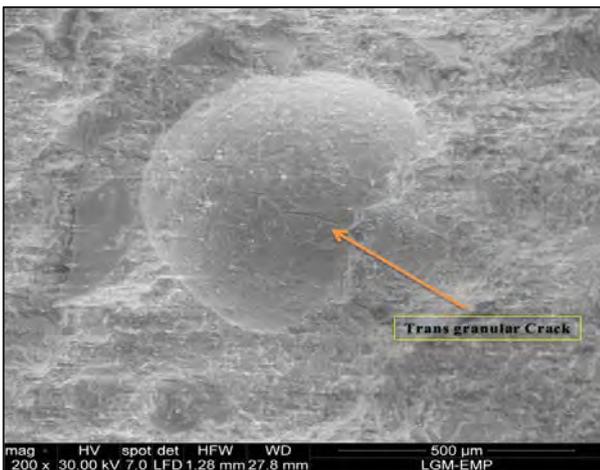
In high performance concrete cracks of different types are present. Trans-granular fissures passing through the aggregates (Fig.13, Fig 14) and inter-granular cracks (Fig.15), generally those of quartz nature. It is possible that these cracks are due to the phenomenon of cleavage which characterizes these aggregates at a temperature of 300° C. In addition to the Intergranular cracks that protrude at the paste-aggregate interface (Fig.14).

Fig. 13. SEM micrographs of (HPC) sample at 300°C, 200x (*Trans-granular cracks*)

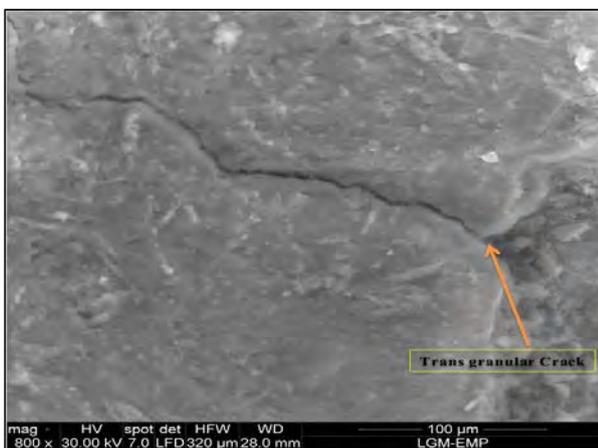
Fig. 14. SEM micrographs of (HPC) sample at 300°C, 800x (*Trans-granular cracks*)

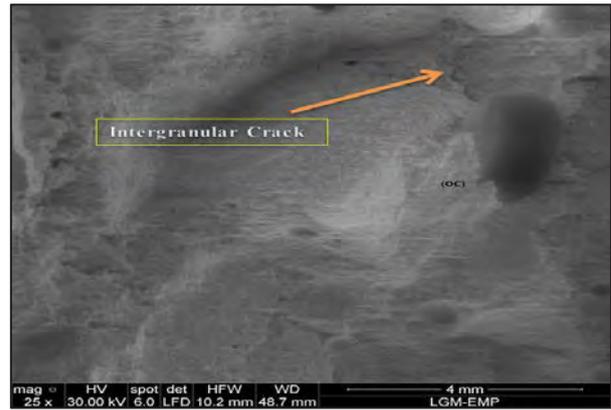
Fig. 15. SEM micrographs of (HPC) sample at 300°C, 25x.

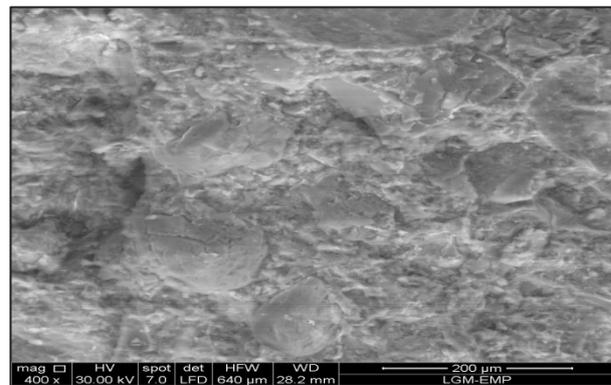
According to (Fig.16), it is clear that the hydration products formed up to 300 ° C, CSH; have a massive structure. And the porosity of the HPC remains relatively low as the microstructure of the latter is not so damaged.

Fig. 16. SEM micrographs of (HPC) sample at 300°C, 400x.

The microstructure of high performance concrete is denser and more compact (Fig.16). Homogeneity of the matrices is however significantly different.

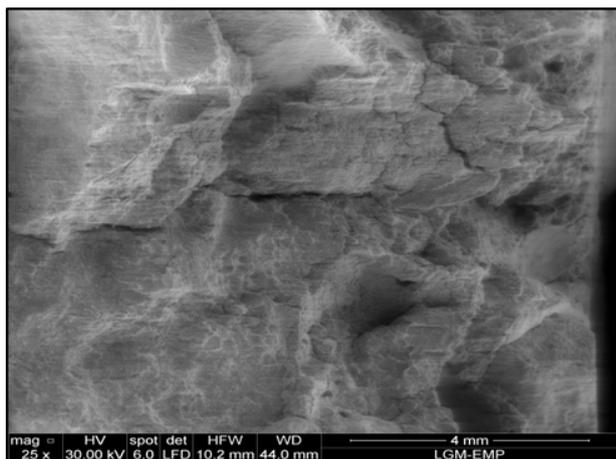
Cracking is much more pronounced for heated samples (Fig.18) and (Fig.19), especially at 600 ° C. At these temperatures, cracks are observed at the dough aggregate interface as at 300 ° C but also within the dough and in the aggregates.

Fig. 18. SEM micrographs of (OC) sample at 600°C, 25x.

From the two previous figures (Fig.18) and (Fig.19), it can be seen that the crack density is much greater in the two types of concrete than that resulting from the previous temperatures.

For (HPC) These cracks are fine (of the order of 1 micron) (Fig.19), (Fig.21) and form a kind of cracking while they are wide (of the order of 10 microns), cross the cement matrix (Fig.18), (Fig.20) and bypass the aggregates in ordinary concrete (BO). The origin of this behavior is not fully understood. Nevertheless, the authors, Noumowé et al [18] believe that the physico-chemical transformations that take place during the heat treatment and after cooling and because of the porosity generated are at the origin of the formation of cracks.

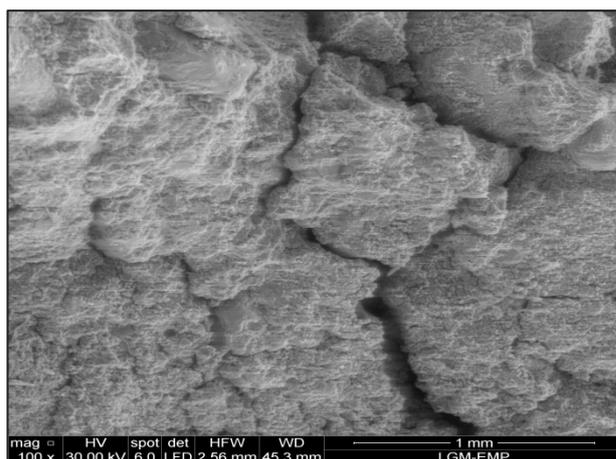
Fig. 20. SEM micrographs of (OC) sample at 600°C, 100x.

In addition, it is noted that the fracture surfaces of the samples, are intergranular in ordinary concretes (Fig.20), and are trans-granular in (HPC) (Fig.22). This can be explained by the fact that the cementitious matrix of the (OC) is less resistant because of weak bonds with the granulate which has a more permeable halo containing a large amount of Ca (OH)₂ portlandit, unlike that of the (HPC) containing mainly CSH which gives to concrete a very strong bond making the dough more rigid than the aggregate, and gives it a low capillary porosity which

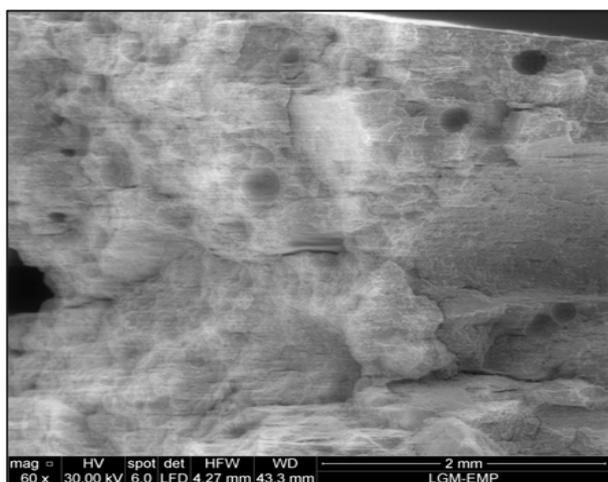
Fig. 19. SEM micrographs of (HPC) sample at 600°C, 60x.

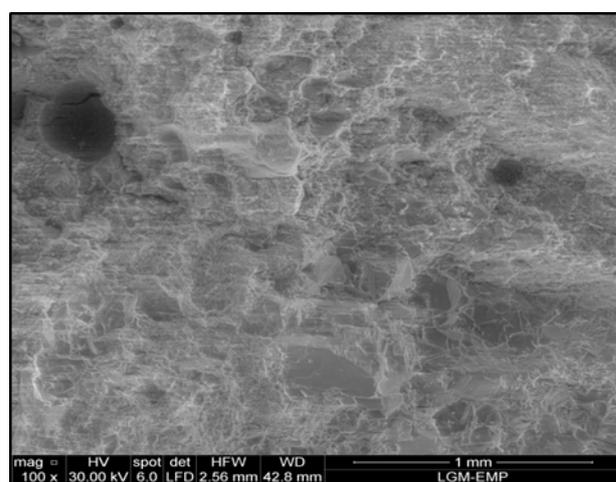
Fig. 21. SEM micrographs of (HPC) sample at 600°C, 100x.

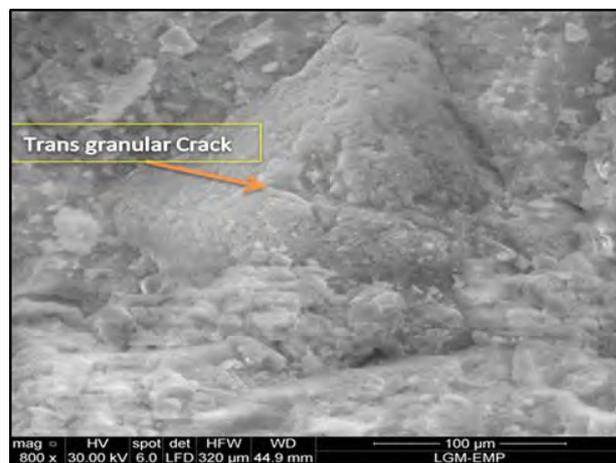
The deterioration of the cement paste after heating to 600 ° C is evident. We can observe the cracks that leave perpendicularly from the surface of a siliceous granulate (Fig.22). Observing an increase in the number of pores and micro cracks from 300 ° C on. At 600 ° C the author [19] identified the presence of sintered areas, cracks, and small ettringite crystals, probably formed after the samples were cooled.

Fig. 22. SEM micrographs of (HPC) sample at 600°C, 800x.
