# Selected problems of protection of historic buildings against the rainwater and the groundwater

*Ryszard Chmielewski, and Paweł Muzolf\**

Faculty of Civil Engineering and Geodesy, Military University of Technology, Warsaw, Poland

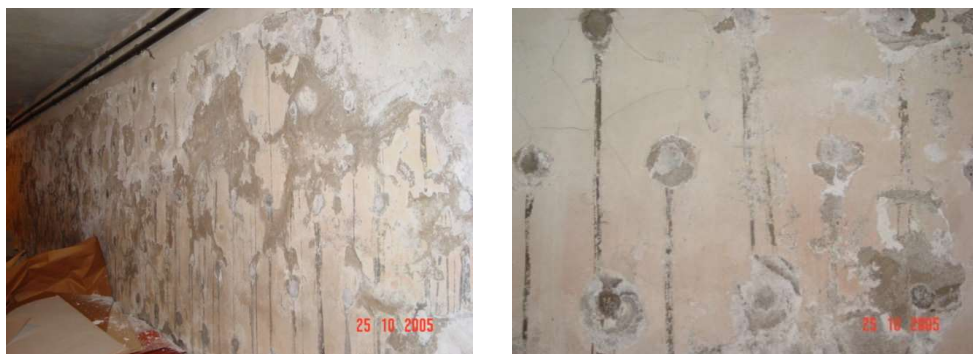
In the cellar rooms, the plaster and wall covering were blistering by migration of water, as well as the salt damp was observed - Fig. 1. In addition, these salts also increased the hygroscopic properties of basement walls. The bubbled and blistered internal plasters reduced also the aesthetics of the basement rooms.

**Fig. 1.** “Salt damp” damage observed (fretting mortar, bubbling paint and plaster, as well as serious decomposition of the wall materials) on the rear wall of the eastern outbuilding in the basement. Visible places of holes in the wall made during the drying works using the crystalline injection method.

It was recommended that the repair works related to the removal of moisture in the basement walls include the carrying out of a new horizontal waterproofing insulation based on the injection with a gel resin having with low viscosity close to that of water, as well as the construction of new vertical walls. The design involved the removal of bubbled,

- Cleaning the external wall surface - i.e. walls should not be wet, dirty, greasy or dusty;
- In the case of elements of bricks poorly connected with the wall, spalling of masonry or the presence of heavily corroded bricks - they were removed, and then the resulting cavities were refilled;
- Gel injection was performed through special packers, which were spaced at least every 20 cm;
- Plasters enabling evaporation of water from a damp wall, as well as providing high water vapor permeability, small capillary and good resistance to salt were used. The plaster was laid in accordance with the plaster manufacturer's recommendations.

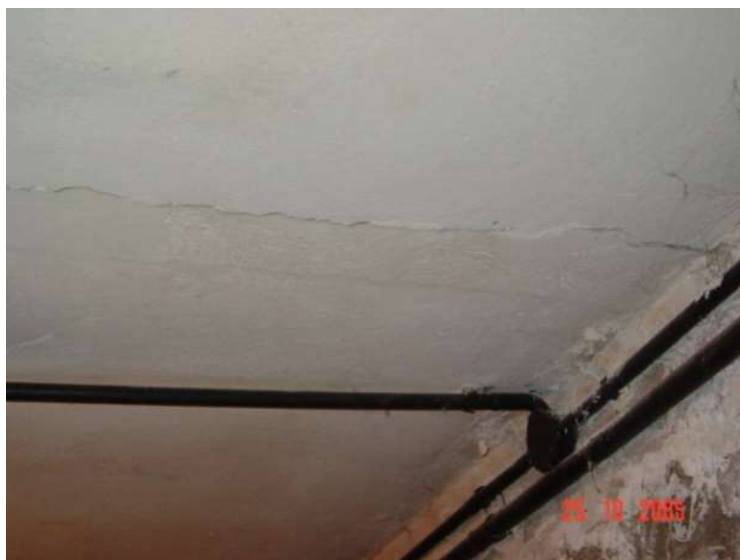
Long-term damage to the waterproof insulation caused the basement walls to get wet above the ground level, in basement rooms up to the level of the ceiling - Fig. 2. It should be stressed that unsuccessful attempt to protect against moisture by using a crystalline injection was made. Therefore, to fully protect the damp external walls against further moisture penetration, it was recommended to perform a new vertical waterproofing and insulation of the walls from the outside using the traditional method. The design provided for the walls to be excavated in sections. Due to the fact that during the building inspection leaky splash apron around the building were found, its restoration while maintaining its leak tightness and proper cross slope from the outside of building was designed.

**Fig. 2.** Ceiling above the basement of the eastern outbuilding.

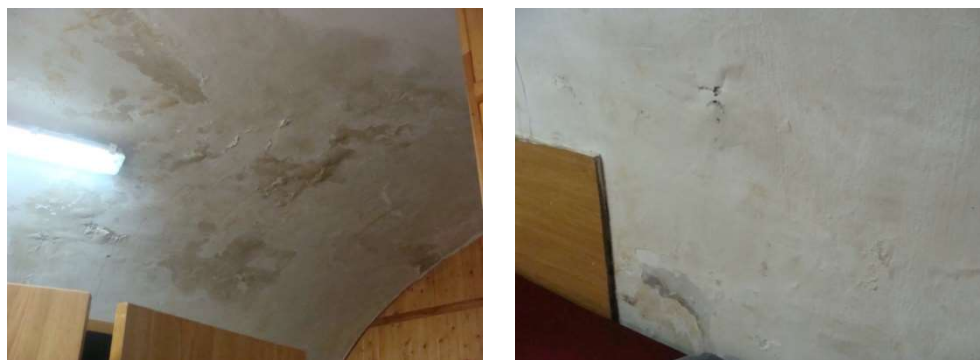
The building numbered as No 36 is located near to the entrance gate from Dymińska street. Moisture in the walls and ceiling vaults of this facility occurred first of all in rooms that are intended for the security guards - Fig. 3. Traces of moisture were observed almost on the whole surface inside the building. Their presence was the result of the lack (or damaged) of horizontal and vertical existing waterproofing insulation. As a result of moisture, a reduced thermal insulation of walls were diagnosed.

**Fig. 3.** Moisture accumulated on the ceiling vault in the building No. 36.

During the in-situ building inspection combined with macroscopic organoleptic tests the bubbled and blistered plasters were observed on the walls of described above rooms. It could be explained as the result of the migration of the mixture of water and salt crystals - Fig. 3. The interaction of the salt solution with the brick structure resulted also in increased hygroscopic properties of the walls.

Due to the lack (building No. 60) or damage (building No. 36) of waterproofing layer above the vaults, the new hydro-insulation, as well as a new flashing is proposed. The following order of repair works is indicated in the design:

- Removal of topsoil along with humus layer over the vaults of buildings;
- Cleaning and alignment of the upper vault surfaces associated with appropriate setting of cross fall gradient;
- Making new flashings;
- Laying new insulation in the form of the following layers (from above):
  - geotextile with a weight of 250 g/m<sup>2</sup>,
  - 0.15 cm of insulation - a PVC welded membrane, eg of the ALKORPLAN type,
  - geotextile with a weight of 140 g/m<sup>2</sup>,
  - 1 cm HDPE drainage film,
  - geotextile with a weight of 140 g/m<sup>2</sup>,
  - a minimum of 5 cm of concrete screed,
- Re-covering of building structures with previously excavated material and restoration of vegetation and grass.

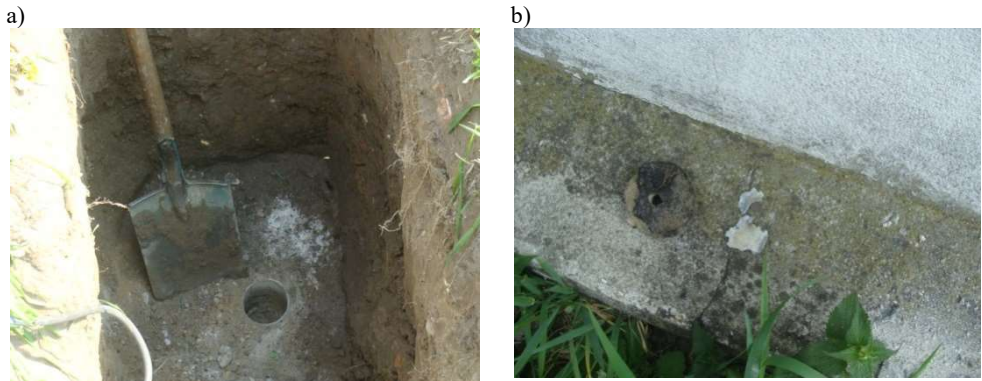
After removing the made ground, the test bore-hole of the wall was performed with a  $\phi$  90 mm diameter of the drill. The aim of this inspection was the verification of the layer arrangement under the embankment and the assessment of the condition of waterproofing insulation over the damp rooms. The following arrangement of layers was found (Fig. 4): mixture of sand, rubble and clay  $\sim$  110 cm, concrete screed (strongly damped)  $\sim$  5.0 cm, lean concrete  $\sim$  5.0 cm, insulation in the form of 2 x tar paper (crumbled and strongly damped) concrete screed  $\sim$  3.0 cm, fine sand  $\sim$  1.0 cm and finally brick vault. In the exploratory bore-hole, the presence of zinc sheet being the original insulation of the building from the period of its construction was also found.

**Fig. 4.** A vault over the damp rooms of the building No. 36; a) the visible the test bore-hole of the wall after drilling b) insulation layers discovered (tar paper and zinc sheet).

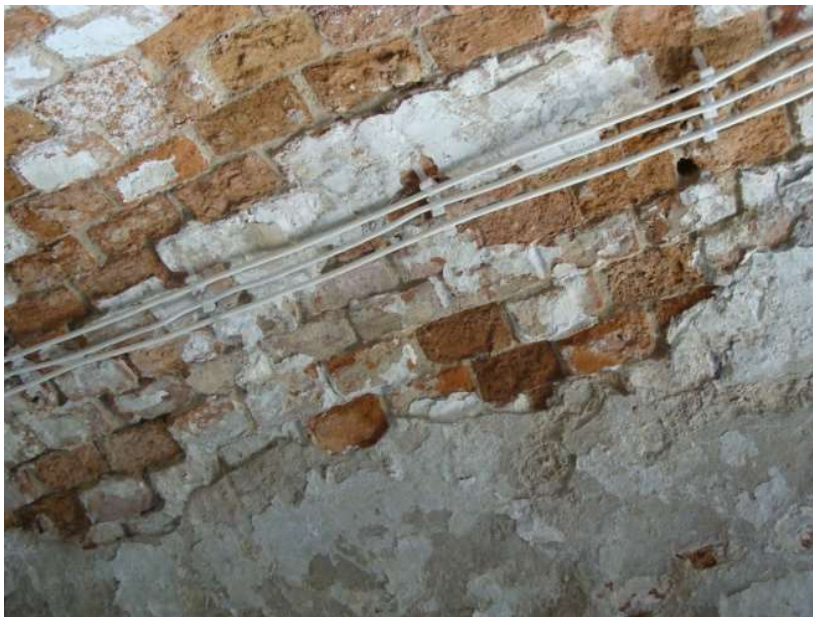
Another analysed building being under assessment was facility No. 60, which is part of the bastion fortifications. Also in the case of this fortification object, moisture occurs both on the entire surface of the walls as well as in the ceiling vaults - Fig.5.

**Fig. 5.** Blistering of wall covering and spalling of masonry construction in rooms of facility No. 60.

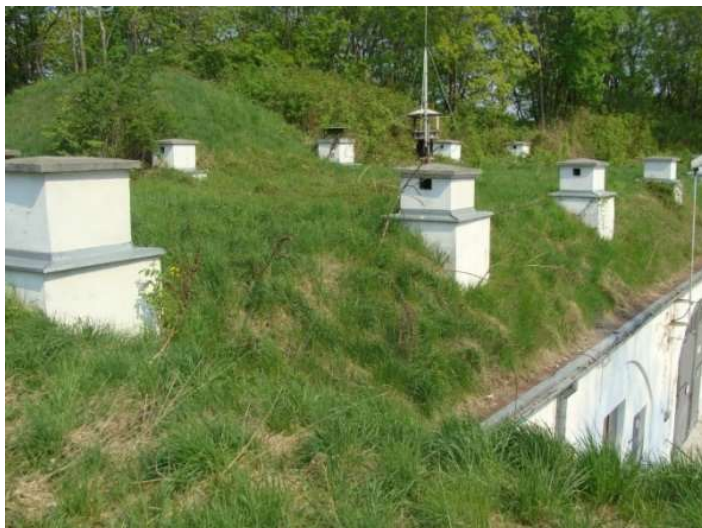
**Fig. 7.** Roofing of the building facility No. 60.

The waterproofing in the form of a weldable membrane has to be tightly connected with the new insulation of the existing ventilation chimneys (Fig. 7), using liquid foil, and turned over to the new flashing. In addition, it is designed to combine it with a new vertical waterproofing of the walls.
