Arrangement of the foundations under the new hotel in Lviv

Abstract. The paper discusses a renovation technique of a historic housing system used in Lviv. The technique presented involves an arrangement of foundations including conservation, as well as displaying exposed fragments of ancient buildings. The foundations of a hotel complex are accomplished owing to drilled injection piers. There are also full-scale tests of drilled injection piers on axial static pressed load which are carried out on the construction site.

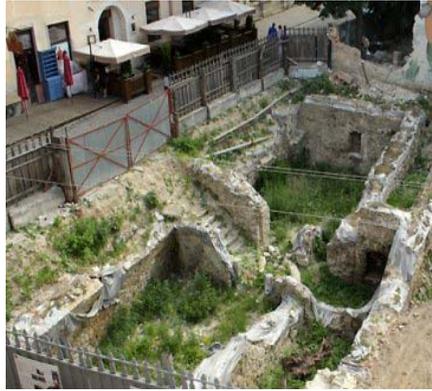
Fig. 1. The discovered pieces of foundation of a building.

In 2010 Lviv borough council and company «Budinvest» organized international architectural contest for a project of a hotel complex in terms of regeneration of historical city block. The winner of the contest was an Austrian architect German Gubert. His project, however, was approached critically by the citizens of Lviv because of the uncharacteristic architectural solution for the urban core and the form of object. After some public protests and public hearings, the investor refused the realization of Gubert's architectural project. In 2010, a new project of hotel was launched by architects of a research-and-development laboratory, which operates under the Department of Restoration of Architectural and Artistic Heritage of Lviv Polytechnic National University. The resources for the project were provided by the investor. At the same time, the realization of project became complicated because of fragments of building foundations dating back to the XVI – XVII century which were discovered during archeological digs on the corner Krakivska and Virmenska street (Fig. 1).

It was determined in the project that the arrangement of the foundations ought to be done with compliance to the law, and, at the same time, maximum conservation should be done and historic fragments of the building should be exposed (Fig. 1). However, geological conditions of the building site complicated the solution of this problem. The existent foundations had different physical-mechanical characteristics because different materials was used for them over time, besides, they had different depth, and they were built on man-made grounds. At the same time, natural grounds, which could become a base (semi-solid clay and semi-rocky ground - marl under clay), dropped by 4.5 m in terms of building site limits. In the other words, the grounds came under the base of separate foundations in one part of the building site; however, they did not come under the base of foundations by 5.4 m in another part of the building site.

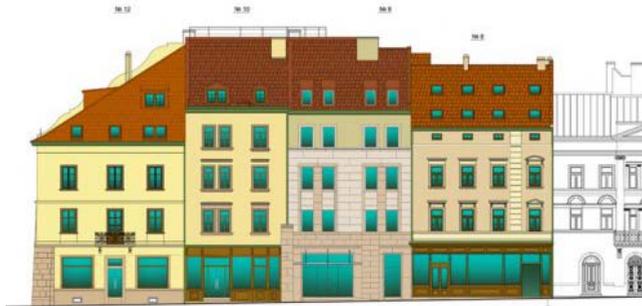
Fig. 2. The elevation of hotel (the look of Krakivska Str.).

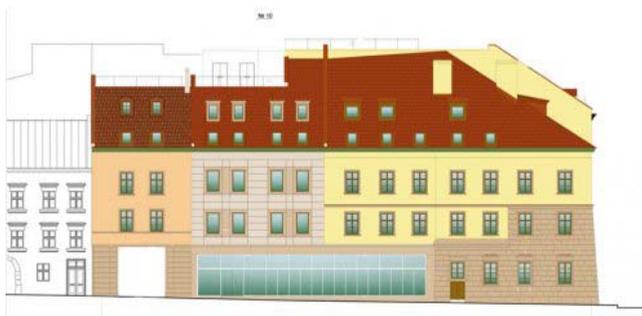
Fig. 3. The elevation of hotel (the look of Virmenska Str.).

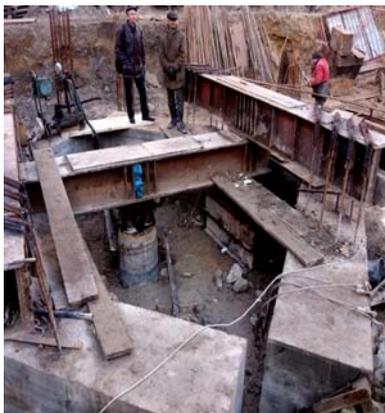
Fig. 5. The test bench for trial of a pier.

There were provided experimental piers, which were subjected to static load, eleven step loads (a range of 240...350 kN) according to [4] (Table 1).

The movement of pier was measured by deflection indicator. Real movement of a pier was calculated as a value of index of two deflection indicators.

The reading was carried out by all measuring instruments in the following sequence:

- zero reading - before loading on pier;
- first reading – immediately after application of loading, then consistently with an interval of 30 minutes to stabilize the deformation, which did not exceed 0.1 mm;
- following readings - a similar procedure, as described earlier.
