Effect of Annealing Process on the Mechanical Properties of X70 Pipeline Steel

Abstract. The influence of the mechanical properties of X70 pipeline steel under different annealing temperature was studied. The corresponding microstructure was investigated by the Field Emission Scanning Electron Microscopy. The results showed that the yield strength and the tensile strength both experienced from rise to decline with the increase of annealing temperature. The grain sizes were coarse and a large amount of cementite precipitated due to preserving temperature above 550 °C, which induced matrix fragmentation and deteriorate the -10 °C DWTT Toughness. There were little changes on the microstructure and mechanical properties when the annealing temperature was under 500 °C.

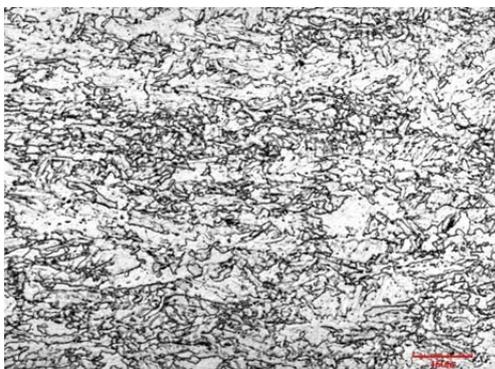
Fig. 4. Microstructure morphologies under different annealing process.

The microstructure was observed by optical microscope and the result is shown in Fig. 4. The blank sample was dominated by acicular ferrite. There has been no significant change of microstructure when the annealing temperature was under 500 °C. However, the grain size increased from 5 μm to more than 10 μm when it was above 550 °C. The increase of grain size can become one of the main reasons of the decrease of low temperature impact properties.

3) There is no significant change in microstructure when the annealing temperature is under 500 °C. When it is above 550 °C, massive cementite precipitation particles appear and the grain size grows up obviously which worsen the DWTT performance and caused the cleavage separations.
