Full Scale Fatigue Test and Failure Analysis of Advanced Jet Trainer Wing

Abstract. A verification method for the fatigue life of the jet trainer wing with integrated fuel tanks is presented. The test was performed to identify the critical points of the structure, to determine strain data and to proof fatigue life of the wing. During the test the non-destructive inspection methods for the identification and evaluation of the critical failures were employed; i.e. visual, ultrasonic and eddy current method. The failures were classified according to significance and reparability. The special test rig was designed to redistribute the load on the structure and to determine test data. The load control system MTS AeroST™ was used for fatigue test control. The fatigue load sequences with multilevel profiles of static and fatigue loading were applied. During the test, more than 230 failures were identified. The critical failures were repaired when found using two types of repair (metal and composite). The repairs were monitored during subsequent fatigue test run and evaluated to utilize in service.

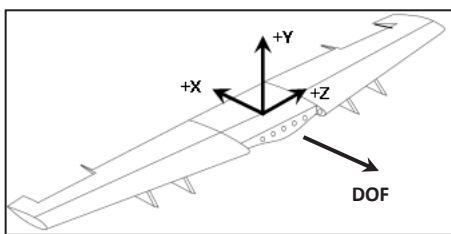
Fig. 1. Scheme of the wing with the coordinate system.

The through-wing with the integral fuel tanks was tested. The flaps, ailerons, tip tanks and control rods were dismantled (see Fig. 1). The wingspan of the wing was 9.5 m, the maximum chord length 2.7 m and maximum chord height 0.35 m.

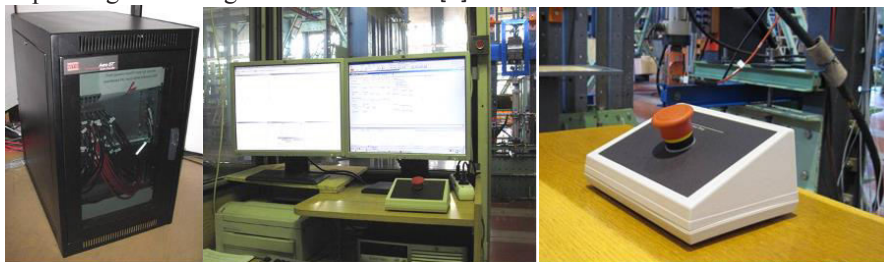
The MTS AeroST™ load control system was used for fatigue test. It is a multichannel digital electro-hydraulic load system, which is designed for testing of aerospace structures. The load forces were generated by hydraulic actuators, equipped by load cells with force feedback and sensors of piston rod position. The load control system is equipped by advanced architecture processor which is designed to meet the wide range requirements for testing of aircraft structures (see the Fig. 2). The safety of tested structure is guaranteed by safety system working at several levels. In the case of danger situation, e.g. reaching limit deflection, sudden change of rigidity, etc., the safety system stops the test and unload the tested structure. The forces, piston rod positions, regulation differences or errors are monitored. If the signals from sensors exceed set limits the safety function acts and the corresponding state is signaled and stored [6].

Fig. 2. a) AeroST™ load control system b) operator's workstation c) emergency button.

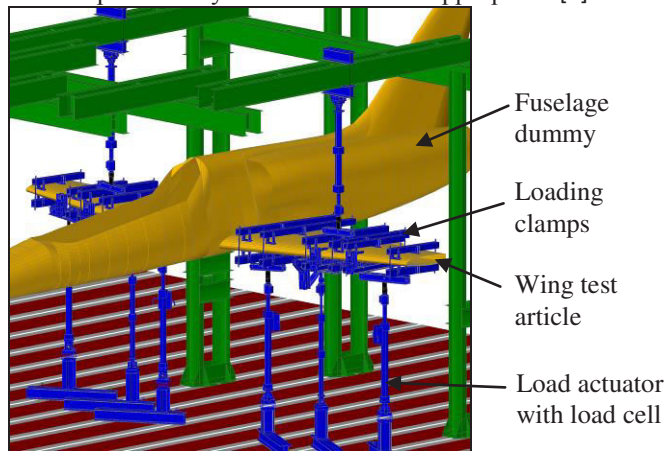
The wing was fixed to the fuselage, so that the fuselage structure was not evaluated, but represented the test jig to authentically apply the load. The whole assembly of the test was fixed to the floor grid of the laboratory through load actuators equipped with the load cells. The fuselage was supported in the position of selected bulkheads and the hinge of the elevator. The vertical load actuators were applied on the dummies of landing gears and on appropriate sections of the wing using load contour board clamps. The load system of the wing is shown in Fig. 3. Other load actuators in fore and aft direction were connected instead of landing gears and in weapon suspension points. The equilibrium position of the aircraft was provided by reaction rods with the load cells in appropriate points. The pressurizing of integral fuel tanks was simulated as well. The masses of all test equipment connected to the wing were balanced and their masses were compensated by counterweights; i.e. contour board clamps, dummies, load actuators, etc. The masses of moving parts and others were compensated by additional loads if appropriate [6].

Fig. 3 The load system of the wing excluding landing gear and cannon dummy load systems.

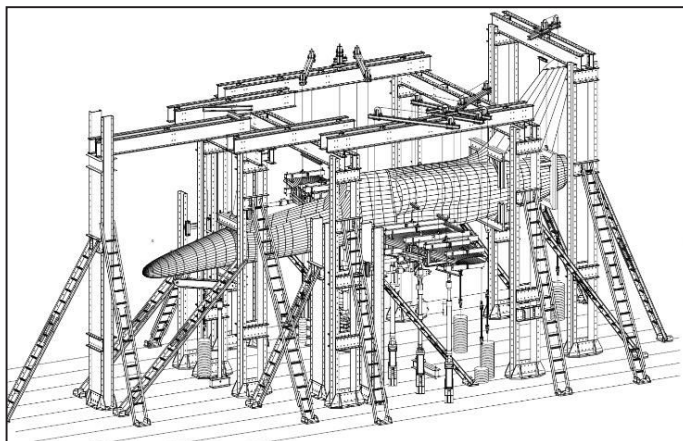
The test rig for AJT fatigue test was assembled from the modular system available in the test laboratory (see Fig. 4). The aircraft load was transferred into the reinforced floor fixing grid. The whole assembly of the test rig (see Fig. 5) was complemented by the system for fuel filling and pressurizing of the integral tank.

Fig. 4 The test rig with test article, load and balancing systems

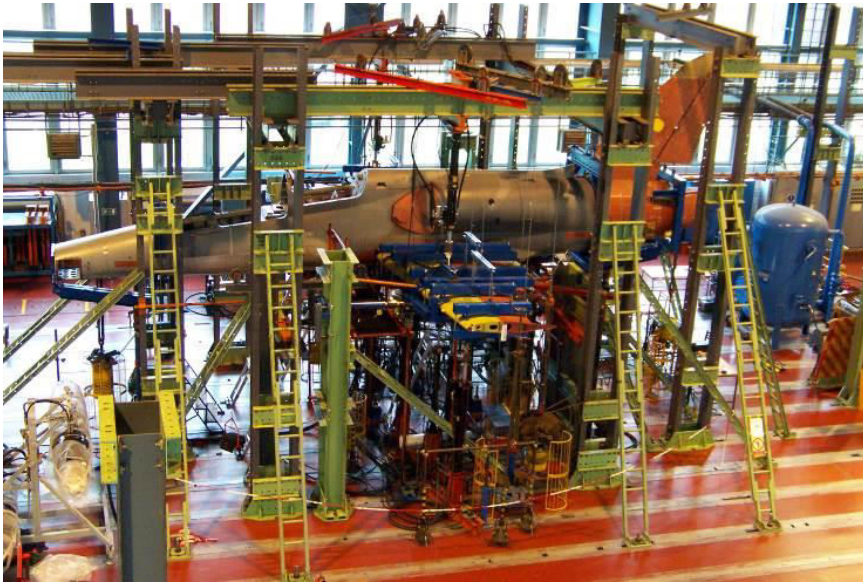
Fig. 5 The real view on the test rig for the wing fatigue test

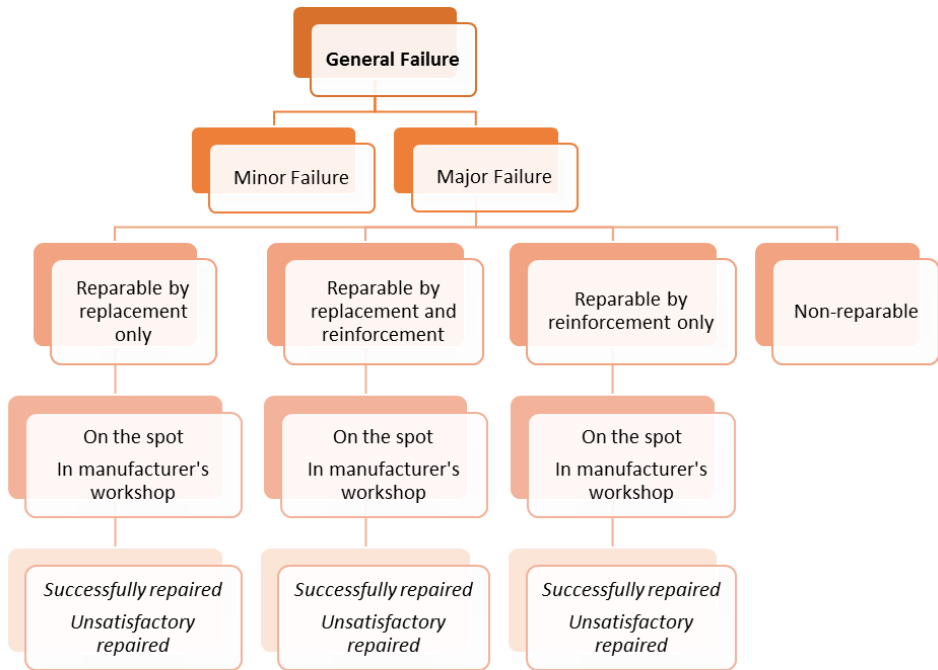
During the fatigue test progress, two new sub-classes have been amended: the successfully repaired failures and the unsatisfactory repaired failures. The review of all failure categories is shown in Fig. 6.

Fig. 6 Failure classification

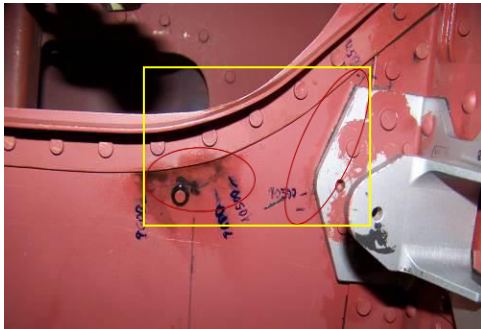
The major failures repairable by replacement of the damaged part without reinforcing occurred as broken pin, ruptured hinge, etc. Another example is the curved L-profile stiffener of the wing skin, shown in Fig. 7. The stiffener was replaced due to its rupture by cracks in the first half of the second life. The new stiffener remained undamaged till the end of the test (4 lives), but other cracks originated on the wing skin in its neighbourhood, see Fig. 8

Fig. 7 Crack in L-profile stiffener

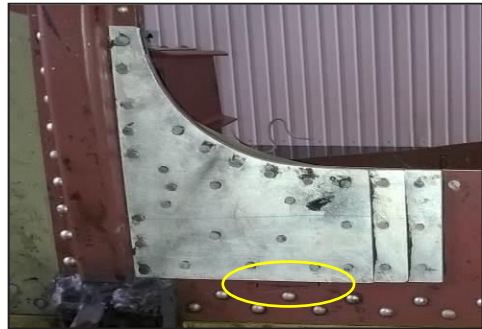
Fig. 8 Failures near the replaced stiffener

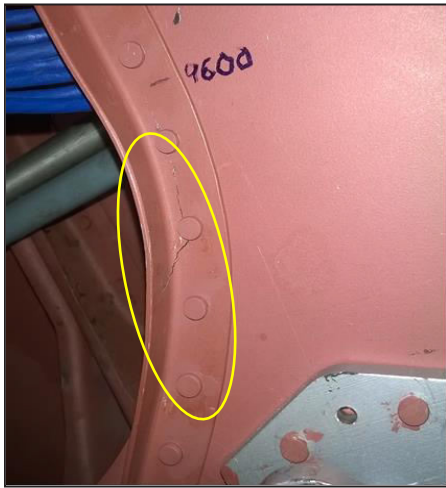
Fig. 9 Cracks near the stiffener to replace

in such manner; an example is shown in Fig. 9. The similar L profile stiffener was replaced and reinforced on the right side of the same part before the half of the fatigue test.

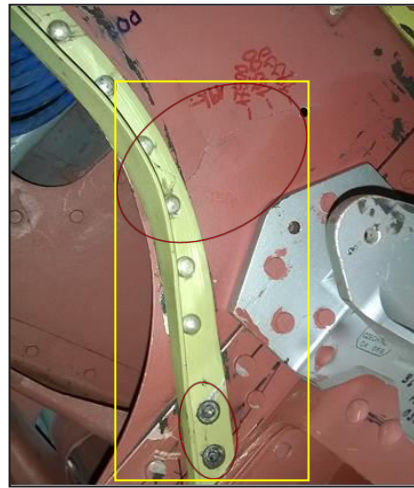
Fig. 10 Crack near the reinforcement plates

Nevertheless, some new cracks occurred in surroundings after the repair, but mostly outside the reinforcement, see Fig. 10.

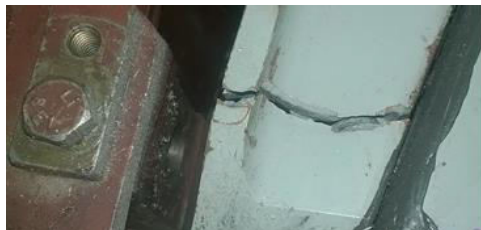
Another example of the major failure repaired by replacement and reinforcement is breakage of the hinge console; see Fig. 11, which occurred at the half of the fatigue test. The repair was partly successful (see Fig. 12); some minor repairs of the rivets connecting the stiffeners to the console and replacement of the stiffeners themselves were necessary.

Fig. 11 Failure of hinge console

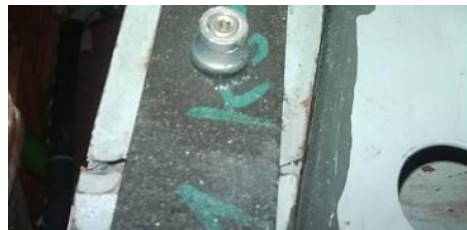
Fig. 12 Repair of hinge console

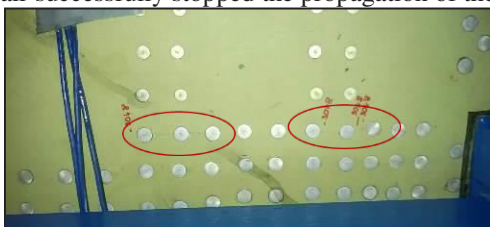
The major failure reparable by using some stiffener only was typically located on the wing skin, where replacement is impossible; see an example in Fig. 13.

Fig. 13 Cracks on wing skin to be repaired

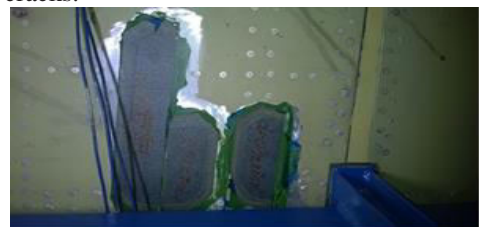
Fig. 14 Repair by composite patches

The failure was repaired using adhesively bonded fibre-composite patches, see Fig. 14, that are generally more structurally efficient and much less damaging the parent structure than standard repairs based on mechanically fastened metallic patches [12]. A boron fibre composite has been used due to similar modulus of extension to aluminium alloy. This repair successfully stopped the propagation of the cracks.
