# Application of geotextile ropes in slope erosion protection

**Abstract.** Paper deals with application of geotextile ropes in erosion protection of slope of gravel pit in Nieboczowy, Poland. For protection of the slope the segments formed from thick ropes were applied. The ropes with the diameter of 120 mm were produced by the Kemafil technology. Ropes were made from strips of stitch-bonded nonwoven produced from a mixture of recycled natural and synthetic fibres and strips of wool needle-punched nonwoven. The protected slope had the length of 4 to 6 m, slope inclination from 1:1 to 1:1.8 and total area of approximately 150 m<sup>2</sup>. It will be shown that installed ropes restrain soil so there is no slope failure in protected section even in case of low soil shear strength parameters and unfavourable hydraulic conditions. Generally slope surface in protected section is without rills and gullies. This case also shows that plants are very good anti-erosion measure. Thanks ropes installed on the slope, favourable conditions for plants growth are created and maintained.

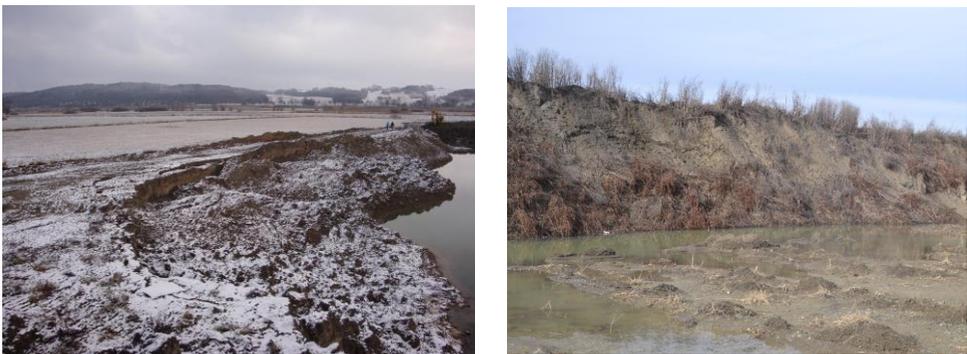
**Fig.1.**The disused excavation of the gravel pit Nieboczowy (left: a pond with slide; right: a plane translational slip of north-facing bank).

In gravel pit Nieboczowy, after several years of exploitation, the deposits were exhausted and the extraction of gravel was interrupted. As a result of mining deep extraction pit with a depth of approximately 10 m was formed. The pit was naturally filled with water to form small pond (Fig.1).

On the banks of the pit steep unstable slopes prone to local sliding and slipping were generated. In the north-facing bank of the excavation on the surface of native ground the artificial embankment with a high ca. 4 m was formed. The embankment erected from overburden material mined during mine operation coupled with the steep slope cut in native ground was especially unstable and endangered by local sliding (Fig.1).

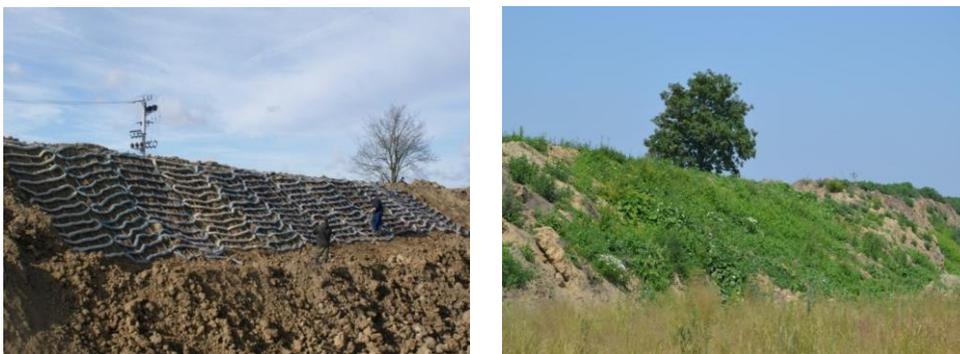
**Fig.2.** Effectiveness of geotextile ropes as anti-erosion measure (left: slope state on 09.02.2016; right: slope state on 23.06.2016).

The ropes were meandrically arranged to form segments with the width of 1.8 m and the length of 6 m. In order to stabilize the segments, the subsequent turns of the ropes were connected with additional links made from thick polypropylene twine. Geotextiles ropes were used to secure a total area of approximately 150 m<sup>2</sup> in the most threatened part of the slope. The protected slope had the length of 4 to 6 m and the slope inclination from 1:1 to 1:1.8. The ropes were anchored in the crown of the slope and fastened at the surface with steel pins. The long “U-shaped” pins made from ribbed bars of diameters  $\phi = 8$  mm were used. To protect bigger section of the slope the subsequent segments of ropes were spread alongside one another. Slope with installed ropes can be seen in the Fig. 2 (left). Effectiveness of installed ropes can be seen in Fig. 2 (right). As we can see in Fig. 2 (right), there are many vegetation and no signs of erosion exist in the protected slope part.

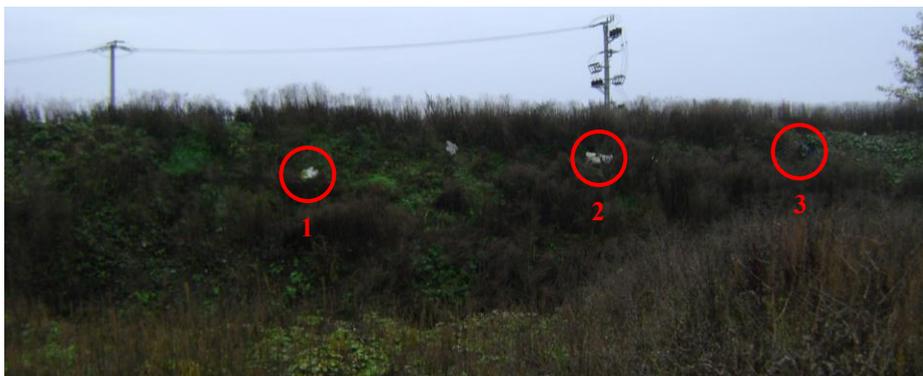
**Fig. 3.** General view of the protected slope in Nieboczowy (numbers mark soil samples locations, state of slope on 22.10.2017).

After 20 months from ropes installation, visitation of protected location took place on 22<sup>nd</sup> October 2017, during which soils samples were taken for further analyses. General view of the protected slope can be seen in the Fig. 3. Numbers on Fig. 3 mark soil samples locations which were chosen in the left, central and right part of the slope (horizontally) and in the central slope part (vertically). Generally, the slope is well protected and covered with rich plants.

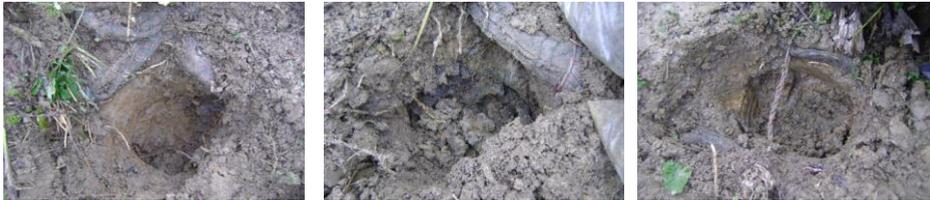
**Fig. 4.** Detail of soil samples locations No. 1, No. 2 and No. 3 (from left to right)

Details of soil samples locations No. 1, No. 2 and No. 3 with installed ropes can be seen in the Fig. 4. It is obviously that the upper soil layer of thickness about 20cm (cover layer) seams different from the lower layer. From mentioned reason 2 soil samples from every location were taken and analysed. Specimens are marked based on location (No. 1, 2 or 3) and letter (letter “a” for upper layer and letter “b” for lower layer), so e. g. specimen marked as “1a” is taken from location No. 1 and it is soil from upper layer.
