New Ashton Arch - functional assessment of direct and indirect construction costs and evaluation of service life with respect to flooding risk

Philip Ronné^{1*}, Abe Newmark¹, Nadri du Toit¹, and Heinrich van Wijk¹

¹AECOM SA (Pty) Ltd, Bridge Engineering, Cape Town, South Africa

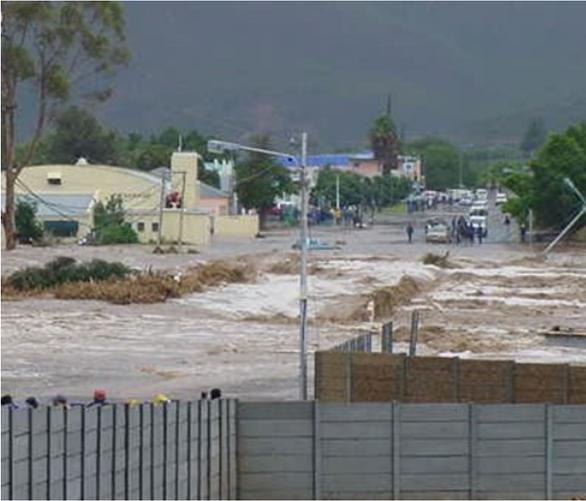
Fig. 1. Overtopping of the existing Ashton river bridge during the 2003 flood.

The Cogmanskloof River flows adjacent to the route for a significant distance and crosses the roadway at four discrete locations by means of existing bridge structures. These bridges do not currently have adequate hydraulic capacity. The greater Ashton-Montagu region, and Cogmanskloof Pass in particular, experienced substantial flood damage that resulted in multiple road closures and significant operational disruptions, with adverse impacts on the local economy. The largest of these recent floods occurred in March 2003 (Fig.1), while significant although less severe flooding also occurred during April 2005, July to August 2006, November 2008 and June 2012. The high debris load in the Cogmanskloof River exacerbates the effects of flooding at the existing short span bridges. Generally these bridges have wide solid wall type piers, orientated at unfavourable skew angles relative to the sometimes variable flow direction. This has resulted in severe debris blocking of the hydraulic opening (Fig. 2) and resulting overtopping, particularly at the river bridge in Ashton.

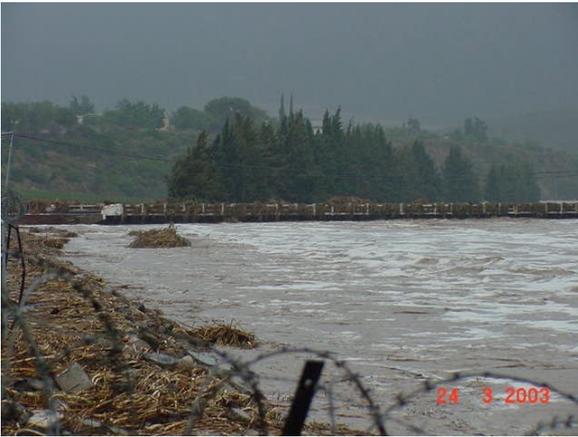
Fig. 2. Debris accumulation at Ashton river bridge during the 2003 flood.

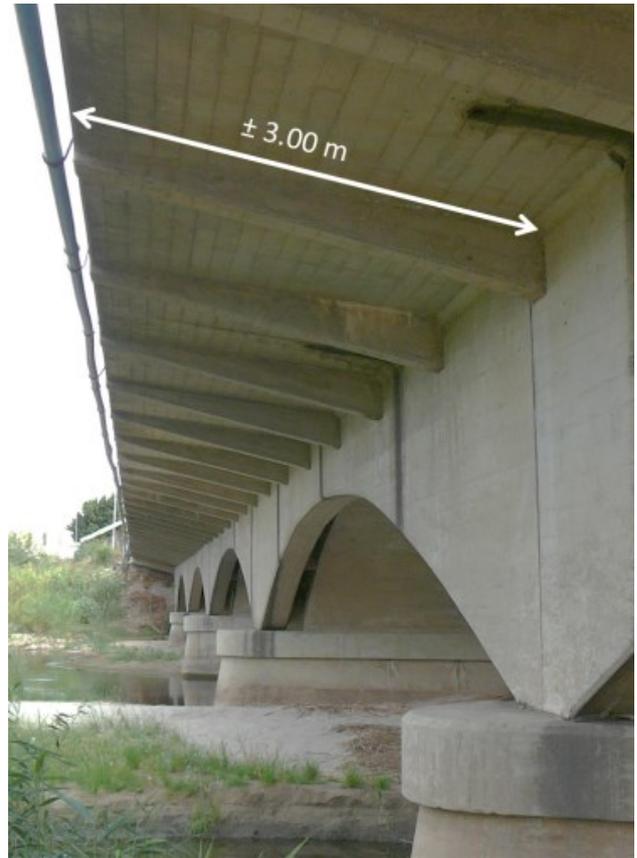
Fig. 3. View along deck of existing Ashton bridge.

In 1950 a substantial structural retro-fitment was undertaken, modifying the superstructure to a cast in situ beam and slab configuration that maintained portions of the arch superstructure (Fig. 3 & 4), including the arch-profile with related hydraulic opening configuration. The retro-fitment allowed two-way single carriageway vehicular traffic of 3,35m traffic lanes and 1,8m pedestrian sidewalks. The 3m wide transverse cantilevers are supported from the arch-profiled longitudinal beams. The retro-fitted road was typically between 5m and 8m above the natural ground level, approximately representing the 1:50 floodline.

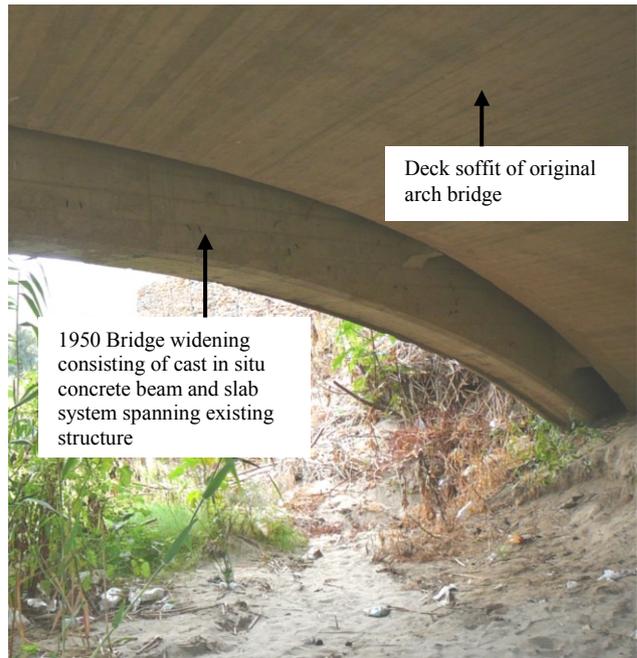
Fig. 4. View of deck underside of existing Ashton bridge.

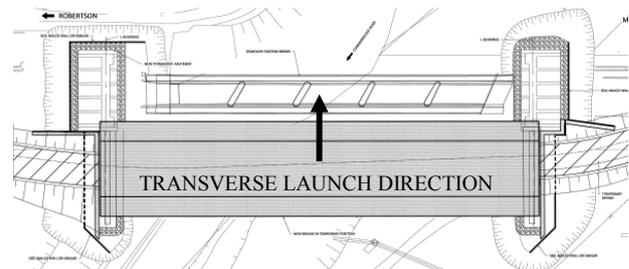
Fig. 5. Temporary position, in plan, of the new Ashton Arch prior to transverse launching.

The proposed transversely launched construction method of the tied arch option allows the new bridge to be used as a traffic deviation in its temporary position, while the existing bridge is demolished. After the construction of the new permanent bridge substructure and associated roadworks (Fig. 5), the tied arch bridge will be launched horizontally into its final position. Thereafter all the temporary works will be removed from the river course.

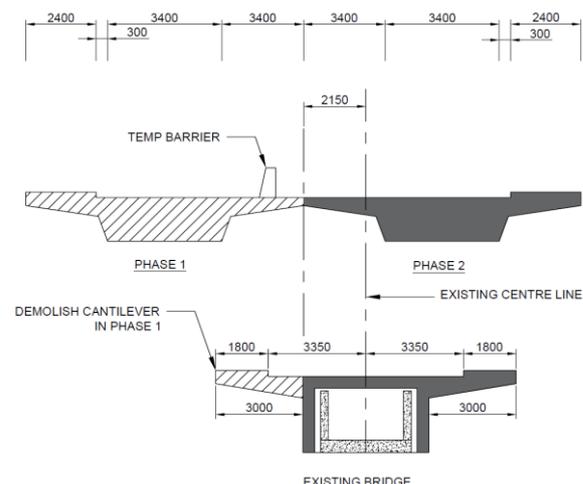
Fig. 6. Voided slab deck option.

A voided slab deck option would require construction of the new deck, approximately 1,5m deep, at a significantly higher elevation (+3,0m above the existing bridge) to achieve the required hydraulic capacity. The presence of piers in the water course, significantly wider than the current sub-structure, would result in additional debris accumulation risk, as well as local scour effects. Higher approach fills (in comparison to the final option) would be required with significant additional construction costs at nearby existing intersections and related impacts on existing properties.

The resulting new deck would have a 2,15m horizontal eccentricity off the current centreline (Fig. 6) with additional adverse effects on adjacent properties.

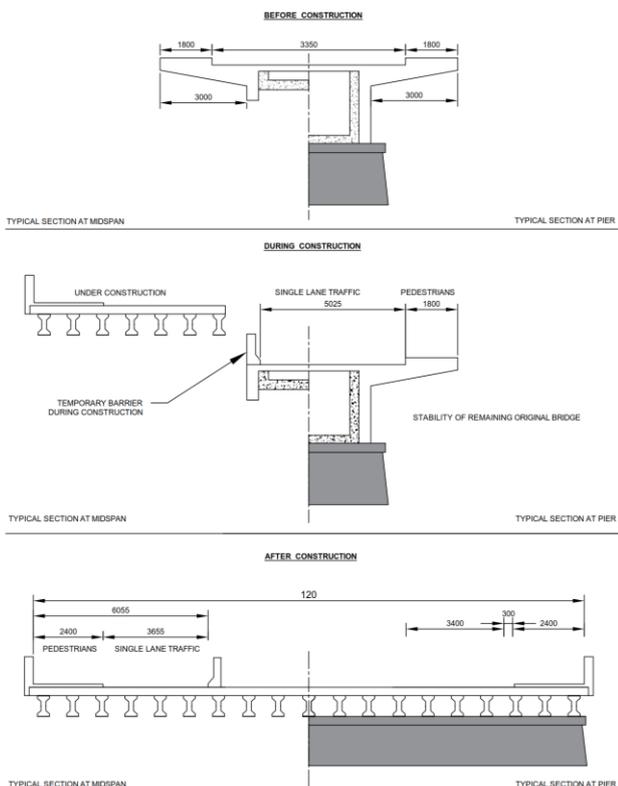
Fig. 7. Precast beam and cast in place slab deck option.

The precast beam and cast in place slab deck option would require construction of the new deck, approximately 1,5m deep, at a significantly higher level (+3,0m above the existing bridge) to achieve the required hydraulic capacity. The presence of very wide piers in the water course, which are significantly wider than the requirement for the voided slab sub-structure (Fig. 7), would result in the highest debris accumulation risk, as well as local scour effects, of all the alternatives considered. Much higher approach fills would be required with significant additional construction costs at nearby existing intersections.

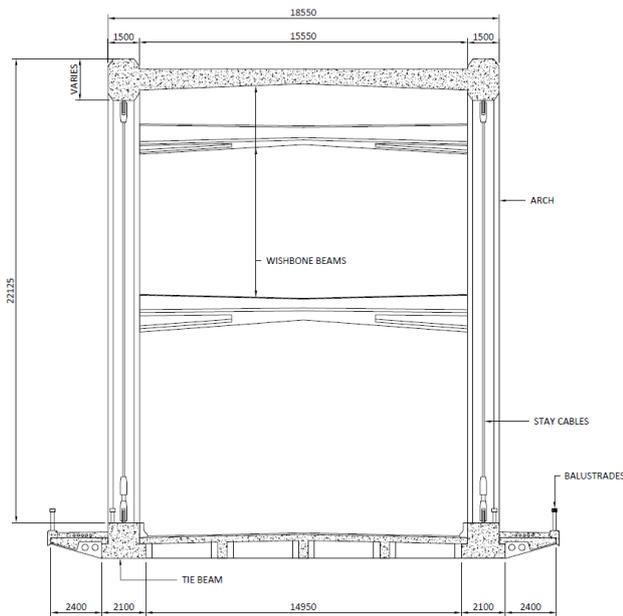
Fig. 8. Typical cross-section of Ashton Arch.

The typical cross-section of the Ashton Arch provides for four 3,4m traffic lanes and two 2,4m sidewalks. The overall height of the bridge is approximately 23m from deck soffit to top of the arch. The twin parallel arch ribs are connected via 15,5m wishbone beams that provide lateral stability to the bridge. Post-tensioned tie-beams complete the arch, along with post-tensioned longitudinal and transverse beams supporting the integral deck slab, resulting in a coffered deck arrangement (Fig. 8). Each arch has twenty-four fully-locked coil-type hangers that connect the arch rib and tie-beam by fork sockets, via a pin connection, to locally cast, engineering-grade, metal anchor plates. The anchor plates are, in turn connected to the concrete structure via high strength threaded, stress bars.

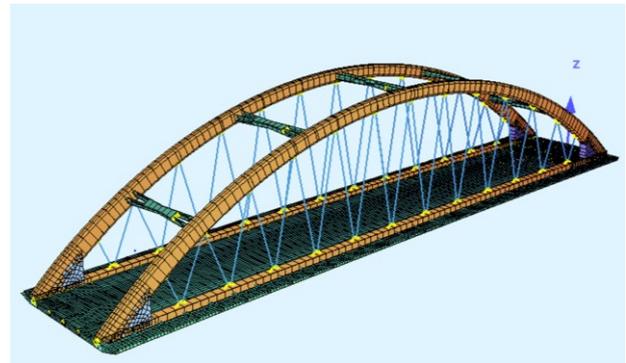
Fig. 9. Structural model of the Ashton Arch.

The arch structure was originally modelled by the Consulting Engineer's local bridge team using Bentley's RM Bridge. An internal design review was conducted by the Consulting Engineer's UK long-span bridge specialist team using SOFISTIK (Fig. 9).

These state-of-the-art bridge analysis software packages were used for the construction stage modelling, in-service analysis, and design. Both software models were updated with concrete material parameters, as determined from laboratory testing. This allowed more accurate simulation of the time-dependant material behaviour during construction. The updated models were then used for the following assessments:

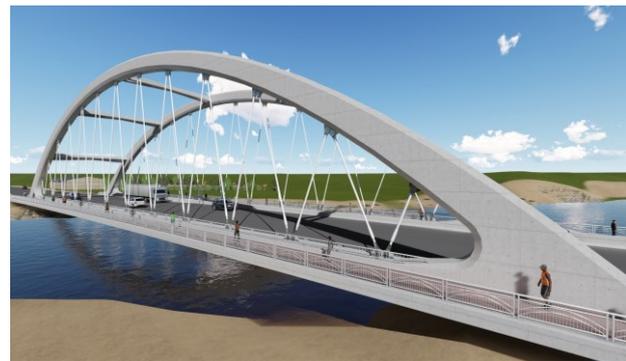
Fig. 10. Visual impression of the completed Ashton Arch.

Bridge lighting also received special design attention to ensure the optimum balance between aesthetic and maintenance requirements. The latest 3D visualization software, with applicable virtual reality simulations (Fig. 10), were included as part of technical presentations to the client.
