Current Status of Degraded Road Bridge Slab Located in Mountainous Area

Abstract. In the mountainous area of the Hokuriku region, bridges are suffering early deterioration caused by salt damage, alkali-silica reaction (ASR) and frost damage. Under such a regional situation, the load carrying capacity evaluation of these bridges has become an urgent issue. In this study, a statistical method—survival analysis—was carried out by using inspection data for bridges in the Hokuriku region, and the relationship between degradation tendency of bridges and regional characteristics causing salt damage, ASR and frost damage has been studied. In addition, the degradation causes of the reinforced concrete deck of a road bridge which deteriorated early in the mountainous area of the Hokuriku region were investigated. Cylindrical core extraction was carried out to analyze the degradation causes. Polarizing microscopic observation of specimens collected from RC slabs confirmed that cracks developed from the andesite particles and cracks were confirmed to be filled with ASR gels. Therefore, ASR was a cause of the deterioration. Moreover, the degradation in the mechanical properties of concrete due

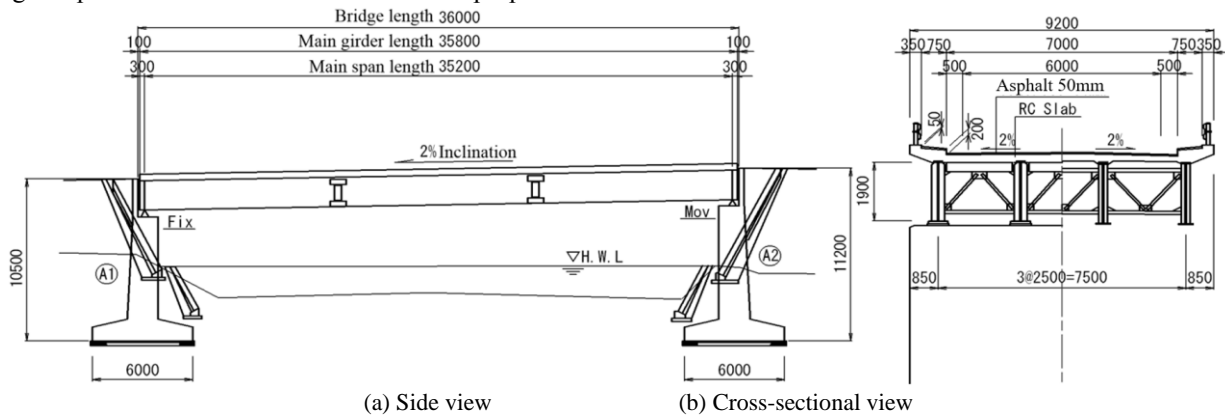
Figure 1. Overview of the test bridge.

As a part of the national highway, the bridge was constructed in the mountainous area (altitude: 559 m) 45 years ago (completed in 1973). From Fig.1, the bridge is a simple composite girder bridge with a bridge length of 36.0 m, and four main girders. Moreover, because the A1 side is lower than the A2 side, the skew angle and the

longitudinal gradient are 60 degrees and 2% respectively. The main girder spacing and the deck thickness are 2.5 m and 180 mm, respectively. Besides, the volume of traffic (small car + large car) traveling on this bridge and the ratio of large vehicles according to 2015 Census were 1177 vehicles per day and 20%, respectively. Because of the small traffic volume, it was difficult to consider that fatigue was a cause of deterioration in this bridge.

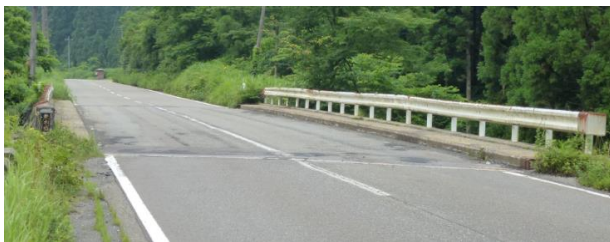
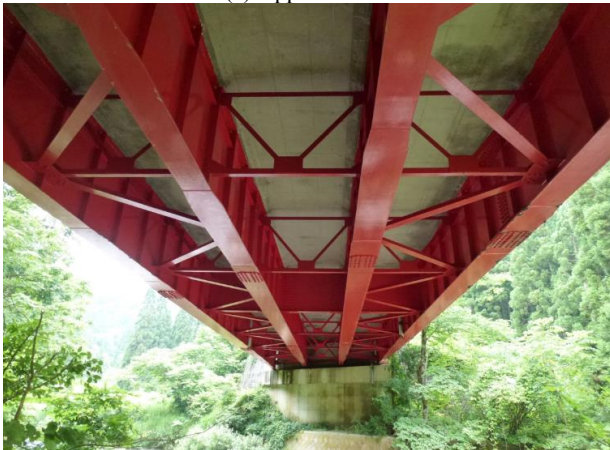
Figure 2. The test bridge.

(a) Upper surface

(b) Bottom surface

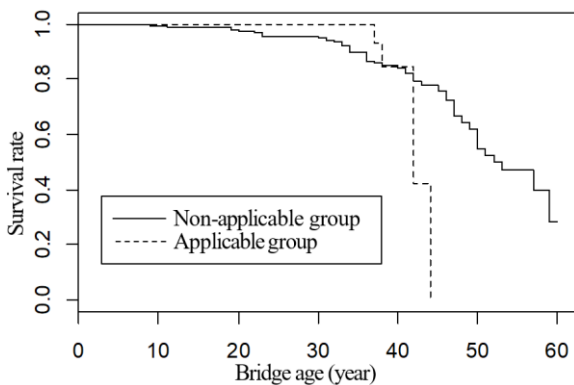
Figure 3. Survival curves of RC slab in target bridge groups.

Survival time obtained by the Kaplan-Meier method for the “applicable” and “non-applicable” groups is shown in Fig. 3. From this figure, while the survival curve of “non-applicable” group gradually decreases, “applicable” group shows a sharp decline after 35–45 years. Although there was a difference in the number of samples and the distribution of bridge age in both groups, it became clear that the RC slabs of “applicable” group tended to deteriorate prematurely.

Survival time analysis using inspection data was carried out for steel road bridge groups with RC slabs in the mountainous area. It was revealed that the RC slabs of the applicable group were deteriorated earlier than other bridges.

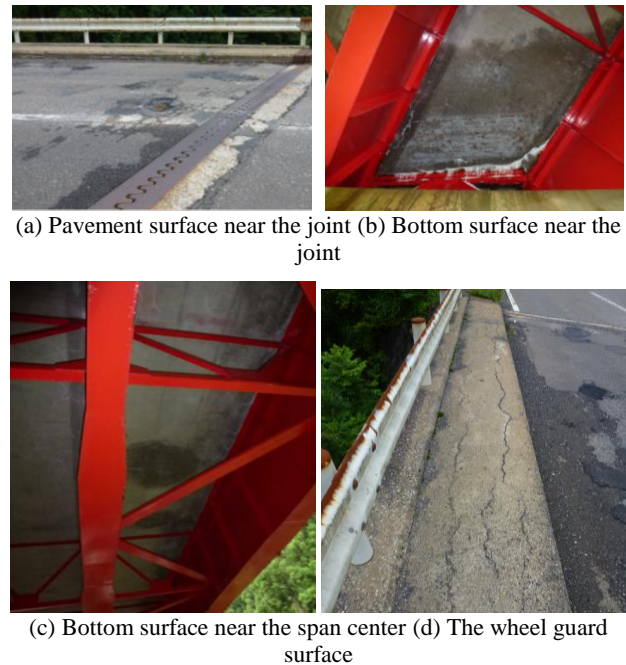
Figure 4. The test bridge.

Fig. 4(a) shows the situation of patching of the pavement which seemed to have been repaired several times at the vicinity of the joint. Patches were also confirmed at some places on the pavement. In addition, efflorescence was observed at the bottom of the RC slab and near the joint (see Fig. 4(b)). Signs of water permeation also appeared under the RC slab and near the span center, as shown in Fig. 4(c). Furthermore, the wheel guard section on the bridge surface (Fig. 4(d)) had many horizontal cracks in the longitudinal direction of the bridge.

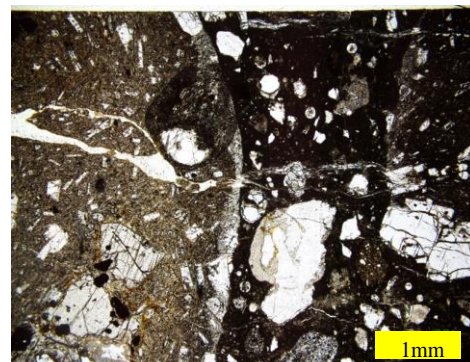
Figure 5. Andesite particles and ASR gel (observation slice 25 mm × 25 mm, thickness 20 μm) under polarizing microscope (normal nicol).

Fig. 5 shows an observation result under the polarized microscope (normal nicol) of the concrete core collected from the water leakage part. From this figure, cracks propagated from andesite particles to cement paste and the ASR gel was filled in those cracks. Therefore, it was inferred that the main cause of deterioration in the RC slab was ASR.

Polarizing microscopic observation of concrete cores collected from RC slabs confirmed that cracks developed from the andesite particles to the cement paste and those cracks were confirmed to be filled with ASR gels. Therefore, it was confirmed that the primary cause of the deterioration in the concrete of the RC slab was presumed to be ASR. In addition, as a result of the investigation on the distribution of chloride ion concentration, corrosion of the steel bar was not confirmed in the leakage-water part as well as the corrosion occurrence limit of the steel material was not exceeded.

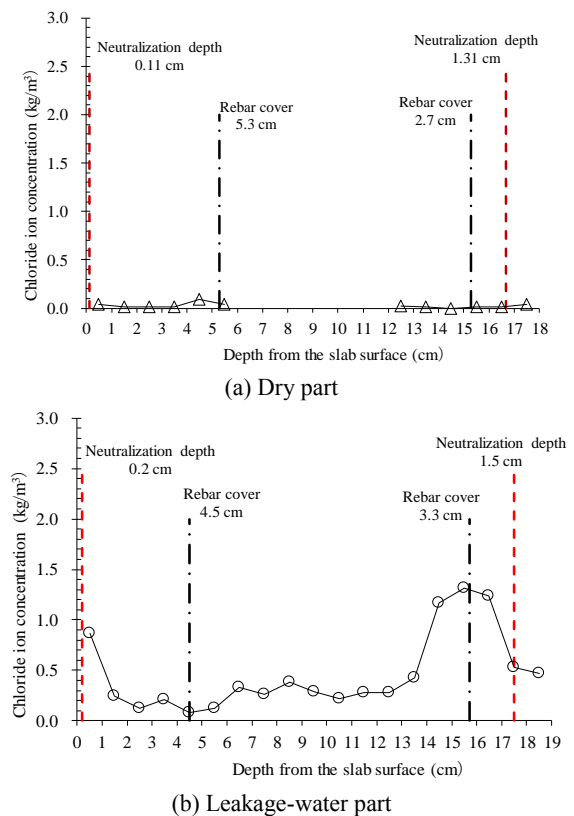
Figure 6. Result of salinity analysis.

determined by the potentiometric titration method, and the chloride ion concentration distribution is summarized in Fig. 6. From this figure, the chloride ion concentration in the dry part is almost zero, but in the leakage-water part, it was estimated to be about 1.32 kg/m³ at the concrete cover of the lower rebar, and the concentration on the lower surface was considerably high. In addition, the measured results did not exceed the limit value of steel corrosion occurrence which could be determined from the proposed formulas $(-3.0(W/C) + 3.4)$; estimated W/C: 55%–60%) by Standard Specification for Concrete Structures of Japan. In addition, the corrosion of the reinforcing bars was not observed at the place where the core was collected.

In addition, the neutralization depth is also shown in same figure. On the lower surface, it was 1.3 cm in the dry part and 1.5 cm in the water-leakage part, and neutralization was not progressed as the deck had been over 40 years old. The explanation of this outcome is that rainfall and snowfall frequently occur in the mountains in the Hokuriku district, the humidity continues to be high, and the humid environment slows the progress of neutralization. Also, because the bridge built in the 1970s does not have a waterproof layer, it is presumed that the wet environment causes ASR to progress continuously, resulting in the deterioration of the RC slab.
