# Trial to Determine Durability and Serviceability for Swine Farm in Thailand

L Lapcharatsangroj and Chalida U-tapao

Department of civil engineering, King Mongkut's Institute of Technology Ladkrabang. 1 Soi Chalong Krung 1, Chalong Krung Road, Ladkrabang, Ladkrabang, Bangkok, Thailand 10520

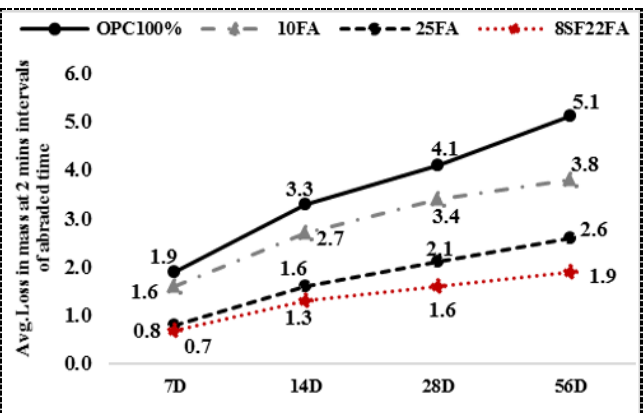
Figure 8. ASTM C944 abrasion testing

The results for the ASTM C944 abrasion testing (single load) are presented in **Figure 8** the average weight loss (grams) per abrading of 8SF22FA samples has the best result (average 1.9 g in 56 days) while the samples of Conventional concrete and with various % replacement of Pozzolan material are worth 56-Day weight loss of all cement. **Figure 9-12**. The results for the Moh's scale testing are presented at 28 days. 8SF22FA gains the highest hardness around 8-9 when compare with other samples. No.8 (Topaz) is silicate mineral created from combination of aluminium and fluorine. No.9 (Corundum) is crystalline from of aluminium oxide and one of the basic rock-forming mineral.
