## Long-term Application of Carbon Fiber Composite Cable Tendon in the Prestressed Concrete Bridge - Shinmiya Bridge in Japan

**Abstract.** Carbon fiber reinforced plastic (Carbon Fiber Composite Cable, CFCC) has the outstanding features in comparison with regular steel. In October 1988, CFCC was applied as the tensioning material in main girders of new Shinmiya Bridge in Ishikawa, Japan. This was the first bridge in Japan and in the world, which CFCC tendons were used in the prestressed concrete bridge to counter salt damage. To investigate the serviceability and durability of the main girders and CFCC, three full-scale test girders were fabricated in 1988. At the same time, a bending experiment was conducted on one girder to investigate the ultimate behavior, load carrying capacity of the PC girder, as well the strain behavior of the CFCC. Besides, two PC girders were placed next to the main girders of the bridge in the same conditions. One of them was used for a destructive test after six years of the construction time (1994). In this study, another test specimen that was exposed to the actual corrosive environment after nearly 30 years was subjected to a destructive test by be

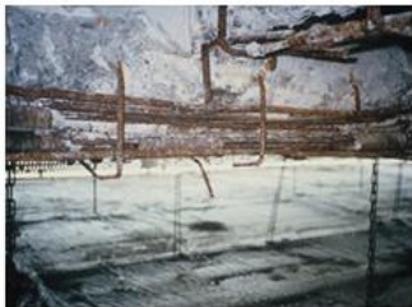
**Figure 1.** Salt damage due to flying salinity in Hokuriku region.

The bridges in the coastal area of the Noto Peninsula, Hokuriku region (including Toyama, Ishikawa and Fukui Prefecture) are significantly affected by the flying salinity on the seasonal wind from the Northwest in Japan. As consequences, the deterioration in these bridges due to salt damage is a remarkable problem (see Figure 1). The old Shinmiya Bridge was a reinforced concrete bridge, which had been damaged by salt corrosion. Therefore, the construction of a new bridge became necessary after twelve years of the construction time.

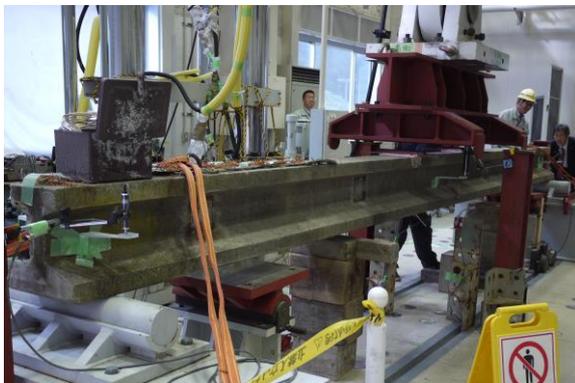
Figure 6. The setup of bending experiment.

The destruction test by bending load was conducted according to the same method of the test, which was done at six years passed after construction. The outline and the test setup of bending experiment are shown respectively in Figure 5 and Figure 6. The load was applied at the two points in the middle of the span with a distance of 1000 mm and two steel rollers supported for the girder. Measuring items including load, displacement, and strain at the center and at the support positions of the main girder were arranged as the Figure 7.

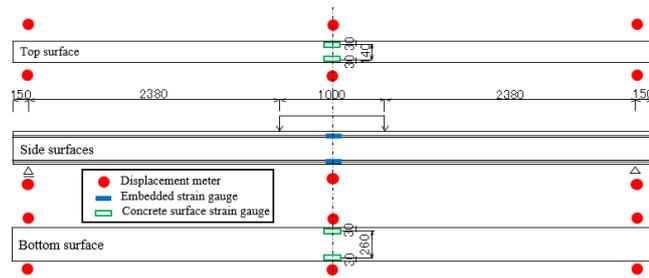
Figure 7. Measurement positions.

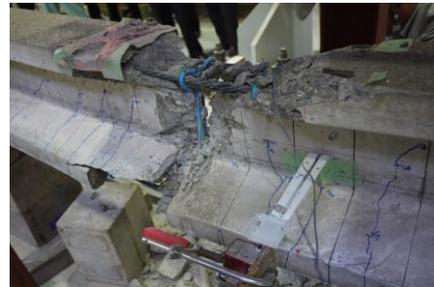
Figure 8. The situation of the girder specimen after failure.

The situation of the PC girder after failure is shown in Figure 8. The relationship between load and displacement at the middle of the span, the relationship between load and strain, and the crack pattern obtained by the destructive test are shown in Figure 9, Figure 10 and Figure 11, respectively. In addition to the results of this loading test, crack initiation load and bending fracture load at the time of construction, six years after construction, and design values are summarized in Table 1.

The failure mode imposed in this loading test was the crushing of concrete in the compressive area after the bending crack propagation (see Figure 8). This occurred because the CFCC had no yield phenomenon, the girder was designed to be a destructive form, which the top flange of the concrete collapsed before CFCC ruptured. In this experiment, the destruction was as the same with design. This destruction was similar to that obtained in the tests at the time of construction time and six years after construction.

The situation of the PC girder surface after the concrete collapse and CFCC after the destruction test were observed. It was found that the CFCC in the upper side was twisted and ruptured after crushing of the concrete. However, at the CFCC of the lower side, failure due to tension could not be confirmed.

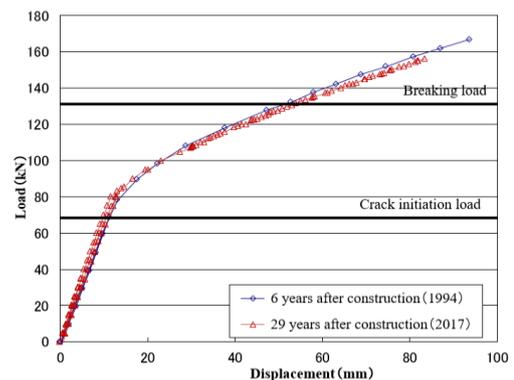
Figure 9. Relationship between load and displacement at mid-span.

From the relationship of load-displacement shown in Figure 9, when the load was unloaded after loading up to design load and crack initial load, almost no residual deflection was observed. The relationship of load-displacement obtained by this examination was

overlapped with the results at the time of six years passed after construction.

This relationship was the linear until the initial crack occurred at the load of 82.8 kN (approximately 50 percent of the final load). In comparing with the applied load of the six years after construction time, the initial crack load decreased by 15.7% but this number was also higher than the design value (68.3 kN). In addition, the ultimate load and the mid-span displacement were 157 kN and 84 mm, respectively. The value of final load reduced by about 6% as compared with the result obtained in the bending test in 1994 (six years after construction time). However, as shown in Table 1 this result was superior to the value at the construction time (132.3 kN) and the design value (131.2 kN). These results revealed that there was no problem in term of the load carrying capacity of the main girder.

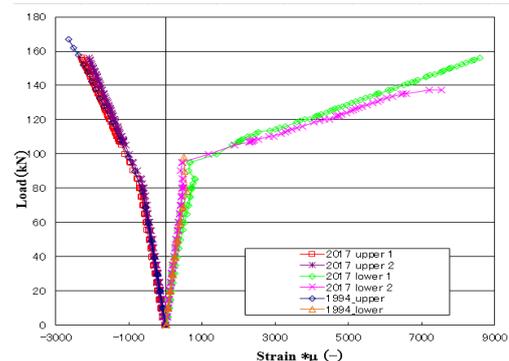
Figure 10. Relationship between load and strain of concrete.

As can be seen from the Figure 10, the relationship between applied load and strain obtained by this experiment was close to the results in 1994.

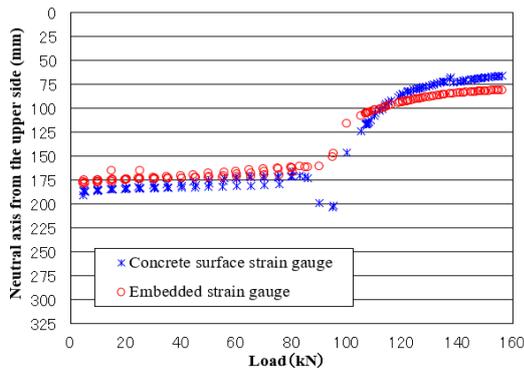
**Figure 11.** The neutral axis depth.
