Certification tests of a protective device such as ROPS to ensure safe usage of tractors

Abstract. According to the safety requirements, all protective devices of tractor units are subject to obligatory certification. One of the main means of protecting the operator during overturning is ROPS system. In accordance with GOST (National State Standard), a performance check of ROPS protective structures is carried out on basis of full-scale tests. The purpose of the presented study is to develop the experimental procedure and to obtain the performance check result of ROPS protective device of the tractor unit's cabin using B10 bulldozer manufactured by the Chelyabinsk Tractor Plant as an example. The tests were carried out at the Ural Test Center NATI. For this purpose, a special bedplate was used, allowing to test the protective cabins of tractors with the total mass of up to 110 tons. The hydraulic system of the bedplate allowed to carry out the process of lateral loading of ROPS step by step, where each step corresponded to the 10 mm structure deformation. The applied load and structure deformation were recorded at each step. The energy accumulated by the structure was calculated a

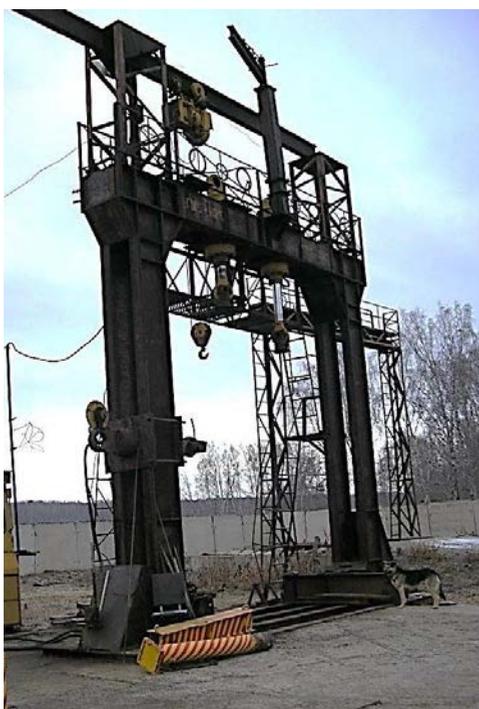
The experiment was conducted at the Ural Test Center NATI, which had a special test bedplate, allowing to test protective cabins of tractors with a total mass of up to 110 tons. The bedplate was made in the form of a power frame mounted on a reinforced concrete base (Fig. 1).

Fig. 1. Appearance of the test bedplate.

The test object was mounted inside the bedplate. The loading was carried out by means of a vertical and horizontal hydraulic cylinder. The hydraulic system of the bedplate provided a maximum force of 2200 kN [6].

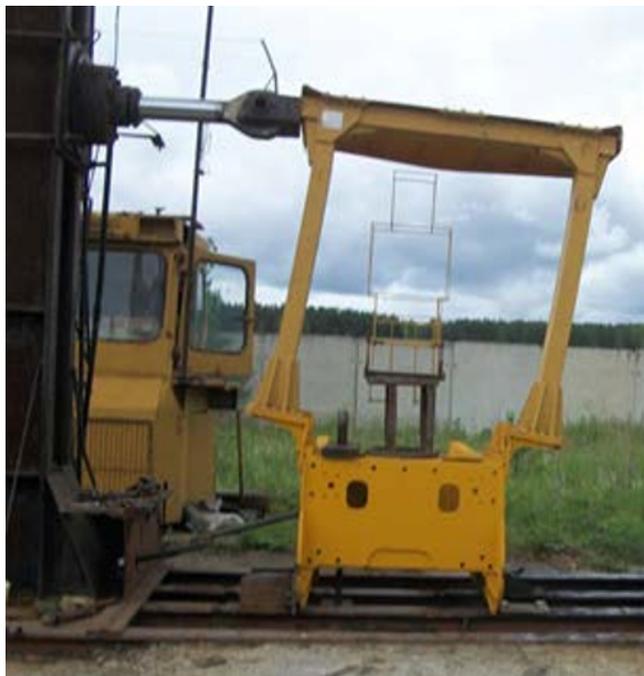
The lateral load was applied to the top of the main ROPS elements (Fig. 2). The lateral load application speed amounted to 4 mm/s, which allowed the load to be considered static. The protective device was loaded step by step with a scale division of 10 mm deformation.

Fig. 2. Lateral loading of ROPS

The impact of the lateral load continued until the force and energy values reached the levels required by GOST. The minimum values of the lateral force F_y (N) and the required absorbed energy U (J) were determined depending on the mass m (kg) of the tested machine [**Error! The reference source hasn't been found.**]:

ROPS protective device of B10 bulldozer with the mass $m = 25000$ kg during side overturning of the machine must withstand the force $F_y = 210197$ N and at the same time absorb energy not less than $U = 40867$ J.

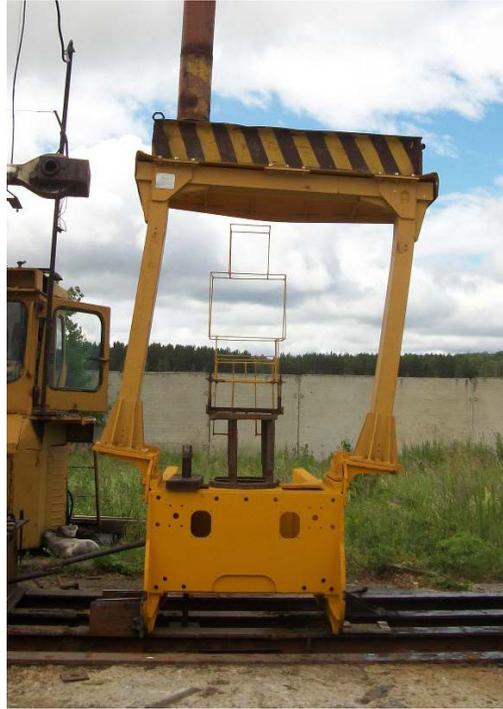
The load was distributed over the entire width of the upper part of ROPS system using a transition element (LDD) (Fig. 3) and lasted 5 minutes.

Fig. 3. Vertical loading of ROPS

After removing the lateral load, a static vertical load F_z was applied to the deformable ROPS structure. According to GOST the minimum value of the vertical load is: $F_z = 19.6$ m = 490250 N.

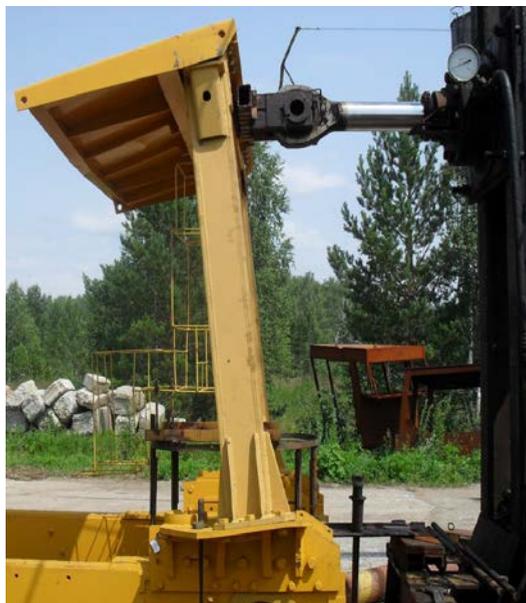
After removing the vertical load, a longitudinal load F_x was applied to the top elements of ROPS. The longitudinal load was applied at the back in the place of closest proximity to the driver's position. The load direction was horizontal and parallel to the longitudinal axis of the machine (Fig. 4).

Fig. 4. Longitudinal loading of ROPS

The loading continued until the force value exceeded the minimum required level according to GOST: $F_x = 56000(m/1000)^{1.2} = 168157$ N.
