Evaluation of efficiency of buses "Volgabus" with determination of critical values of vibration acceleration of transmission

Abstract. The article provides a rationale for diagnosing the condition of the driving shafts of buses "Volgabus". It is determined that the efficiency of the transmission depends not only on the influence of operational factors, but also on the quality of maintenance. The authors monitored the malfunctions of the driving shafts of buses and determined the task of diagnosing the transmission without removing the units and aggregates. The technique of fast diagnostics of the bus transmission by the instrumental method is offered. The article presents the results of a study of vibration acceleration of the buses "Volgabus" transmission with different mileage values. Critical values of vibration acceleration at which buses cannot be used are determined. The recommendations for the rapid diagnosis of the transmission of buses are given.

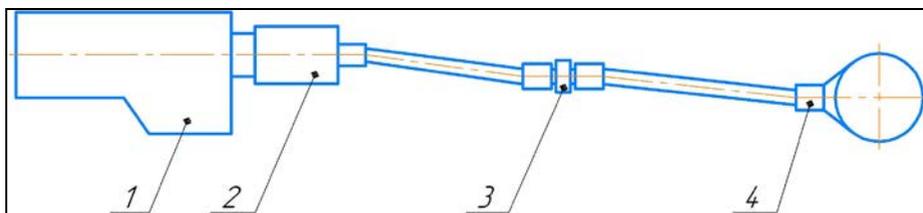
Fig. 1. Scheme of sensor attachment points for measuring vibration acceleration: 1 - engine pan; 2 - the gearbox housing; 3 - the support bearing (or the center of a frame); 4 - a flange of the main gear.

The measurements were carried out in three axes X, Y, Z at control points, "Fig. 1". The directions of the measuring axes of the vibration sensor were adopted as follows. The X-axis is parallel to the axis of the rear axle in the horizontal plane, the Y-axis in the horizontal plane parallel to the longitudinal axis of the bus, and the Z-axis in the vertical plane perpendicular to the road.

The duration of the measurements for each axis was 10 seconds. The scheme of the sensor attachment points is shown in "Fig. 1". The vibration acceleration sensor was attached to the engine pallet, on the gearbox flanges and the main gear. On buses with a single driving shaft the sensor was fixed in the center of the frame. On buses with a divided driving shaft and a support bearing, the sensor was attached to the support bearing.

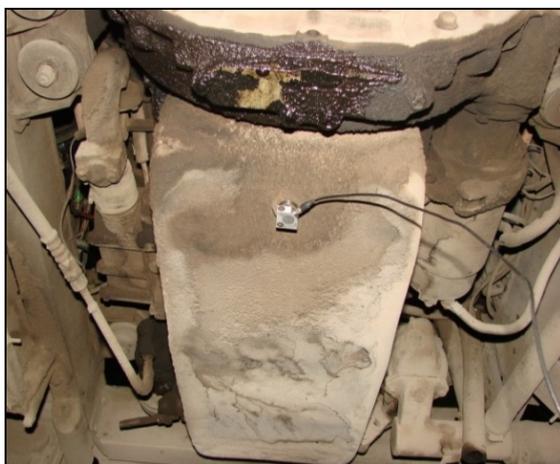
Fig. 2. Attaching the sensor on the gearbox housing.

The "Fig. 2, 3, 4, 5" are the photos of the sensor attachment on the gearbox housing, on the engine pan, on the rear axle body, on the frame in the center.

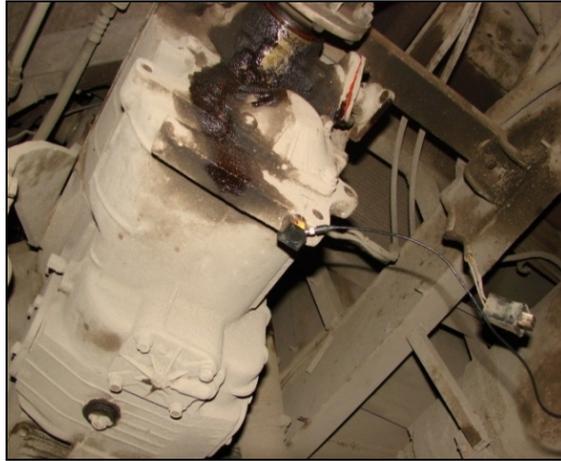
Fig. 3. Attaching the sensor on the engine pan.

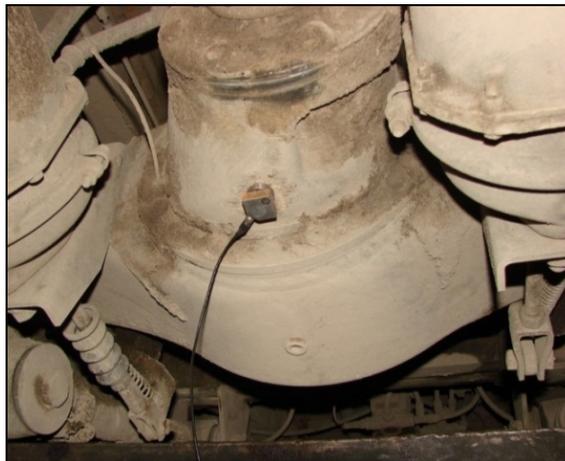
Fig. 4. Attaching the sensor on the rear axle body.

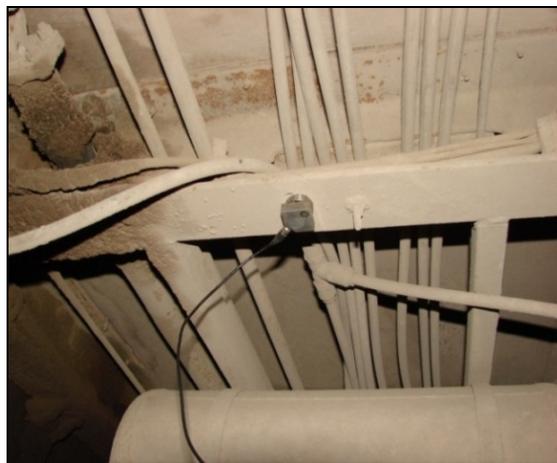
Fig. 5. Attaching the sensor on the frame in the center.

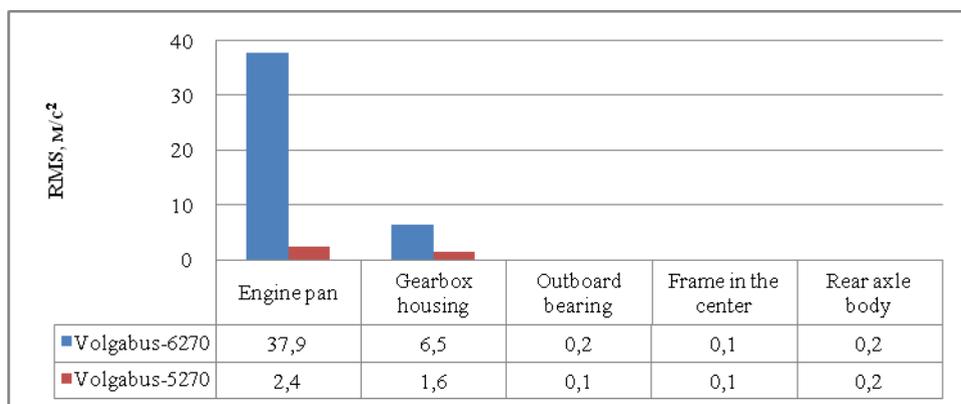
Fig. 6. Root-mean-square deviation of vibration acceleration along the X-axis of the buses "Volgabus-5270, 6270" at idle speed of the engine.

At idle speed of the engine on both buses along the X axis, there are practically no vibrations, only on the engine pan of the Volgabus-6270 bus the high deviation value is 37.9 m/sec².

From "Fig. 6 and 9" it is visible, that parameters at the first gear and idling did not change.

A comparative analysis of all the diagrams at "Fig. 6 – 11" shows that the highest vibration acceleration occurs along the Y axis on both buses.

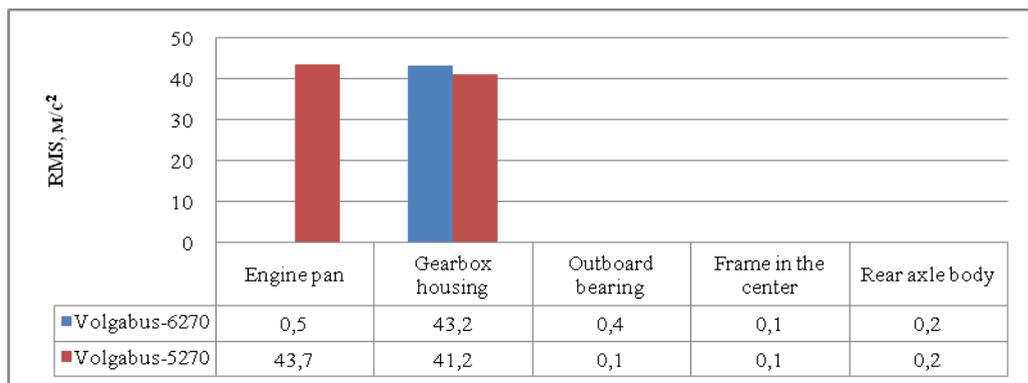
Fig. 7. Mean-square deviations of vibration acceleration along the Y axis of the buses "Volgabus-5270, 6270" at idle speed of the engine.

On the Y axis at idle, the maximum values of vibration acceleration occur on the gearbox housing of both buses.

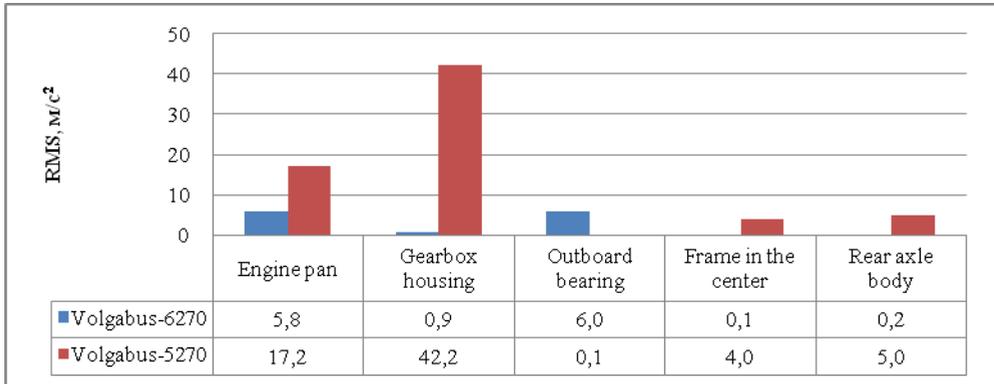
Fig. 8. Root-mean-square deviations of vibration acceleration along the Z axis of the buses "Volgabus-5270, 6270" at idle speed of the engine.

As a result, at idle speed the maximum vibrations are available on engine pan and gearbox housing.

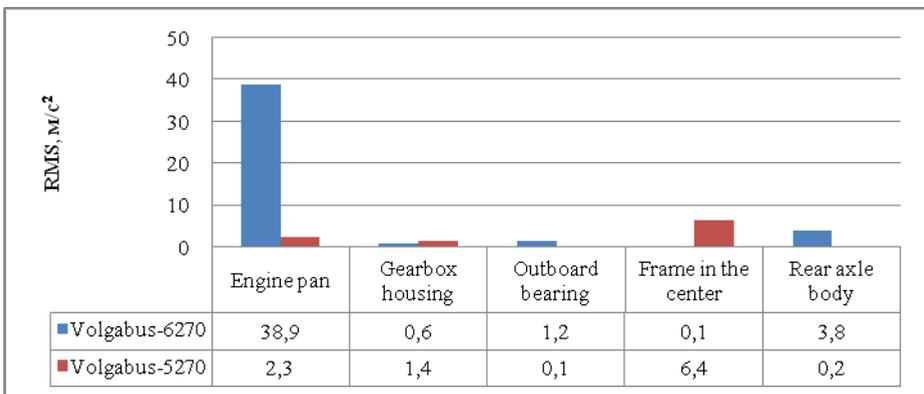
Fig. 9. Root-mean-square deviations of vibration acceleration along the X axis of the buses "Volgabus-5270, -6270" at the first gear.

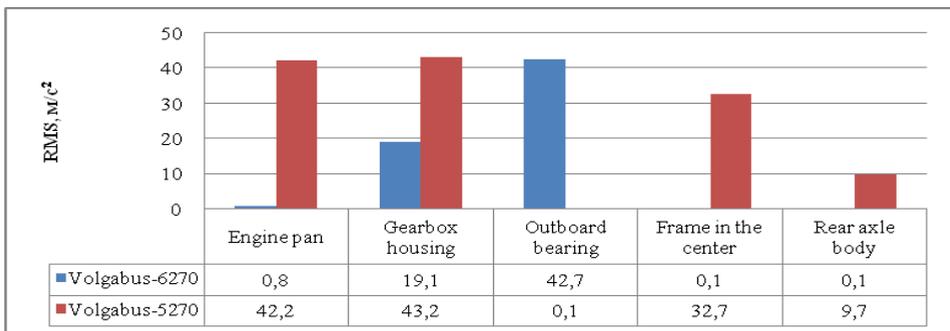
Fig. 10. Root-mean-square deviation of the vibration acceleration along the Y axis of the buses "Volgabus-5270, 6270" at the first gear.

Under the load at the Y-axis, vibrations occur at the rear axle body of the bus "Volgabus-6270" and at the frame in the center of the bus "Volgabus-5270".

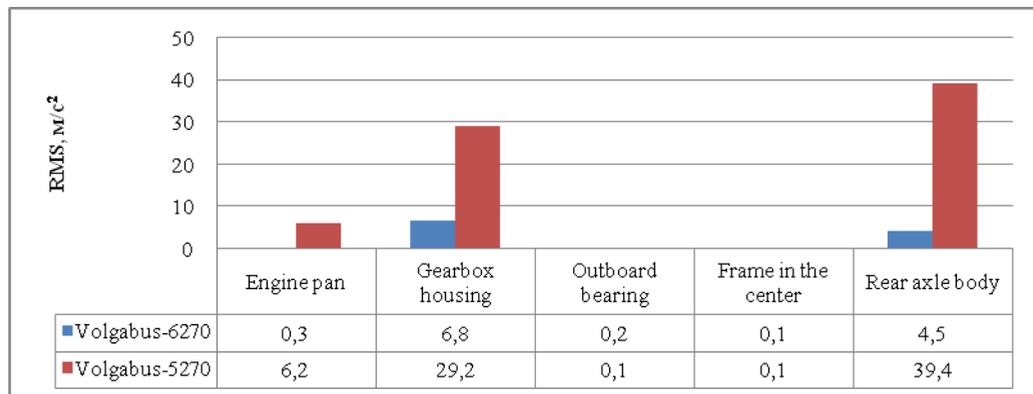
Fig. 11. Root-mean-square deviations of vibration acceleration along the Z axis of buses "Volgabus-5270, 6270" at the first gear.

On the rear axle body of the bus "Volgabus-5270" the increased vibration along the Z axis is almost 40 m/sec² "Fig. 11".

Studies of vibration acceleration made it possible to determine the critical vibration acceleration equal to 20 m/sec². At values greater than 20 m/sec², a weakening of the fastening of the bolts of the gearbox housing flanges and the rear axle and the breaking of the bolts of the support bearing were detected [13].
