Simulation Study on the Potential of Braided Hose Failure in Internal Combustion Engines

Abstract. In this study, damaged braided hoses was obtained from the actual site to investigate the possible causes of failure in the internal combustion engines. The hoses were assembled with polytetrafluoroethylene (PTFE) as the inner tube and externally braided outer tube corrosion-resistant steel (CRES). The hose had undergone failures near the end of the fittings. The braided hose was measured and modelled using SOLIDWORKS CAD software. The ANSYS static structural stimulation was used to measure the stress distribution on the hose due to pressure applied with various bend shapes. The simulation was done by fixing the end of the pipe and exerting the working pressure inside the inner layer of PTFE. The results of the simulation have shown that the inner tube experienced high stresses near the fittings which is then aggravated with the bending. With cyclic pressure loading, the hose was unable to stand the high stresses near the fittings and therefore failed. Further analyses were done to the braided hose to investigate the other possible of failure using failure analysis method.

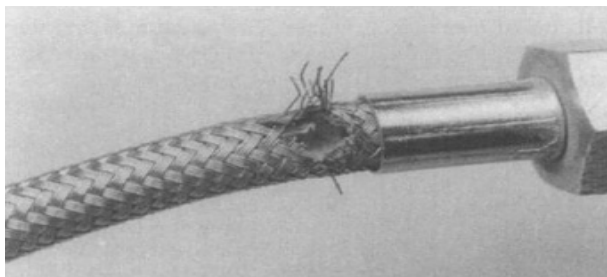
A key factor of the presence of contaminants of hydrocarbon leads from the ignition point and following the path of flow are the reason of failure. The failure occurred on the cylinder end, near the connector or fittings of the braided stainless steel hose. There were small holes found near the connectors or fittings were caused by the thinning of the liner PTFE due to ignition. As shown in Fig. 1, the point of failure stated is most similar failure point when compared to the actual prototype of the braided hose failure (Royals et al, 1997).

Fig. 1. Failed section of braided hose.

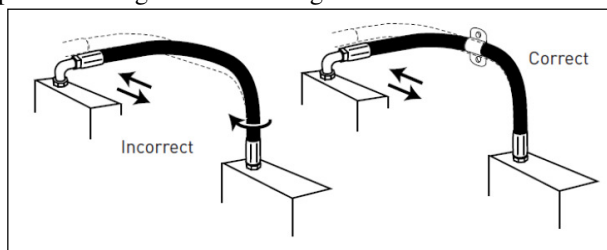
Based on literature study reviewed, the most common causes of failure in hydraulic hoses are the multi-plane bending that result in twisting of its wire reinforcement. The service life of a high-pressure hydraulic hose is reduced as much as 70% for twist of five degrees and a seven degree twist can result in a 90% reduction in service life. Multi-plane bending occurs from inadequate or unsecure clamping where the hose is subjected to vibration of machine or actuator movement (Voirin, 2011). The hydraulic hose are recommended to be segmented to prevent multi-plane bending as shown in Fig.2.

Fig. 2. Recommended installation of braided hose.

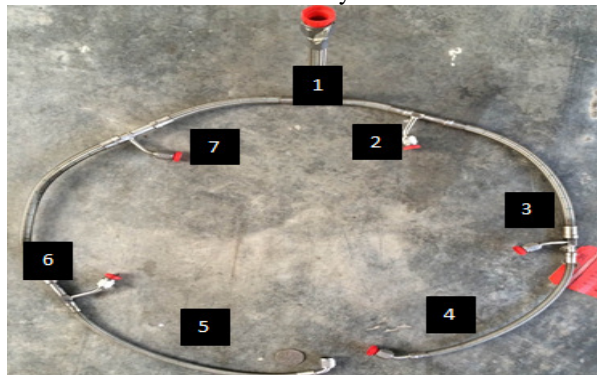
In this study, the actual sample of braided hose was used with inner tube of polytetrafluoroethylene (PTFE) and externally braided outer tube corrosion-resistant steel (CRES), taken from the plant. The sample of braided hose was divided into section to improve the analysis of study as shown in Fig. 3. This is done in order to identify the specific section of failure that occurs on the hose assembly.

Fig. 3. Sample of braided hose taken from the plant.

The failure parts of the hose occur have been identified in sections 3 and 6, respectively. However, hose 3 has minimal damage and the hose is not elongated from its original diameter. In addition, section of hose 6, were undergone elongation and burned. Hose section 3 and 6 are assumed to be same initial length and diameter without fittings, as shown in Fig. 4 and Fig.5, respectively.

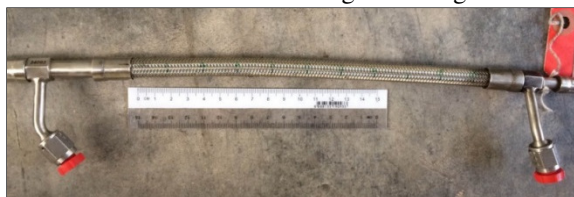
Fig. 4. Sample of braided hose taken from the plant.

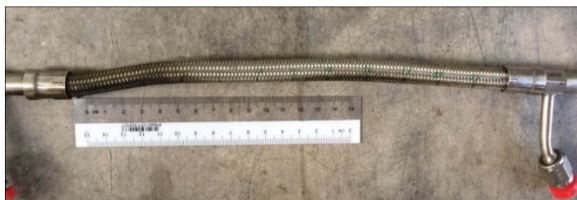
Fig. 5. Section 6 of the braided hose sample.

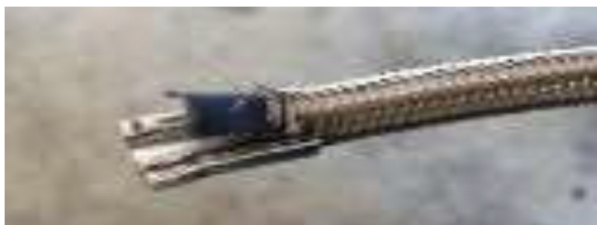
The hose was cut into cross section to identify the fitting details of the hose as shown in Fig. 6. The end of the pipe are clamped between two layer fittings 15.27 mm away from visible hose. The length of the pipe is 220 mm for both stainless steel and PTFE excluding the fitting. Both the hose outer and inner diameter are measured using vernier caliper in the lab.

Fig. 6. Cross section of the braided hose sample.

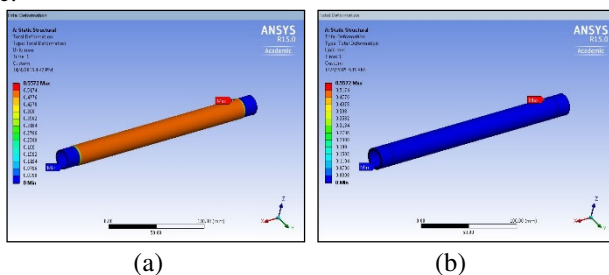
The maximum Von Mises stress is 108.12 MPa and the minimum is 0 MPa. According to the yield strength of the stainless steel, the design is safe. The Von Mises stress for the horizontal hose is less than the yield strength of stainless steel which is 207 MPa. By installation of horizontal position, there was no stress failure detected. The maximum stresses are mostly detected near the fittings of the hose. Total deformation as in Fig. 8 shows the maximum point at 0.5572 mm where both the material can withstand the deformation of plastic and elastic.

Fig. 8. Total deformation on horizontal with PTFE (a) and FB (b).

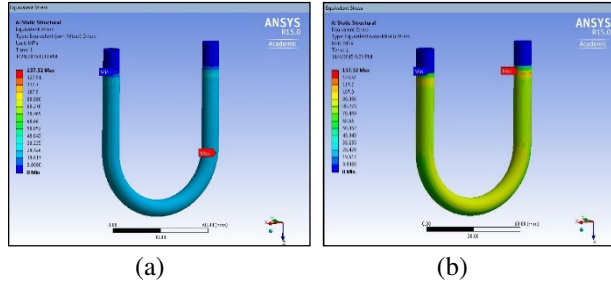
Figure 9 shows the U-shape position of PTFE and FB. The maximum Von Mises stress is 137.32 MPa and the minimum is 0 MPa. According to the yield strength of the stainless steel, the design is safe. The Von Mises stress for the horizontal hose is again less than the yield strength of stainless steel which is 207 MPa.

Fig. 9. Von Mises stress on U-shape with PTFE (a) and FB (b).

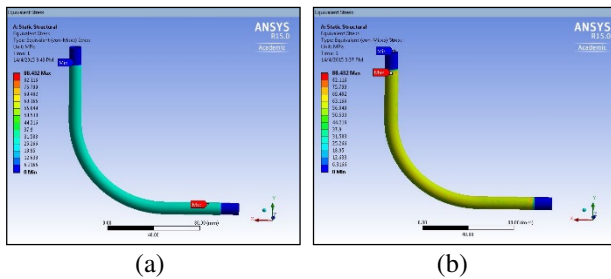
Based on Fig. 11, the maximum Von Mises stress is 88.432 MPa and the minimum is 0 MPa. L shape position indicates that it would produce smaller Von Mises Stress compared to horizontal hose and U shape hose installation. By installation of L shape position, there was no stress failure detected. The maximum stresses are mostly detected near the fittings with and without the stainless steel material.

Fig. 11. Total deformation on L-shape with PTFE (a) and FB (b).

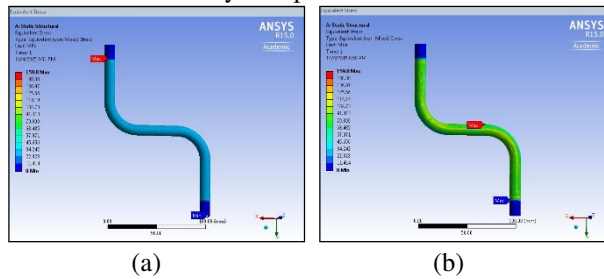
The maximum Von Mises stress for S-shape is 159.8 MPa and the minimum is 0 MPa, as shown in Fig. 12. S shape position indicates that it would produce much larger Von Mises Stress compared to the other hose installation. By installation of S shape position, there was no stress failure detected but near to failure. The maximum stresses are mostly detected near the fittings of the hose. The full body of the S shape hose indicates maximum Von Mises diverted the Von Mises stress away from the fittings.

Fig. 12. Von Mises stress on S-shape with PTFE (a) and FB (b).

Braided hose leakage in equipment will inflict significant cost in downtime and material wastage. It is crucial to investigate factors to improve the braided hose reliability and mechanism to detect the potential leakage. From the results, the highest maximum Von Mises stress is 159.8MPa for S shaped hose. The lowest maximum Von Mises stress is L shaped hose which is 88.432 MPa. The total deformation results show that the horizontal position has the highest maximum deformation of 0.5572mm and lowest total deformation is for S shape hose with value 0.28982mm. The deformation has minimal effect on the braided hose failure. However, both Von Mises stress and total deformation have confirmed that the maximum values of stress and deformation occurs near fittings. The best shape for installation is horizontal hose position for minimum stress on braided hose. To prevent the hose from multi-plane bending, the hoses should be installed with adapters. A hydraulic hose subjected to machine or actuator movement should be routed properly with bracket or installed on the wall to prevent failure of the hose near point of fittings.

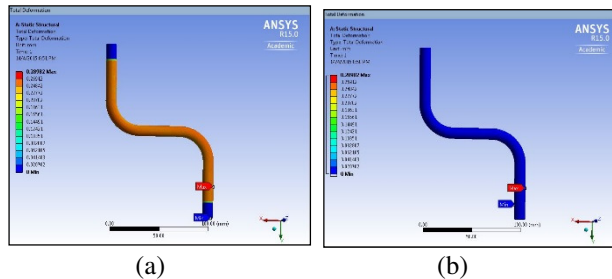
Figure 13 shows the maximum total deformation is 0.28982 mm for S shape hose position which is smallest deformation compared to other installation position. This further proves, horizontal position have a highest total deformation. According to the observation of the results for the layer of stainless steel and PTFE, the total deformation is maximum near the fittings. Due to the pressure exerted inside the PTFE layer and fixed support at the end of the hose, the deformation is concentrated near the fittings. However, the PTFE layer did not deformed beyond the stainless steel layer as predicted.

Fig. 13. Von Mises stress on S-shape with PTFE (a) and FB (b).
