Case study of application geotextile tube in the construction of sea dike and shore protection

Eun Chul Shin^{1,*}, Sung Hwan Kim¹

¹ Dept. of Civil and Env. Engg., Incheon National Univ., (Songdo-dong)119 Academy-ro, Incheon,22012, Korea

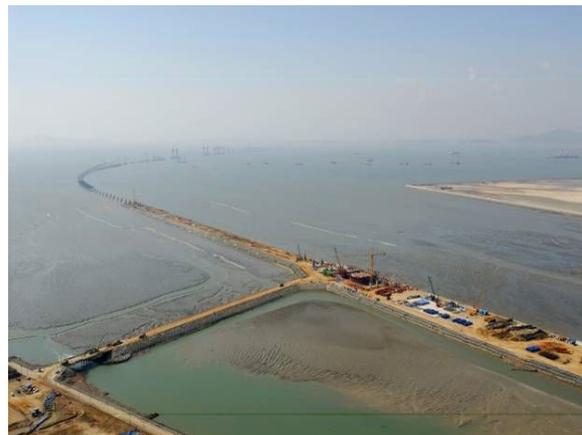
Fig. 2 The Stacked Geotextile Tube of 1,560m long was implemented at the approach Bridge of Songdo New City

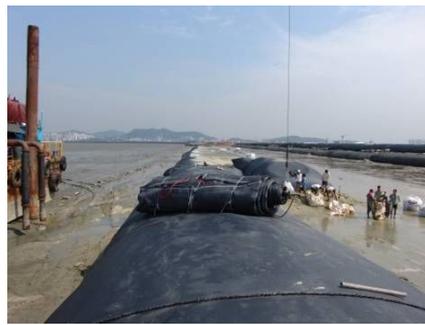
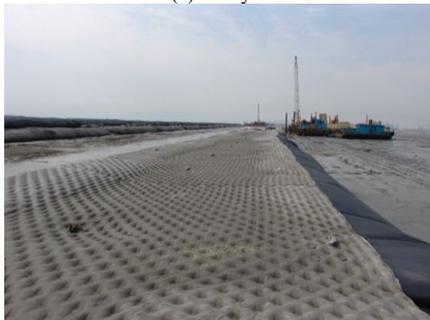
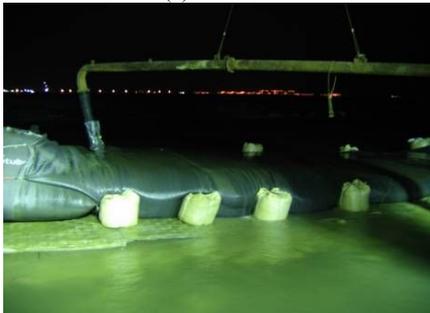
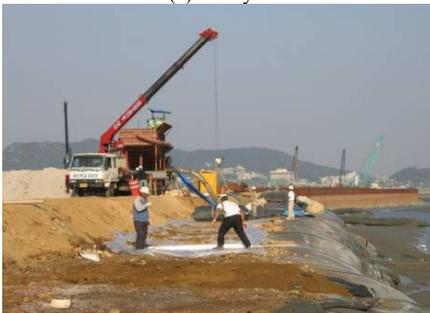
Fig. 4 Construction Procedure of Stacked Geotextile Tube Construction at Incheon Bridge

(a) 1st layer

(b) Sand mat

(c) 2nd layer

(d) 3rd layer

The geotextile used was 50m long and the tube was 5m in diameter at the 1st layer under the submerged condition as shown in Fig. 4 (a). The spacing between an inlet and outlet was 15m in this construction. These ports are utilized for filling and also for releasing excess water. Eighty percent of the filling material (U.S.C.S. : SP) was water and the rest was sand. Injection pressure was controlled to less than 30kPa to prevent tube rupture. To increase the friction between the geotextile tubes, a prefabricated sand mat was used at the interface between upper and lower tubes on the second layer, as shown in Fig. 4 (b). The highest high water level at Incheon is 4.635m. The tube was elevated to 6.2m, which is 1.2m higher than that of the internal embankment. The geotextile tube was filled with coarse grained sand by hydraulic pumping [12].

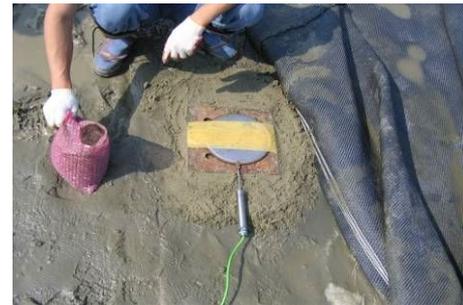
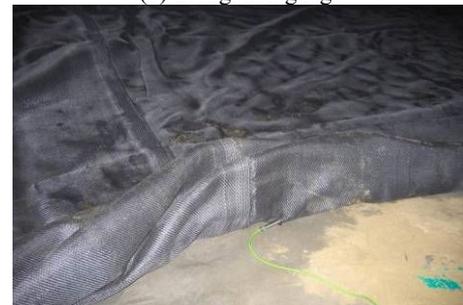
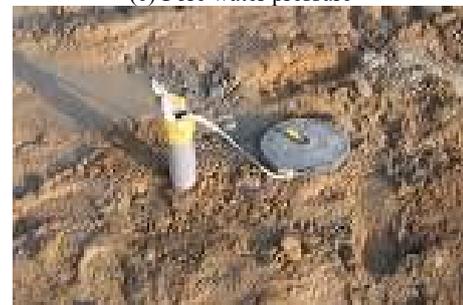
Fig. 6 Installation of Monitoring Instruments in Embankment

(a) Earth pressure

(b) Elongation gauge

(c) Pore water pressure

(d) Ground water level

Earth pressure, pore water pressure and the lateral displacement strain of the geotextile were measured in the structures of the geotextile tubes. The vertical and horizontal pressures were measured automatically during the construction and after the construction of a geotextile tube. The piezometer was installed into the ground before spreading the geotextiles; it was located at the centre of inside the geotextile tube, on the first layer. In the second and third layers, it was installed in the centre of the inside bottom of the geotextile tube. The elongation gauge was installed in the middle of the side of the geotextile tube where the maximum elongation was expected.

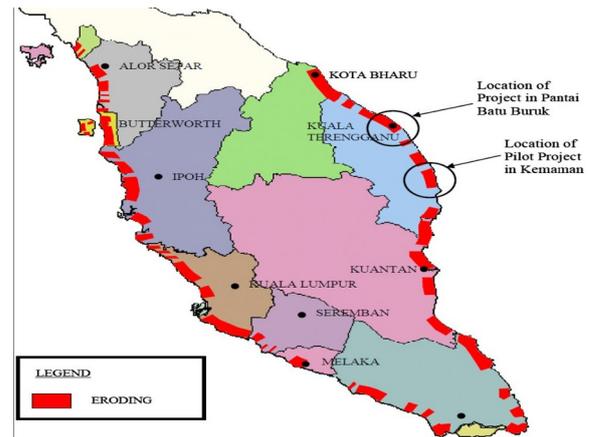
Fig. 10 Shoreline undergoing erosion in Peninsular Malaysia (EPU, 1985)

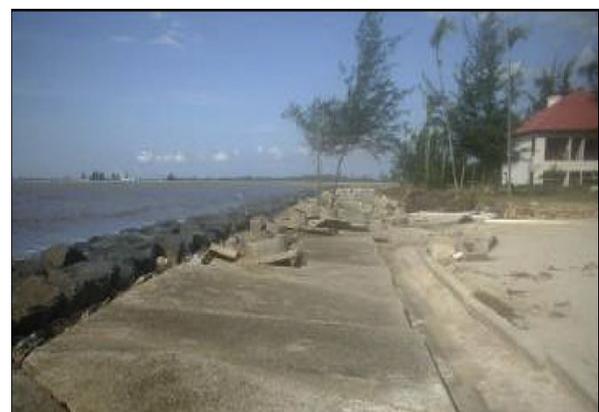
Fig. 11 Concrete units used for erosion protection

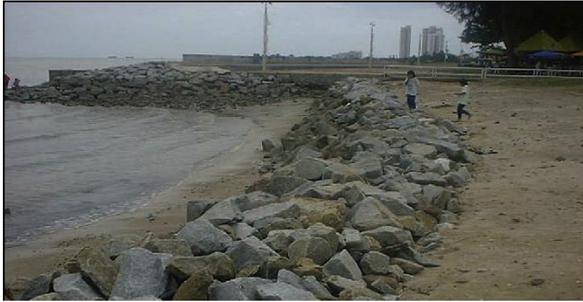
Fig. 12 Rock revetment used for erosion

The function of the revetment structure is to prevent the loss of shore sediment and to limit wave run-up from overtopping the structure. Wave run-up is reduced by the roughness of the revetment surface and the size of the rocks is determined by wave height. Soil bearing capacity will determine the strength of the foundation support of the structure. Commonly, a layer of geotextile is incorporated into the revetment structure as a filter and separator.

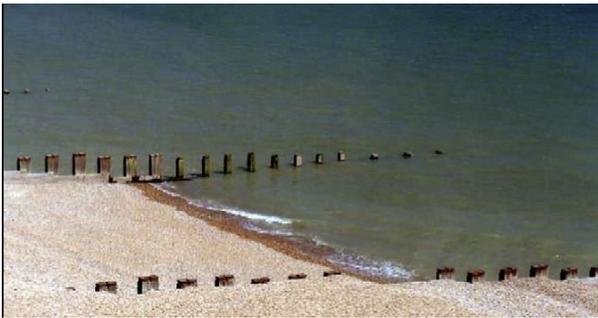
Fig. 13 Concrete groyne structures protection

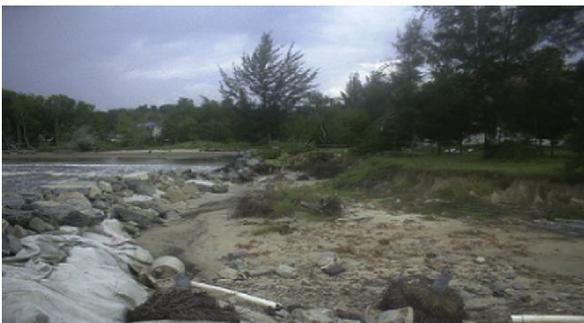
Fig.14 Failure of protection measure protection

Common causes of failure to these hard structural measures are undermining of the toe, excessive settlement, failure due to lateral movement, overtopping and flanking. Failure of filter system will also result in excessive loss of materials behind the structure and may result in an excessive settlement

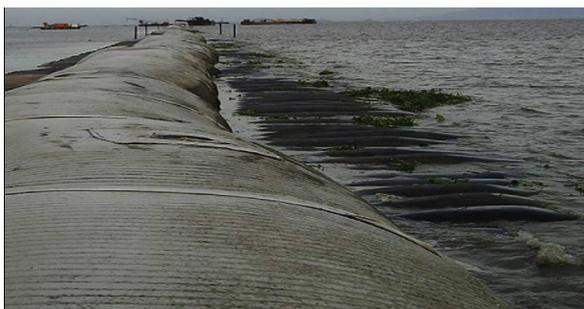
Fig. 15 Geotextile tube used for coastal protection works

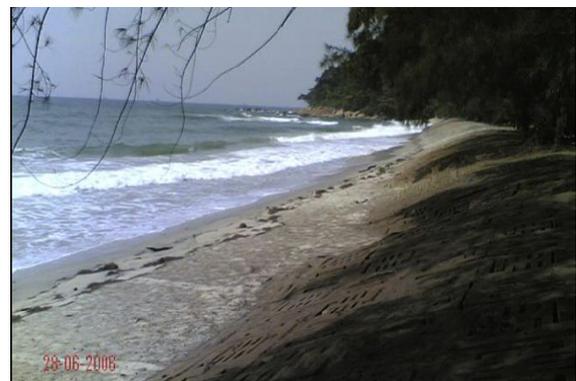
Fig. 16 The condition of shoreline before application geotextile tube protection works (June 2006)

The shoreline along the coast of Teluk Kalong is composed mainly of granular sandy materials. These sediments are easily erodible when subjected to wave forces and if not adequately protected. A length of about 500 m in length of this existing shoreline had been exposed to severe erosion, resulting in instability of the existing seawall, which consisted of precast concrete slabs as shown in Fig. 16. Fig. 16 shows the severity of the shoreline erosion and the strength of the waves

approaching the shoreline. Loss of sandy materials behind the concrete panels due to severe erosion had resulted in large and uneven settlements of the panels. The condition of the beach front was also not suitable for recreational activities due to the rather narrow and steep foreshore area. A pilot project was initiated in 2006 by the Public Works Department to remedy the situation by using the geotextile tube as a submerged dyke. The design concept for the coastal erosion protection and beach enhancement is to use a system of geotextile tubes sitting over a layer of apron mattress, as shown in the typical cross section in Fig. 17. The inner structure of these geotextile tubes consists of high strength woven polypropylene geotextile with ultimate tensile strengths of 150 kN/m in warp and weft directions. An outer layer of nonwoven polypropylene geotextile having the ultimate tensile strength of 40 kN/m in the machine and cross-machine directions were stitched onto the inner reinforcement layer, to increase the durability of the tube due to abrasion and ultra-violet degradation. The fabrics are all tested for compliance to high seam strengths in excess of 80% of the ultimate tensile strength.

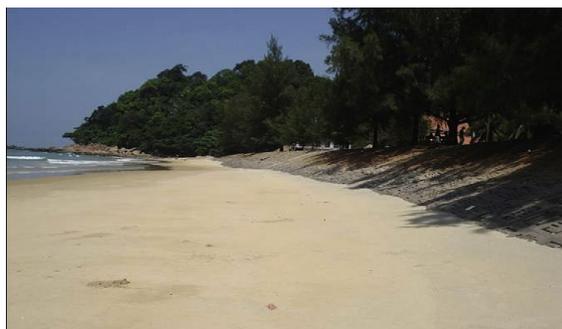
Fig. 18 The condition of shoreline and beach in December 2009 after completion of submerged geodykes installation
