Efficient method of eliminating accidental damage of sewer tunnel

Abstract. The article is devoted to the development of technological and organizational solutions for elimination of local emergency damage to sewage tunnel collectors. In the article, conditions of operation and constructions of the sewage tunnel collector destroyed by corrosion are investigated on Grekovska street in Kharkiv, Ukraine; the methods of production of repair and restoration works are analyzed in this article; technological and organizational solutions have been developed for the liquidation of emergency damage to sewage tunnel collectors, taking into account technical, organizational and economic indicators. Thus, when comparing recovery options by different methods, it is noted that the proposed technology is more economically feasible in view of the relatively low cost of the material for this solutions. At the same time, the duration of the work by the proposed method of extrusion by introducing a secondary lining with anticorrosive properties will be reduced by 30%.

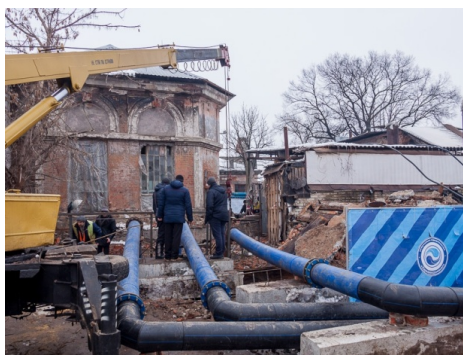
Fig. 1. Temporary disposal of wastewater.

The procedure for the elimination of accidents in sewage networks is stipulated by the technical operation rules for water supply and wastewater disposal systems of residential areas of Ukraine, approved by the Order No. 30 of July 05, 1995. Organizational and technological measures for the elimination of local damage to an operating tunnel collector with open access to soil inside it include pre-construction and basic works. At the first stage, it is necessary to stop the soil washing and to ensure the drainage of wastewater by switching to a reserve collector or by installing a bypass line. But there was no technical capability to switch the tunnel collector on the Grekovskaya street to another line, and a bypass line was installed in the shaft, that allowed to ensure the functioning of the water distribution and disposal system (Fig. 1). Main organizational and technological operations of the preparatory stage include:

- fencing of the emergency work site,
- arrangement of wastewater drainage via three lines of the PE pipeline (D=300 mm) with pumping stations,
- conducting the geological engineering survey in the emergency area,
- backfilling of the collapse cavern with soil to prevent further collapsing,
- conducting geophysical studies on the basis of the actual state of the soil mass with the indication of sheeting limits, karst caverns, existing ground water tables for the subsequent development of a practicable design solution for the method of reconstruction.
