Analysis of cyclists' behaviour on different infrastructure elements

Katarzyna Cieśla¹, Tomasz Krukowicz^{2,*}, and Krzysztof Firląg²

²Warsaw University of Technology, Faculty of Transport, ul. Koszykowa 75, 00-662 Warsaw

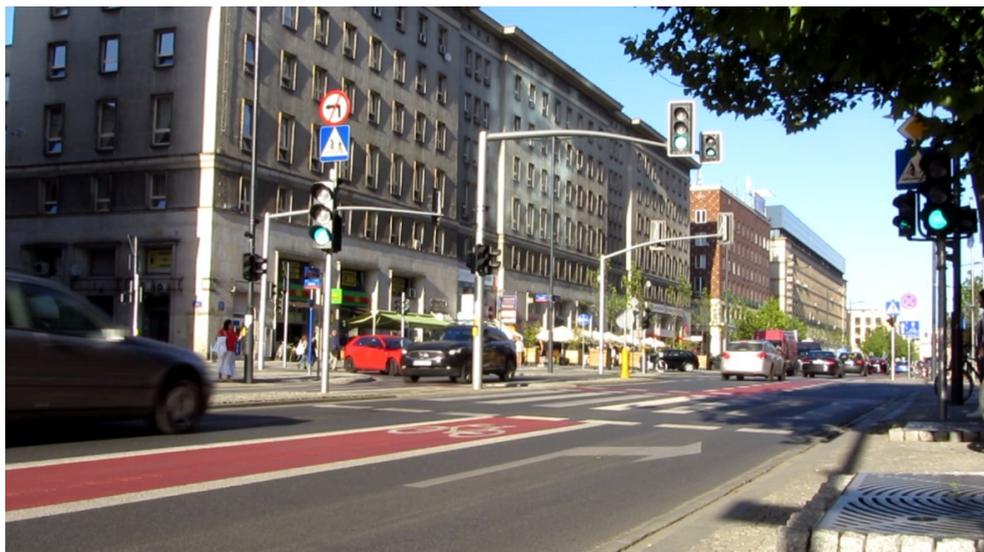
Another place where the research was carried out is the bicycle lane along Świętokrzyska Street at the intersection with Jasna Street. At the western approach of this crossroads, the traffic of cyclists was controlled by the S-6 signal which was built before the introduction of the amendment [13], which provided for the use of three-aspect traffic lights in such cases. The permit signal for cyclists ends earlier than for the vehicles, due to the longer intergreen times (object 4 – fig. 1).

Fig. 1. Bicycle lane along Świątokrzyska Street at the intersection with Jasna Street (object 4).

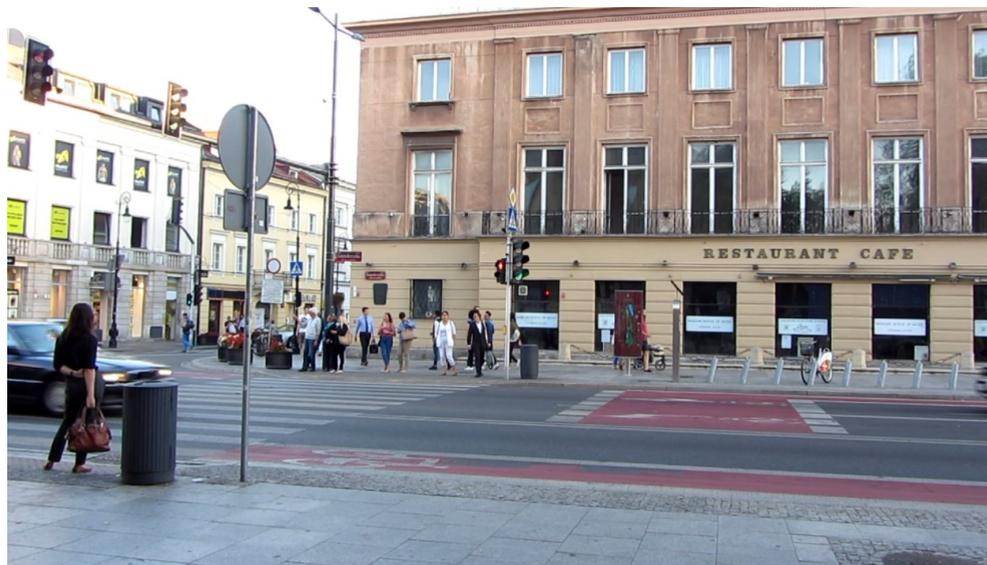
The measurements were made for the advanced stop line at the intersection of Świętokrzyska Street from Nowy Świat Street. The tested advanced stop line is located at the western approach of the crossroads and allows the cyclists to turn left in the direction of the University of Warsaw. An analogous advanced stop line is also located at the opposite approach. There are bicycle lanes on both sides of Świętokrzyska Street (object 13 – fig. 2).

Fig. 2. Advanced stop line at the crossroad of Świętokrzyska Street and Nowy Świat Street (object 13).

The advanced stop line (object 13) is the most complex among the examined infrastructure solutions. It distinguishes as many as 13 different behaviours. Many of them result from the lack of knowledge of the rules of using such an object, as well as from the fear of moving on the road or the lack of patience of cyclists.
