Reconstruction of road accident using video recording

Abstract. Presented was the procedure of reconstructing a motorcycle-motor car collision with both vehicles moving in the same direction and performing simultaneous manoeuvres: a left turn and overtaking. Because of the conflicting reports of witnesses, the procedure also involved recordings from a stationary video camera. These data allowed us to retrace the movement and manoeuvres of vehicles as a function of time and then to identify the perpetrator of the accident.

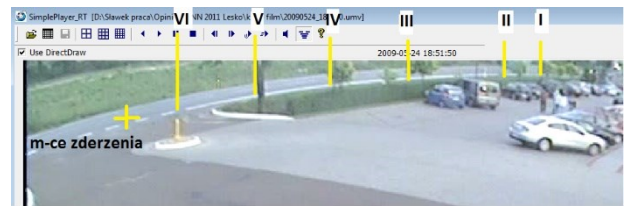
Fig. 1. Distribution of selected reference point.

While moving relative to the camera, the vehicles seen in the recording were passing reference points visible in the frame (trees and a road location marker). They were designated with numbers I – VI – Fig. 1. After the identification of these points, it was necessary to determine the distance between them. Other measurements concerned the distribution of landmarks in the form of road marking elements. The following distances from the right edge of the road were measured: the position of the beginning and end of the double solid line after the intersection and the solid left edge line.

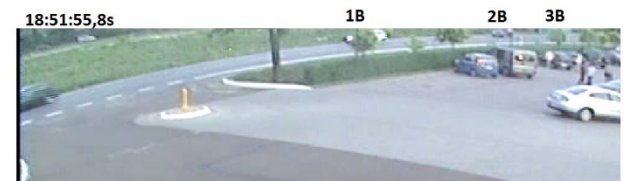
Fig. 3. A shot from the camera recording showing the moment when the car 1 begins to decelerate.

Analysis of the course of the collision begins with the moment when the motorcycle appeared in the field of view of the camera (position 3A) (Fig. 2). The car 2 was then in the field of view of the camera near point II (position 2A), and the car 1 was in the field of view of the camera in the vicinity of point III (position 1A). The motorcycle 3 was situated next to the solid line, still on the right-hand lane (in accordance with the testimony of the motorcyclist), approximately 12.5 m behind the car 2 and about 42 m behind the car 1. The car 2 was at this time about 25.5 m behind the car 1, which was situated at a distance of about 38 m from the right edge of the entry to the parking lot. Based on the analysis, it can be concluded that the average speed of the motorcycle 3 had been reduced on the section between points IV and V in the field of view of the video camera. The duration of passage between these points was equal to 0.4 s and was shorter than the statistical driver's average reaction time to an expected threat ($t_r = 1$ s). At the moment when motorcycle 3 was in the field of view of the camera near point IV, the car 1 changed its direction and probably crossed the axis of the road (Fig. 3). The above findings

field of view of the camera and after passing point II, the motorcycle was still behind the car 2. Theoretically, with this position on the road (3B, Figure 3) relative to the preceding vehicle, it could have still been moving in the right lane. Given the short distance (approx. 8 m) between the vehicles in this phase of the accident, it was considered unlikely. It was more likely that the motorcycle had already been in the left lane. The motorcycle 3 was definitely in the left lane at the time shown in Figure 4 (position 3C), being located about 25 m behind the rear bumper of the car 1, which at this time had already been significantly slowing down. The reduced speed of the car 1 could have been imperceptible to the motorcyclist due to the fact that his motorcycle was intensively accelerating in this phase of the collision. The driver of the car 1 would have had the objective chance to notice the motorcycle 3 in the side view mirror, had he observed the road behind him while decelerating. Assuming the correct arrangement of side mirrors in the car 1, the motorcycle 3, which was about 9 meters behind the rear bumper of the car 1 (position "D" in Figure 4), was then still outside the so-called driver's blind spot in the left side mirror. The motorcycle 3 performed the overtaking manoeuvre in a dynamic manner and in a short time greatly increased its speed. Such behaviour could have impeded the proper assessment of the traffic situation by the driver of the car 1. In the present case, when the driver of the car 1 was making sure it was possible to turn left, the motorcycle 3 could have still been invisible behind the car 2.

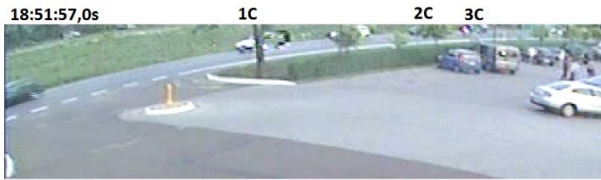
Fig. 4. A shot from the camera recording showing the moment when the motorcycle reaches the level of the car 2.

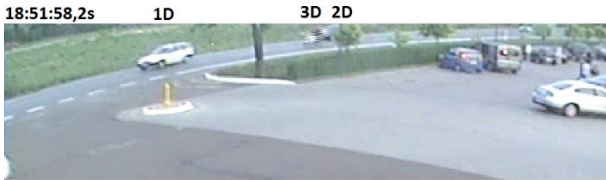
Fig. 5. A shot from the camera recording showing the moment the car 2 passes point III in the field of view of the camera.

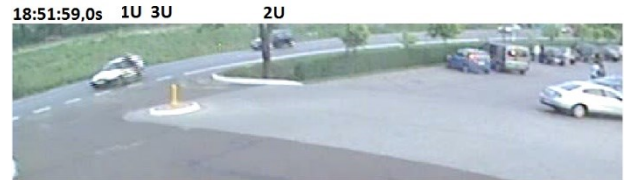
Fig. 6. A shot from the camera recording showing the collision of the motorcycle with the car 1.

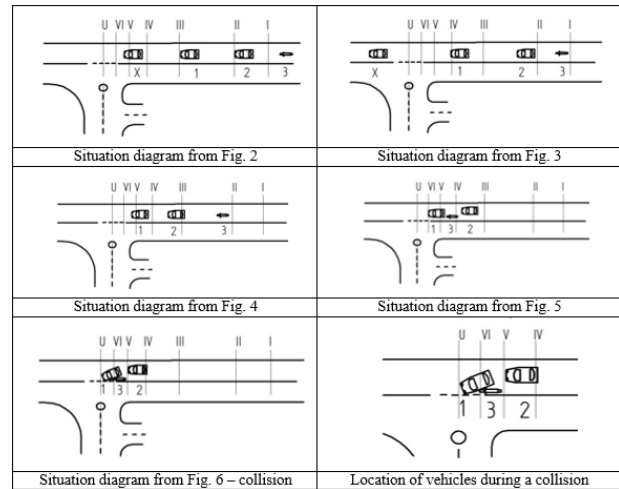
Fig. 7. Scheme of the accident: I, II, III, IV, V, VI – reference points, U – point of collision, 1, 2, 3, X – vehicle identification.
