Behaviour of Reinforced Concrete Frames with Central Opening Masonry Infill under Lateral Reversed Cyclic Loading.

Abstract. This paper will describe the seismic behaviour of masonry infilled RC frame with a central opening structure under reversed cyclic lateral loading. To achieve the purpose of this study, four 1/4-scale single story and single bay RC frame specimens were tested, i.e. one bare frame, one clay brick masonry infilled RC frame without opening and two clay brick masonry infills with a central opening in infills. The ratios of opening size to panel area were 25% and 40%. Through reversed cyclic lateral loading tests, the seismic performance of RC frames with a central opening brick masonry infills was investigated. As the results, significant distinctions of failure mechanism, lateral strength, stiffness, and ductility were observed between these specimens. In the case of infills with a central opening, the cracks sprouted and developed at the corners of the opening. Although the presence of the opening in infill reduces the lateral strength and stiffness overall structure, the brick infilled frames with a central opening of 25% and 40% of panel area show better sei

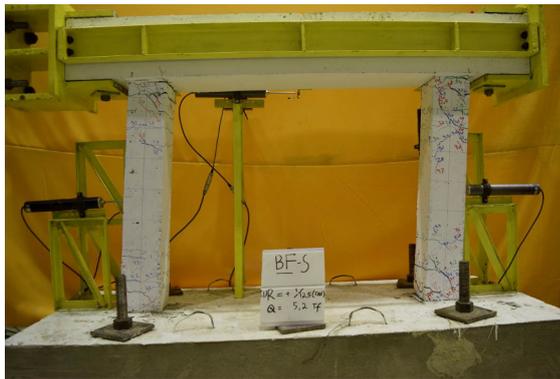
(a) BF specimen

0.16 . In the next cyclic loading of $1/200$, first shear crack was observed at the base of the compressive column at the drift ratio of 0.5 . Flexural cracks significantly appeared during the cycle of $1/100$ at the ends of both columns. Moreover at the subsequent cycles loading the flexural cracks grew become flexural-shear cracks and shear cracks propagated at the ends of columns. During the cycle of $1/12.5$, the compressive column failed in shear at the drift ratio of 7.85 . At the next cycle of $1/10$, after the shear failure of both columns, the lateral strength significantly degraded. Photo 1(a) shows the condition of BF specimen by cycles $-1/25$ rad. Figure 4(a) shows the crack pattern of BF specimen.

Photo 1. Typical damage of specimens under lateral load at the cycles 1/12.5

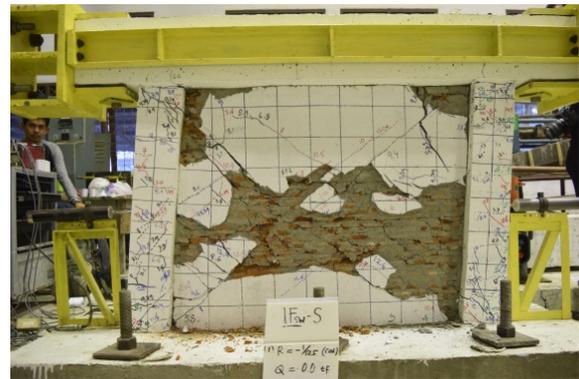
(b) IF_{sw} specimen

During cycle $1/800$, a separation crack occurred between column and wall at the drift ratio of 0.05 . Initial flexural and shear cracks were detected at tensile column during the cycle of $1/400$ at drift ratios of 0.17 and 0.21 , respectively. Initial diagonal shear crack at the centre of panel wall came out during cycle $1/200$ at the drift ratio of 0.45 . During the next cycle loads, shear cracks developed at the ends of columns and then followed by peeling off the wall plaster. After the shear failure of the brick wall during the cycle $1/25$, the lateral strength degraded significantly. Shear failure of the boundary column happened at the cycle $1/12.5$ after the failure of the infill wall in out of plane direction. Photo 1(b) shows the condition of the IF_{sw} specimen by cycles $-1/25$ rad. The crack pattern of IF_{sw} specimen is exhibited in Figure 4(b).

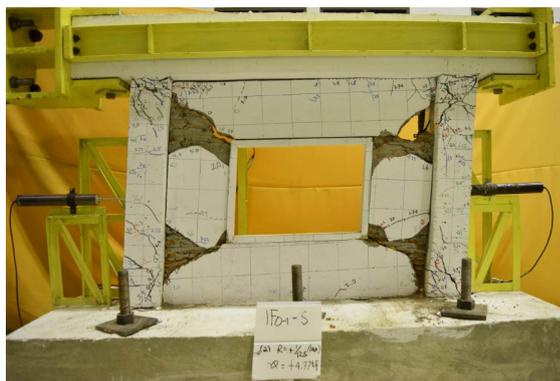
(c) IF_{o1} specimen

Initial shear cracks existed at the top left corner and at the bottom right corner of opening at drift ratio 0.06 during the cycle $1/800$. Separation crack between columns and infill wall was detected during the cycle $1/400$. At this cycle, the earliest flexural crack was observed at the tensile column at drift ratio 0.25 . The first shear crack at the tensile column occurred during the cycle $1/200$ at drift ratio 0.47 . At this cycle, flexural cracks grew at the middle height of both columns. In further cycles, flexural cracks appeared along columns height and shear cracks increased at the corners of the opening. Peeling off the plaster took place at the corners

of opening and then the infill wall failed in shear at the corner of opening during the cycle 1/25 followed by degradation of lateral strength. Shear failure of tensile column happened during the cycle 1/12.5. Photo 1(c)

shows the condition of IF_{o1} specimen by cycles-1/25 rad. The crack pattern of IF_{o1} specimen is demonstrated in Figure 4(c).

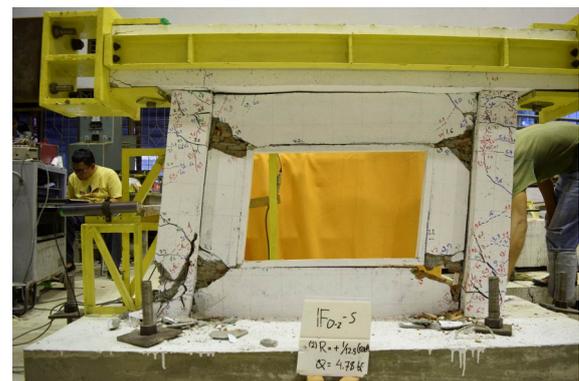
(d) IF_{o2} specimen

During the cycle 1/800, explored events were an initial flexural crack at the tensile column at drift ratio 0.05, separation crack between column and wall at the drift ratio of 0.06, initial shear crack at the left top corner of opening at the drift ratio of 0.11. Initial shear crack at the top of the tensile column was detected at the drift ratio of 0.32 during the cycle 1/200. The shear cracks on both columns and at the corners of opening propagated during the subsequent cycles. Shear failure of the bottom compressive column occurred during the cycle 1/12.5 followed by failure of the wall in out of plane direction. Photo 1(d) shows the condition of IF_{0.2} specimen by cycles -1/25 rad. The crack pattern of IF_{0.2} specimen is shown in Figure 4(d).
