IRT research on influence of long-term loads on defects in FRP strengthened RC beams

Marcin Górski¹, Rafał Krzywoń¹, Rafał Białozor¹, Ryszard Białecki², Wojciech Adamczyk², Ziemowit Ostrowski²

¹Silesian University of Technology, Faculty of Civil Eng., Department of Structural Eng., ul. Akademicka 5, 44-100 Gliwice, Poland.

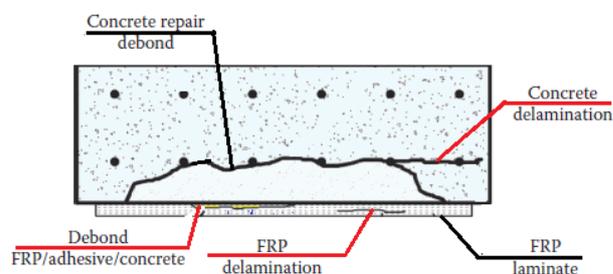
Fig. 1. Location of potential degradation in FRP strengthened structural member [3].

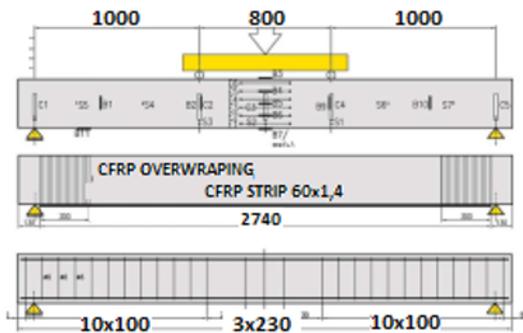
Fig. 2. RC beam geometry used for a test [8]

Beam was made of concrete of the guaranteed class C25/30. Its properties determined in the laboratory tests are: the average concrete cube strength 44.7 MPa, the modulus of elasticity of 31 GPa and tensile strength in the Brazilian test 3.20 MPa. The main reinforcement of beams consists of three #12 bars in the bottom (tension) zone and two #8 top bars (Fig. 2). As the shear reinforcement #6 stirrups were used in the 100mm spacing. The tensile strength of the #12 steel specified in the tests was 660.8MPa, yield strength 570.06MPa, modulus of elasticity 200.7GPa.

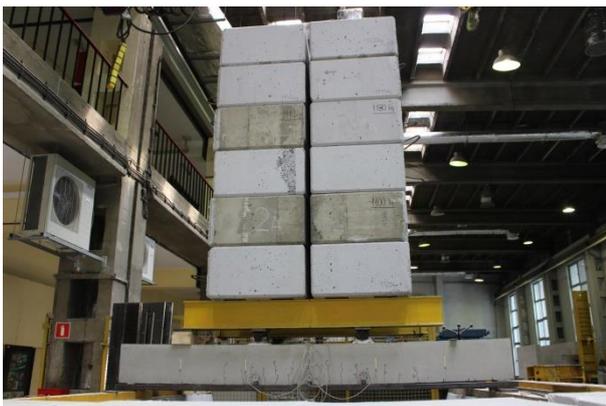
Fig. 3. Side view of laboratory long-term tests.

All beams were tested in the four-point bending test. The load was applied in the form of concrete blocks with a total weight exceeding 13 tonnes. This is about 67.7 kN per each beam, around 50% of observed real failure force and 80% of force which causes the yield of reinforcement. In authors opinion, such a value corresponds to the real conditions of long-term maintenance of this type of construction.

During the tests (Fig 3-4) the deflection was measured in the middle of the span, at the supports and at the ends of the constant moment segment (analogue indicators), deformation of concrete and composite overlays in the plane section of the maximum bending moment and in the anchoring zone (strain gauges and analogue extensometer).

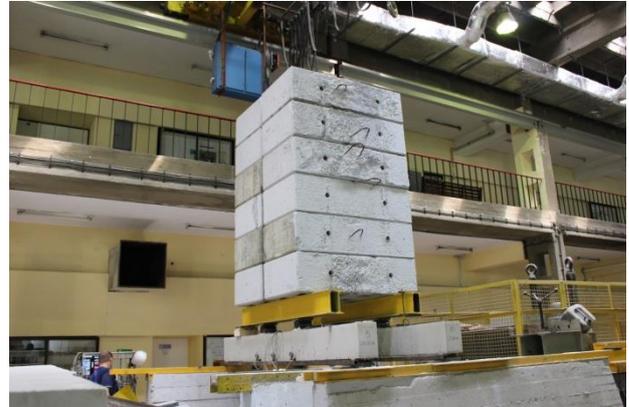
Fig. 4. Front view of laboratory long-term tests.

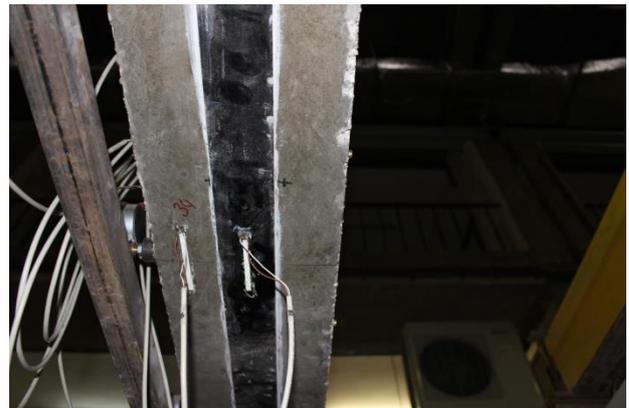
Fig. 5. CFRP strip on the bottom surface of RC beam.

The main objective of this research was to check CFRP reinforcement efficiency in the reduction of deflections for long-term loads (Fig. 5), as well as observation of defects development. The beams were tested for a period of two years. The readings were initially carried out at weekly intervals, the average monthly increase in deflections does not exceed 0.2mm, therefore, after six months the frequency of readings was reduced to a month. Figure 6 shows the graph of the growth of the beam's deflection as a function of load time.

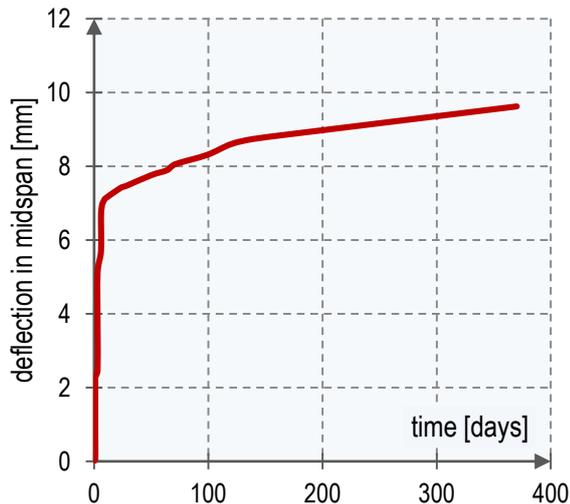
Fig. 6. Deflection of RC strengthened beam as a time function

The average crack spacing for the beam it is 140mm. The crack opening in this case, does not exceed 0.1mm. The range of the cracking zone practically does not change in time, the observed crack image has been stabilized in the first two weeks, and no new cracks appeared.

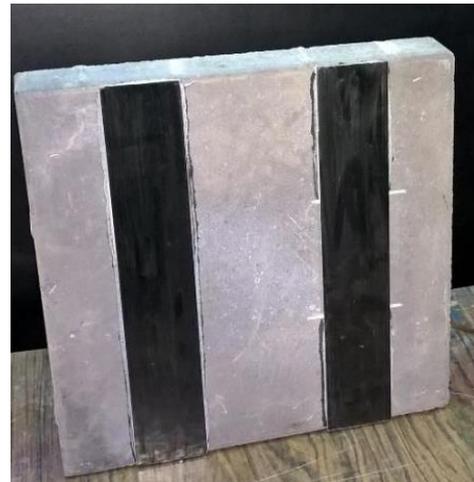
Fig. 7. Specimen of CFRP strips for initial thrmography tests

The initial thermographic study was performed and calibrated with use of FLIR camera type. Images were recorded with resolution of 640x460 with the frequency of 9-30 Hz. The testing surface was covered with thin layer of graphite paint in order to limit the reflectivity and minimize the effect of heat emissivity on the camera readings. The temperature gradient between object and environment was forced by using convective electric heater with control of both temperature and blowing intensity. Measurement methodology was as follows: after thermal excitation thermograms were recorded within 1 min. Recorded images were processed using an self-made LabVIEW application producing information on material delamination of FRP or/and concrete cracking. Initial tests were performed on concrete blocks of 30x30cm with two CFRP samples (Fig. 7), one with artificially prepared defect. It can be observed (Fig. 8) that process of the surface cooling was slower in place where defect was prepared.

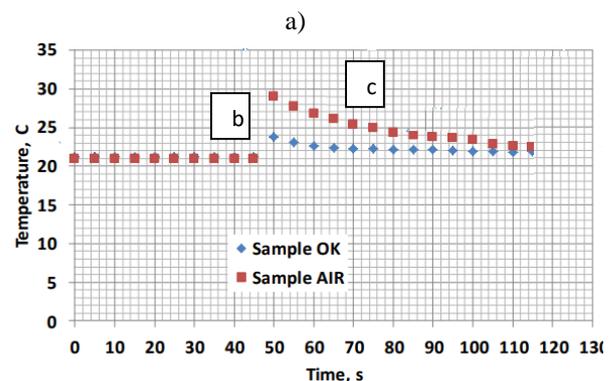
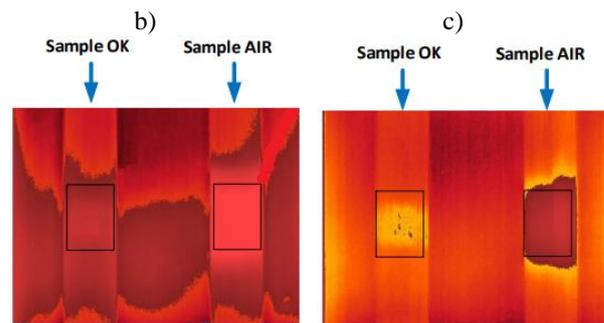
Fig. 8. Time - history of thermal behaviour of specimen a) comparison of thermographic images of specimen just after heating b) and during cooling process c).

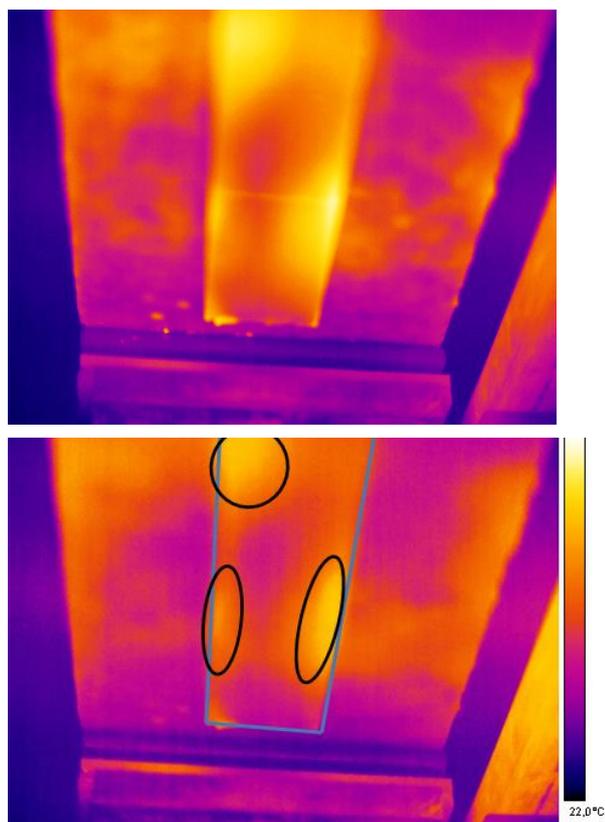
In this case, the thermographic analysis was performed in the same manner as the initial study. Thermographic images have been taken along the beam every 30 centimetres. Two examples of thermograms were shown in figure 9. The first picture presents temperature field just after heating and the second 20 seconds later. Images were recorded using the same scale of temperature. Bright areas indicate a worse quality of bonding of FRP with the structural member. Even just after heating non-uniform distribution of temperature gradient can be distinguish as a result of different contact between CFRP and concrete.

Fig. 9. Comparison of thermographic images of strengthened beams just after heating a) and during cooling process b).

The similar defects were observed in a few places along the beam. The estimated area of potential defects is up to 6.4% of total area of the initial bonding layer. Assuming that this area is not taken into account in load bearing, it can be simply estimated that moment bearing capacity is about 3% lower compared to a member without any defects.
