Experience in the restoration of permafrost degradation areas adjacent to transport infrastructure facilities

Abstract. The construction of transport facilities in the regions of the Extreme (or Far) North and the Arctic Zone is a very specific task with plenty of peculiarities. This can be referred to ever-frozen subsoils, hard-to-reach areas, low temperatures most of the year, as well as limited reserves of inert materials (stone, construction sand) used for construction.

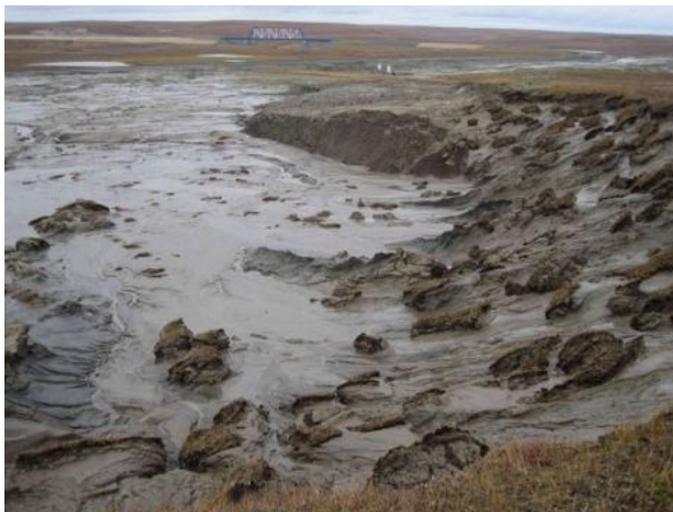
Local loamy soils containing ice are used in the construction of roadbeds for highways and railways. They have relatively high degree of subsidence, as well as lose its bearing capacity and become fluid in a melting time, leading to sufficient deformations of roadbeds, clogging of culverts and ditches. Moreover, an adjacent territory requires much attention as the source of basic danger for roads. The danger means, that the process of a frozen base degradation of the adjacent territory can be quickly transferred to the roadbed. It can start from an adjacent lake, a small stream, a ditch and other source and quickly expand towards the road. In some cases, it is not only local degradation of a frozen soil, but a solid wash-out of smooth slopes caused by imbalance of shear pressures (Fig.1).

Fig.1. Wash-out of a road adjacent to the railway.

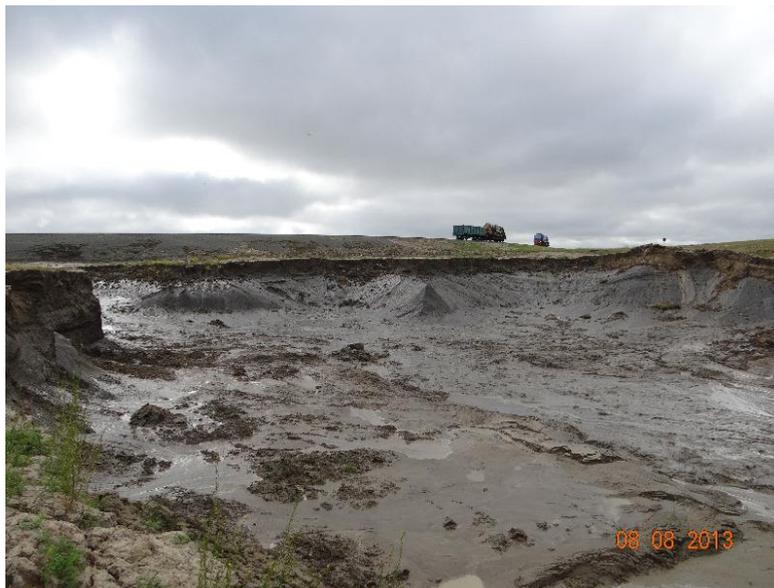
One of the most striking examples of degradation of the adjacent territory with a real threat to the integrity of the functional railway track occurred in August 2013 at the 536th km of the Obskaya-Bovanenkovo railway line. The work was completed 3 years ago, and the road was in service. The site was a cut up to 2 meters deep, where the permafrost layer was broken during the construction, as well as on the slope of the cut. After filling the embankment, the slope was covered with 50 cm thick local soil and strengthened by geotextiles with grass seeds. But the grass practically did not grow because of the cold weather and lack of feeding. The slope in winter is full of snow, and in spring a warm melting water washed-out this local soil from under the slope reinforcement, forming deep wash holes and completely clogging a catch-water ditch along the embankment. Finally, water began to flow through the body of the embankment towards the lake, bulging out (or lifting up) the slope, as well as soaking into the soil of the active layer along the embankment and rapidly breaking it out. The runlet appeared from the empanelment side, flowing into the lake along the slope and washing away the permafrost of the bank. During one of the hottest days of August (temperature was up to +33⁰C) such melting water passed upstream and started to actively expand the channel under the intensive sun. Within three days the area of degradation reached approximately 50m in length and 30m in width. Next evening by the time of our arrival to the site, there has already been a great wash up to 100m in length, 52 m in width and up to 4m in depth. The table soil flowed into the lake, and it was only 10m from the railway (Fig. 2). The inspection of the site proved that it would be difficult to immediately stop such degradation and close the site due to the lack of resources. Thus, it was decided to divide this into stages. Urgent measures have been taken to prevent from further melting towards the railway. It was necessary to stop melting process towards the road at the first stage, and then close the bottom and walls of the wash, not allowing further degradation development. First thing to do was the substitution of the running soil by the rocky soil using geotextile for the length of a dangerous site.

Fig. 2. Degradation of the adjacent railway territory.

This allowed saving the embankment and part of the soil along the slope with a simultaneous filling of the washed edge. At the same time, we started to clear a catch water ditch to separate (or cut off) a water flow into the embankment. The rest part of the site was covered by geotextile till the next delivery of the rocky soil and further decision-making. Later on, a project for restoration of this site was developed within 24 hours. It consisted of 2 steps. The first step included filling and restoration of the cut slope, as well as reconstruction of the ditch along the slope, and the second one included liquidation of the washed area adjacent to the railway line. But due to the lack of resources, we managed to perform only the most urgent measures suspending the melting of permafrost and flowing of the running soil into the lake. Moreover, the temperature on the next day dropped to $+12^{\circ}\text{C}$, the cold wind blew, significantly slowing down the melting process. During that day it was possible to expand the filling line of the washed area up to 5m, cover the bottom with geotextile and partially fill with the rocky soil. The work on liquidation of the washed area has been stopped due to the lack of soil and geotextile, avoiding the risk of full destruction of the railway road. While surveying the site, our group has left for the development of a proper comprehensive project on restoration of the degradation area (Fig. 3).

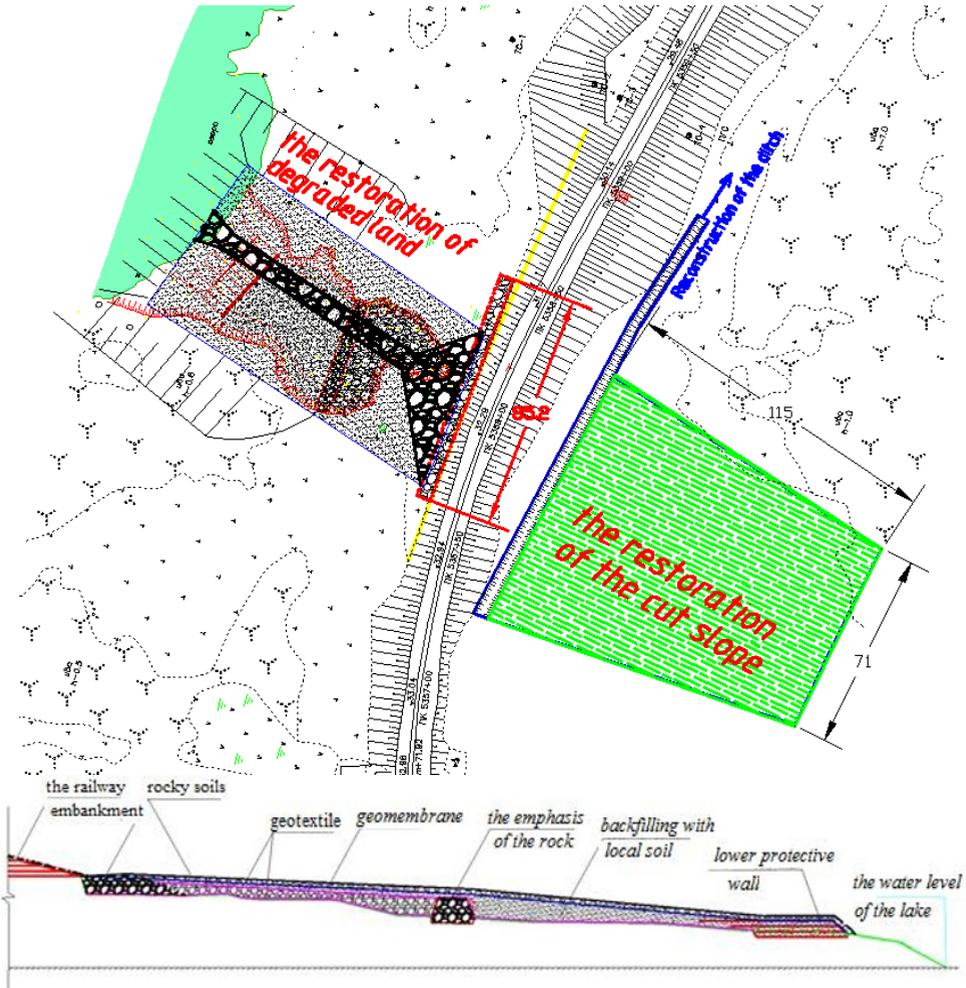
Fig. 3. Plan and cross-section of the project for restoration of the degradation area.

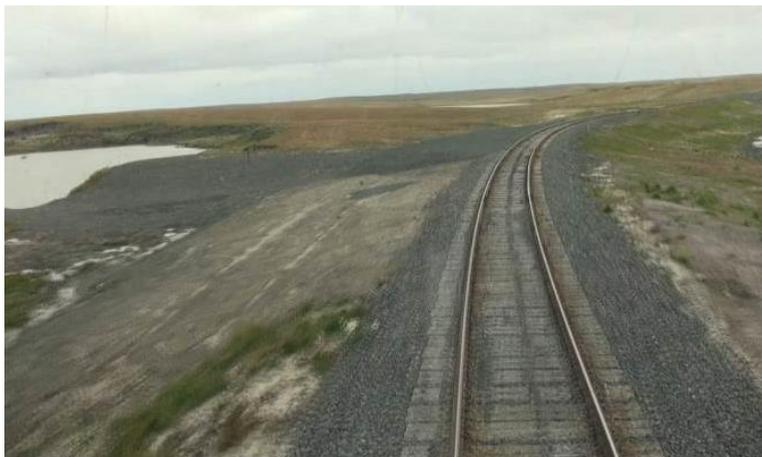
Fig. 4. The site after restoration (2015).

The project was developed in a short period of time and sent to the railway administration of the Obskaya-Bovanenkovo line. This project was used for further liquidation of consequences due to the melting of permafrost, as well as reinforcement of the slope. Within one year the site was restored (Fig. 4), and currently is in a stable condition.
