Sometimes, when we talk about Damaged Buildings- it can be controversial

This paper will present two of the historical buildings in Syria; Suleiman Tikie located in Damascus city and Maarat al-Numan Museum located in Idlib city. The two buildings have been subjected to different degrees of damage due to current military actions as well as time effects.

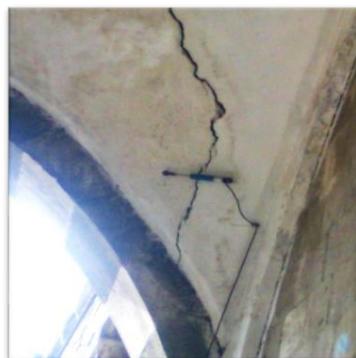
Fig. 2. Cracks in the cupolas of Suleiman Tikie.

Cracks appearance were observed in walls and cupolas. After 3 years of detecting the vertical movements: the maximum settlement was 2.44 mm and the minimum was 0.5 mm. Furthermore, it appears corrugation in the soil surface in the courtyard [3,4]. Many methods

could be used to improve and support foundations but the usage of modern material which are different from the original foundation materials has disadvantages. Therefore, this paper will discuss the use of lime because of its neutrality which won't effects the historical mission of the building. It should be mentioned that many mortar shells have been fallen around the location of Suleiman Tikie in AL-marjeh and more investigations should be made to detect the damages on both foundations and building structure which made the waves appearance in the courtyard even worse.

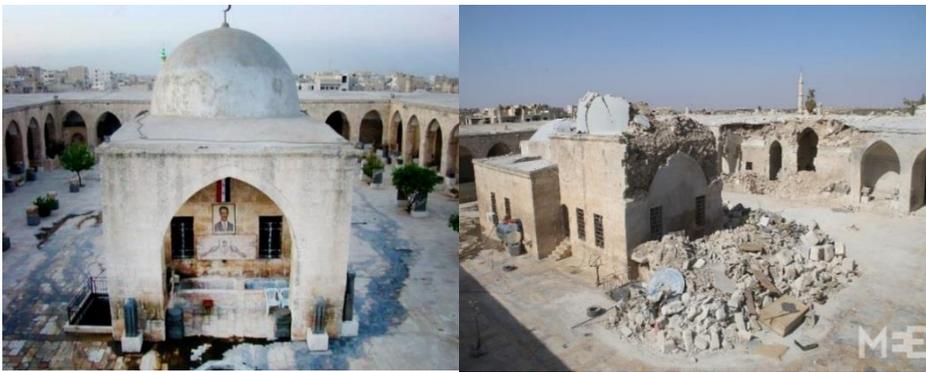
Fig. 3. Maarat al-Numan Museum (before - after).

It is a mosaics museum from the Dead Cities located in Maarat al-Numan city which also known as al-Ma'arra. This city in north-western Syria is located at the highway between Aleppo and Hama near the Dead Cities of Bara and Serjilla. The museum was built from huge lime stones. The building consists of a wide opened heavenly courtyard with Tikie in the middle. Unfortunately, a huge part of the museum has been destroyed by the recent war. Walls and foundations need supporting in order to rebuild this historical museum.

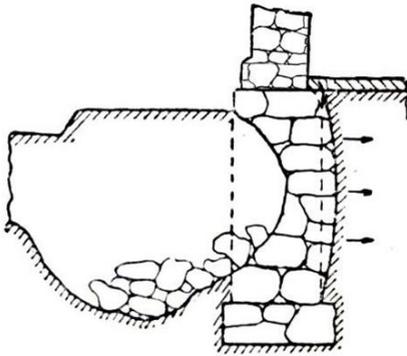
Fig. 4. Destruction of strip foundations within the explosion.

Maarat al-Numan museum foundations are the same of any historical buildings made of stone. The museum as we mentioned before subject to a rough military strikes and explosions led to effect the building as well as the foundations. Foundations material used was broken wage and lime with ash as mortar and when the foundations experienced an explosion, it quickly discloses bulging, bowing, shifting and settlement. From the current situation of the museum, most of the foundations facing a failure problem as huge stones have already failed and cracks appeared in the remain parts. Strengthen the foundations can be achieved by increasing their width using local and natural materials, construct pile foundations under the building to support the foundations, micro piles, using concrete or metal beams under foundations.

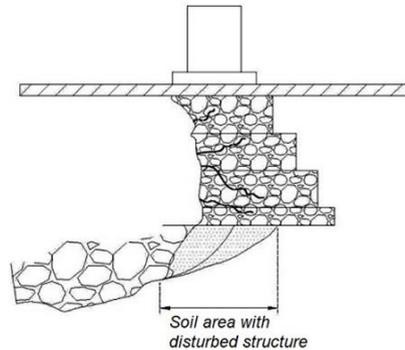
Fig. 5. Destruction of Foundations under columns within the explosion.
