Incidents of damage to berm drainage ditches in cold region and countermeasures

Atsuko Sato^{1,*}, Takahiro Yamanashi¹, and Takayuki Adachi²

¹Civil Engineering Research Institute for Cold region, Hiragishi 1-3, Toyohira-ku, Sapporo, Japan

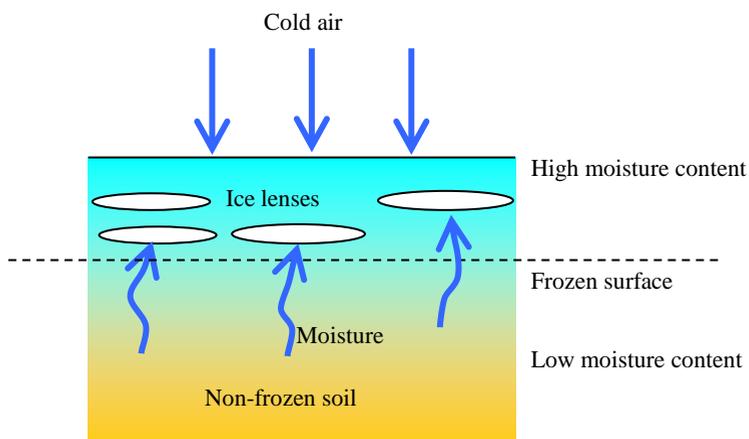
Fig. 1. Principle of frost heave.

When the temperature drops below the freezing point in winter, the ground freezes from the surface. At this time, if the ground is susceptible to freezing, ice lenses are formed near the freezing surface due to the moisture that moves up from the unfrozen part below the frozen surface, as shown in Figure-1 [3]. The thickness of each ice lens differs according to the temperature, soil properties of the unfrozen part, and the moisture amount, which leads to unevenness of the ground surface.

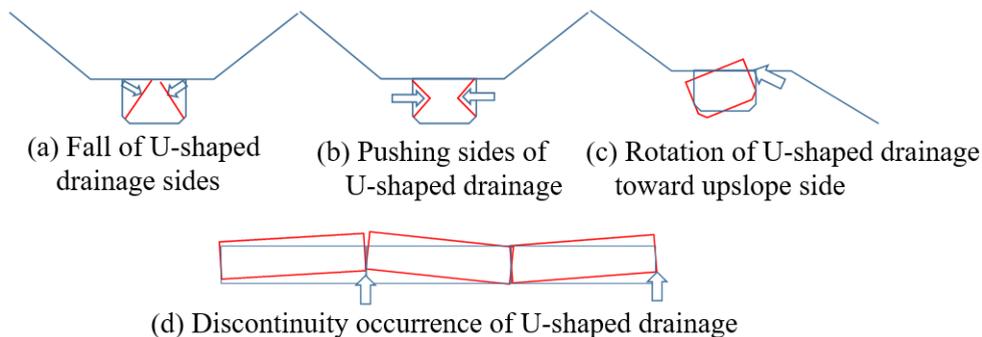
Fig. 2. Change of U-shaped drainage conditions due to frost heave.

This is caused by the cooling from the inside of the U-shaped drainage, which cools both the berm surface and the downslope side inclination surface. A diagram of the change is shown in Figure-2, and an actual example is shown in Fig. 3. Figure-2(a) is an example of a both-side inward fall caused by the breaking of the lower portion of the U-shaped drainage of which both sides of the upper ends are affected by equivalent frost heaving pressures from two sides of the inclined surface.

Figure-2(b) is an example of a similar phenomena to (a), but the side of the U-shaped drainage is pushed and destroyed. Figure-2(c) is an example of rotated U-shaped drainage. This phenomenon is caused by the difference in freezing thicknesses of the right and left sides of the U-shaped drainage because both sides of the berm and trough are cooled.

The rotation direction of this phenomenon may be affected by the difference in frost heaving pressure on both sides. Figure-2(d) is an example of discontinuation caused by joint destruction due to the different vertical frost heaving pressures acting on the U-shaped drainage bottom surface.

The previous study showed that the asymmetrical frost-heave pressure acts on the berm drainage because the frost heave amount differs according to the year and place, and between the upslope side and the downslope side of the berm, which suggests that the change of conditions shown in Figures-2 (c) and 2 (d) is caused.

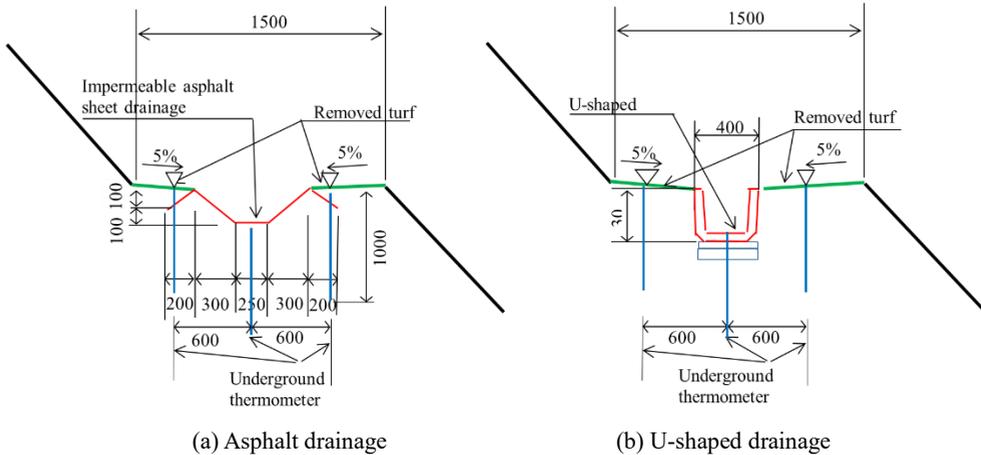
Fig. 4. Cross section of the test configuration and the position of the instrumentation.

Figure 4 shows cross section of the test configuration and the position of the instrumentation. The asphalt drainage and U-shaped drainage were constructed in the middle of the berm, the berm slope was 5%, and the surface water was processed. The Kunneppu, Hokuto, Hidaka, and Rumoi sites were protected by the removed turf.

To investigate the freezing situation of the asphalt drainage and U-shaped drainage, earth thermometers were installed in the center of each drainage ditch and 60 cm away from both the downslope side and upslope side of the berm, and the soil temperature was measured. Instruments to measure the frost heave amount were installed at the downslope side and upslope side 60 cm away from the center of each drainage, and the frost heave amount of the berm was measured periodically, about once per month. For the Hokuto, Hidaka, and Rumoi sites, only the condition change and durability due to the frost heave were confirmed for two years.

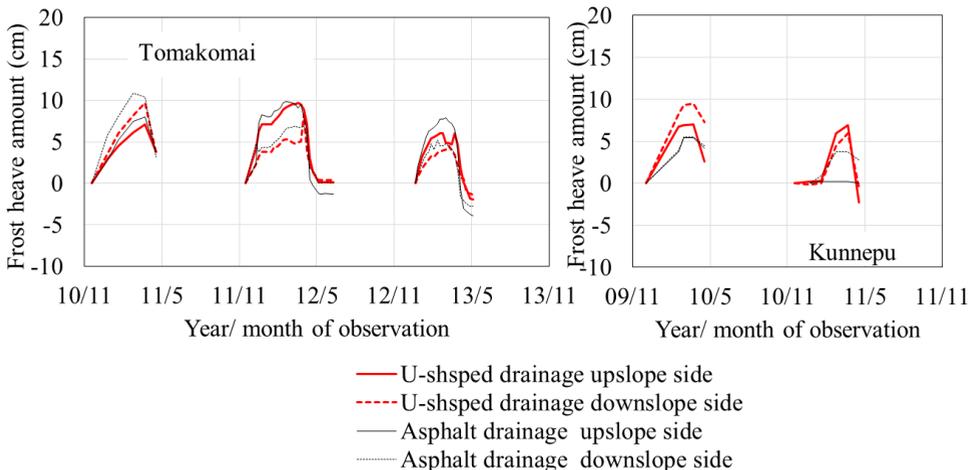
Fig. 5. Changes in frost heave amount.

The change of the frost heave amount around each drainage at the Tomakomai and Kunneppu sites is shown in Figure 5 as examples. The height of the ground around the drainage starts to rise in late November, reaching a maximum in late February to the beginning of March, and returns to or becomes lower than the original height early in May. Moreover, the change of conditions around the drainage due to frost heave was repeated for the observed period, which shows that the repeated frost-heave pressure was acting on the asphalt drainage and U-shaped drainage.

Three years of measurements showed that, even though the ground has generated frost heave, the asphalt drainage returned to the original shaped following the change of conditions at the time of melting, which proved that the asphalt drainage could flexibly respond to the change of conditions caused by frost heave.

Figure 5 of the Tomakomai case shows the frost heave amount from largest to smallest, falling in order of the asphalt drainage downslope side, U-shaped drainage downslope side, U-shaped drainage upslope side, and asphalt drainage upslope side for the first year. The maximum frost depth shown in Figure 6 is in the order of the U-shaped drainage downslope side, asphalt drainage downslope side, U-shaped drainage upslope side, and asphalt drainage upslope side, which is the little different from the frost heave amount. same order as that of the frost heave amount. In the second and subsequent years of the Tomakomai site, the frost heave amount around the upslope side of the drainage was larger than that around the downslope side of both the asphalt drainage and U-shaped drainage.

Figure 5 of the Kunneppu case shows the frost heave amount from largest to smallest, in the order of the U-shaped drainage downslope side, U-shaped drainage upslope side, asphalt drainage downslope side, and asphalt drainage upslope side for the first year. The maximum frost depth shown in Figure 6 is in the order of the U-shaped drainage downslope side, asphalt drainage downslope side, asphalt drainage upslope side, and U-shaped drainage upslope side. The drainage ditch around the U-shaped drainage downslope side, of which the frost depth was the deepest, showed the largest frost heave amount.

For the second year of the Kunneppu site of Figure 5, frost heave was hardly generated on the asphalt drainage downslope side, and the frost heave amount of the U-shaped drainage was larger than that of the asphalt drainage. The reasons are considered to be that the drying of the downslope side was reduced because it is covered with the removed turf on the Kunneppu site and that the properties of the soil make it comparatively easy to maintain water content. Therefore, the frost heave amount of the ground around the U-shaped drainage, of which frost depth is the deepest, became larger than that of the ground around the asphalt drainage. These results show that under these conditions and soil properties that make it easy to maintain water content, the asphalt drainage can reduce the change of conditions caused by frost heave.

Therefore, it is considered that the difference in the frost-heave pressure acting on a drainage ditch becomes small and reduces the change in conditions of the drainage ditch. Figure 5 shows that the change of the frost heave amount indicates that asphalt drainage can reduce the change in conditions due to frost heave in a deep frost area, which is a low-temperature area, because the change of the asphalt drainage is smaller than that of the U-shaped drainage.

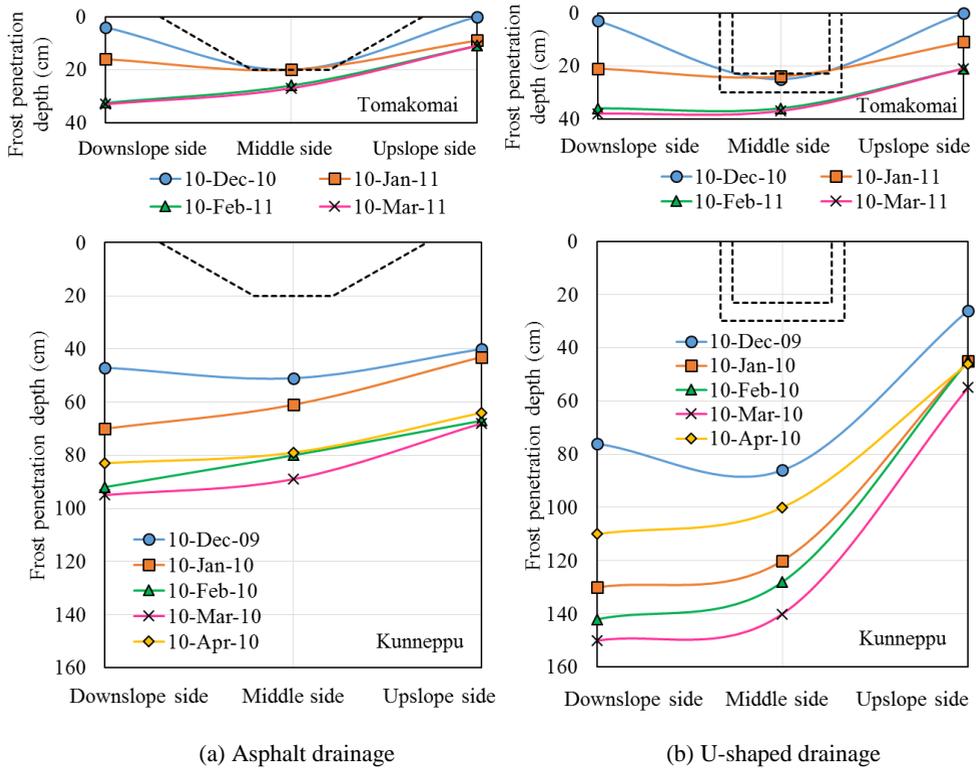
Fig. 6. Change of freezing surface.

Figure 6 shows changes of the freezing surfaces around asphalt drainage and U-shaped drainage one year after construction, using the examples of Tomakomai measured in FY2010 and Kunneppu measured in FY2009. The freezing surface was defined as the region where the temperature was negative according to the thermometer data of the bank. The depth of freezing surfaces of both upslope side and downslope sides of asphalt drainage and U-shaped drainage became deeper with time. The freezing speed and the frost depth of the downslope side was faster and deeper, respectively, than those of the upslope side. This was considered to be because the downslope side was affected by the cold air from the slope surface other than that of the ground surface. Moreover, the frost depth of U-shaped drainage is deeper than that of asphalt drainage, because the cold air entered from inside the U-shaped drainage. For both sites of the Tomakomai and Kunneppu, the frost depth just under the asphalt drainage was shallower than that under the U-shaped drainage. The actually measured thermal conductivity of an impermeable asphalt sheet was 0.223 Wm/K, which is considerably lower than that of concrete, 1.6 Wm/K. The reason why the frost depth under the asphalt drainage was shallower is that the effect of the thermal insulation of the impermeable asphalt sheet is large enough to be able to neglect the construction thickness. The measured results suggest the possibility of further reducing the frost depth around the ground where asphalt drainage is constructed than that where U-shaped drainage is constructed due to the construction configuration and lower thermal conductivity.

The change of the freezing surface in Figure 6 shows that, for the Kunneppu site, where the frost is deep, the difference in frost depth between the upslope side and downslope sides of the asphalt drainage is smaller than that of the U-shaped drainage.

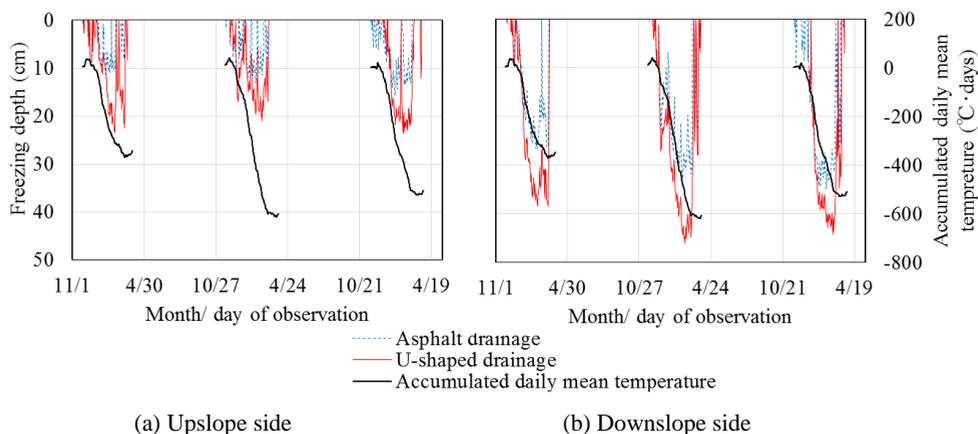
Fig. 7. Date of measurement and the frost depth.

Figure 7 shows the frost depth of each place as an example of the measurement date together with the accumulated daily mean temperature at the Tomakomai site. The frost became deeper gradually when the accumulated daily mean temperature became the highest (when the average temperature became negative), and the freezing disappeared rapidly when the accumulated daily mean temperature became the lowest. The change of the frost depth showed the same trend at all measured places. The frost of the downslope side was deeper than that of the upslope side, and the frost of the U-shaped drainage was the deepest, about 14 cm deeper than that of the asphalt.

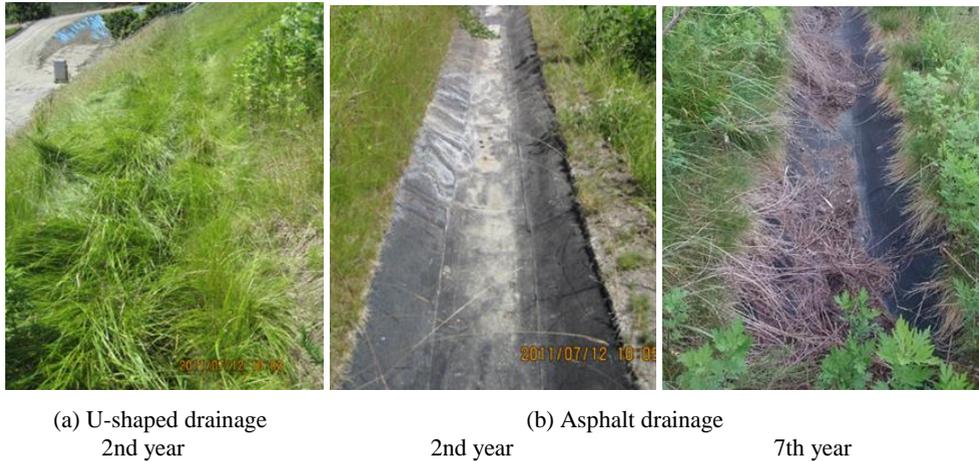
Fig. 8. Time and conditions of asphalt drainage.

The anti-weed effect of asphalt drainage was confirmed. Fig. 8 (b) shows the situation two years after construction. The U-shaped drainage was covered with plants for protection of the entire berm, two years after the construction, but the asphalt drainage did not show the growth of plants in the drainage ditches. The embedment part of both sheet ends is considered to disturb the growth of plant roots. Moreover, as shown in Fig. 8 (b), on June 23 seven years since the construction, which was in the season of flourishing plant growth, although dead plants appeared in the drainage ditches, plant growth was not recognized in the asphalt drainage. Work to check the maintenance and management of the berm is performed on foot, and the ground is difficult to see when plants are growing around U-shaped drainage, which makes the work very dangerous. From that viewpoint, asphalt drainage is a safer structure,

as it inhibits plant growth. Moreover, it was visually confirmed that the conditions of the asphalt drainage have not changed, even though seven years have passed since the construction.
