The influence of disastrous floods on riverbeds processes in the Far East of Russia

Abstract. The article is focused on great influence of disastrous floods on riverbeds processes and repartition of water flow between distributaries in the Amur basin rivers. In the result of morphological analysis of the Far eastern riverbeds and their dynamics the places with the most intensive riverbed reformations were revealed. The intensiveness of erosive-accumulative processes caused by the Amur flood in 2013 was estimated. Some upper reaches of secondary branches and estuaries of large tributaries were recognized as zones of increased accumulative alluviums in the Amur riverbed.

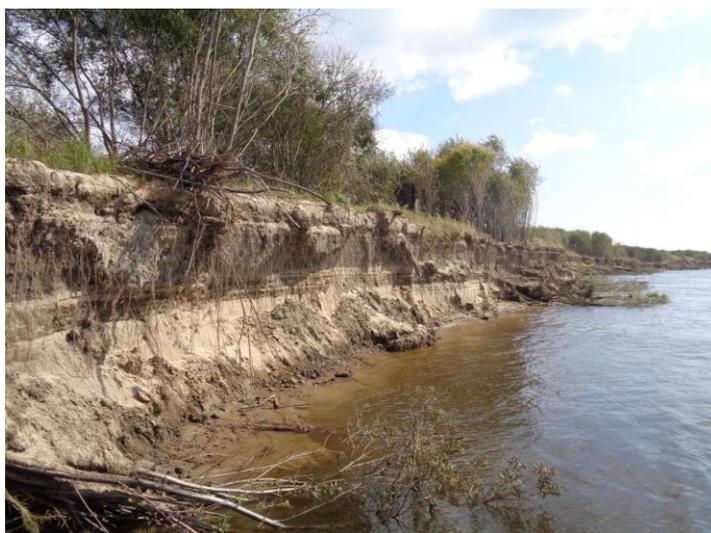
The disastrous flood of 2013 in the Amur river made a significant erosion-accumulative activity in the river bed. Especially intensive banks erosion occurred in the Amur distributaries which had increased their water content resulting the redistribution of flow. Steep erosion ledges, formed as a result of erosion, stretched in the head of flat bends of the main riverbed for several kilometers (Fig. 2).

Fig. 2. Intensive erosion of the Amur bank following the flood of 2013.

The observations, conducted in 2014 after the flood, revealed the accelerated bank erosion in the areas where it had occurred before. The activation of erosion is often caused by displacement of the rifts in the Amur or formation of accumulative forms in the main and secondary distributaries of the river.
