Analysis of Weld Cold Cracking In Excavator Bucket Adapter

Abstract. This paper presents a failure analysis on welding of bucket adapter for an excavator that made of low carbon steel with Ideal Diameter (DI) value 341 and Carbon Equivalent 0.73. The bucket component is stated OK as the final inspection, but four months later found cracked and even it has not been used yet. Adapter mounted to bucket through CO₂ gas shielded Gas Metal Arc Welding (GMAW) process, filler metal MG-50 (AWS A5.18 ER70S-G), pre-heating and post-heating. Crack occurred on the boundary of weld metal and adapter casting. The metallurgical examination was conducted in the crack origin and the adapter casting. Nondestructive test (NDT) covered visual and magnetic test (MT), while destructive test (DT) covered fractography, mechanical properties, and Electron Probe Micro Analyzer (EPMA). The investigation resulted in that crack initiated from slag inclusion in the weld metal due to insufficient cleaning on weld joint. The higher hardness of martensite structure in the heat affected zone (HAZ) of adapter indicates high cooling rate that generates high residual stress. High stress that caused by insufficient pos

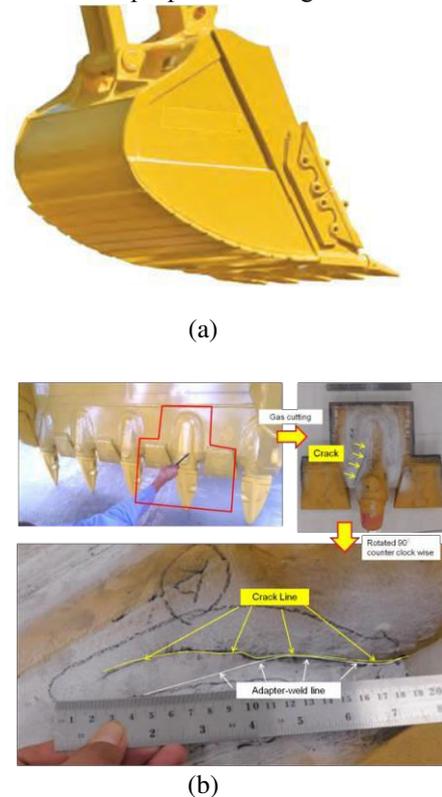
Some buckets showed Fig. 1a), that already installed on the excavator, found a crack on its adapter casting as seen in Fig. 1b). Interval time between fabrication process (welding) and crack finding reported four months. Due to crack characteristic visually similar, one of the buckets

Fig. 1. (a) Attachment bucket in an excavator, failed (fracture) location (b, top) and its magnification adapter casting (b, bottom)

Magnetic test (MT) using white contrast paint conduct again for verifying report from the field. Length of crack measured about 165mm, with 80mm, is the boundary of weld metal-adapter casting and the rest in the adapter. VT on the crack line is not enough to determine the crack initiation site.

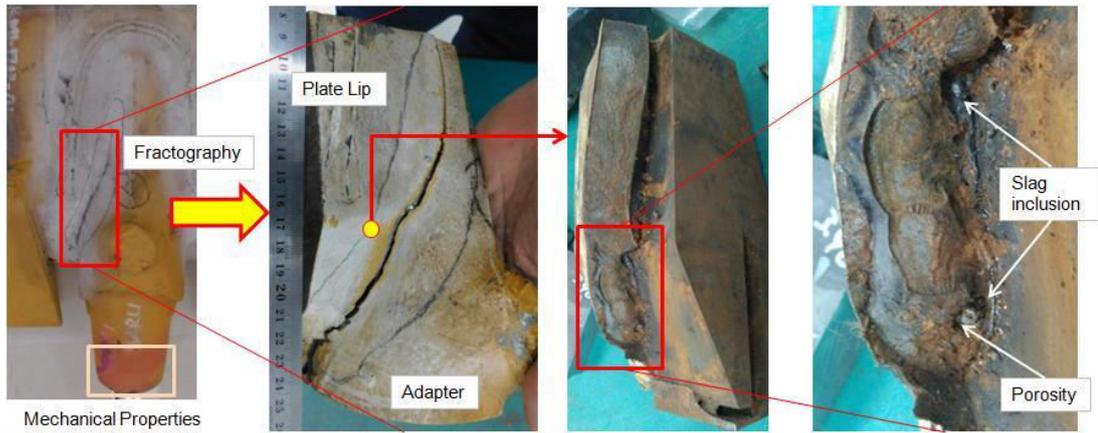
Visual examination on opened fracture surface (Fig. 2) show that there is a welding defect, i.e., gas porosity and weld slag/ inclusion, spotted on the first layer of welding. This inclusion can be caused by unclean of welding bead by the position in the root of weld metal. The presence of non-metallic inclusion and high concentration of Phosphor and Sulphur can cause hot cracking, instead of cold cracking [1]. The chemical composition of adapter and weld metal resulted in low Phosphor and Sulphur (below 0.025wt.%) and ultrasonic testing (UT) result after 24 hours was good. So, possibilities of hot cracking can be eliminated. In another hand, cold cracking generally occurs at temperatures below $205^{\circ}C$, but in some cases, these are initiated at a higher temperature and then grow-

Fig. 2. Opened fracture by Electric Discharge Machine (EDM, wire cut) and fracture surface before cleaning

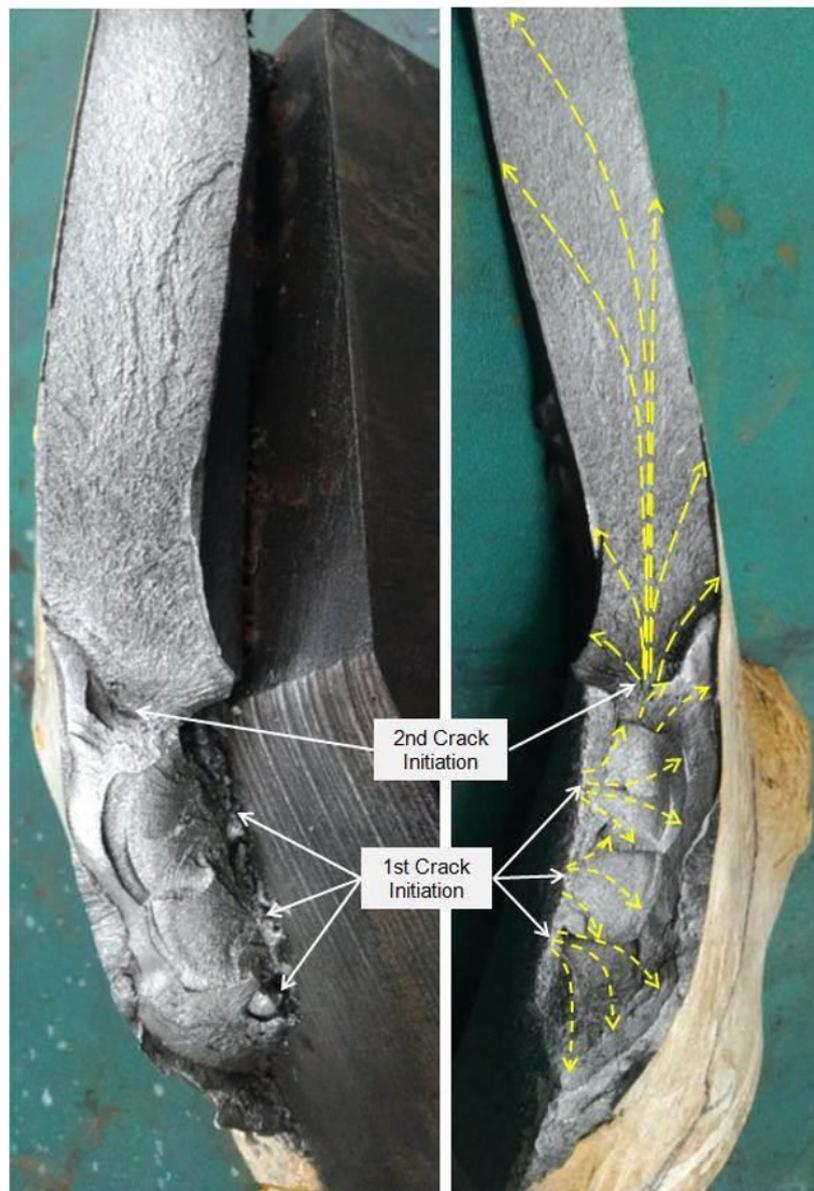
Fig. 3. Fracture surface pattern after cleaning

Fractography observation on the opened crack (Fig. 3) show that crack initiated first from weld area in the inclined side of the adapter. Then crack propagated to the surface and adapter casting area. Crack propagation mark by the yellow line in Figure 4.

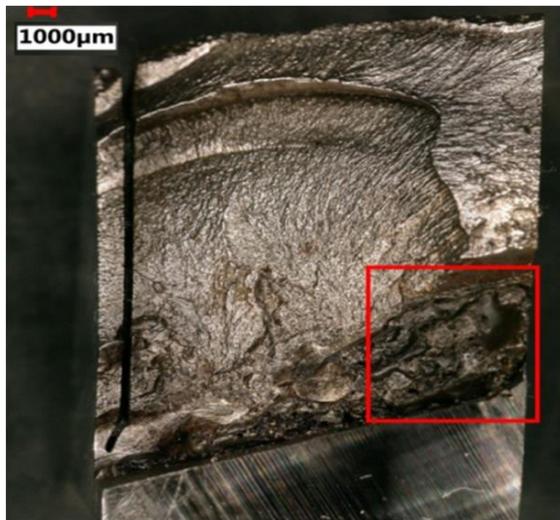
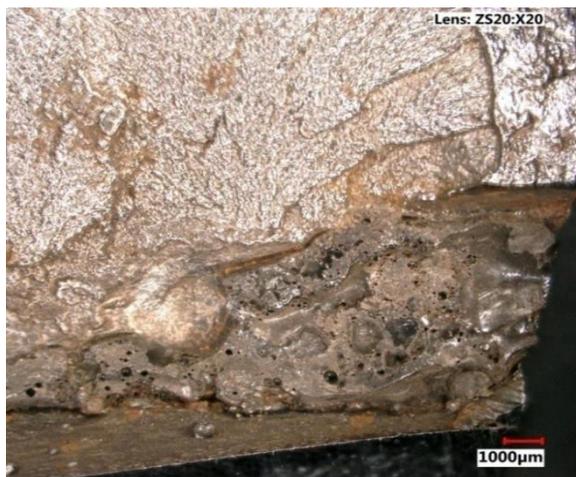
Fig. 4. (a) Piece of initiation area taken from fig. 3 left. (b) Magnification red square of slag inclusion in fig. 4a.

Fracture mode identified as rapid or brittle fracture characterized by chevron pattern [13]. Since the bucket was not yet used, the stress comes

from residual stress generated in the previous process, i.e., the welding process. Brittle fracture indicates that the component undergone overload even not yet applied to the external load. Three factors combine to produce cold crack: stress, hydrogen, and susceptible microstructure. High stresses may be generated by thermal expansion and contraction, or due to austenite-to-martensite transformation. Martensite structure is more vulnerable than ferritic and bainitic structure.

Weld defect in the initiation point, i.e., porosity and slag inclusion, found in the initiation area (fig. 5a) that is the boundary of filler metal, adapter casting, and plate lip (Fig. 4a & 4b). Porosity may come from insufficient shield gas, inadequate preparation of weld joint, or porosity on adapter bead. Joining adapter to the bucket using CO₂ Welding (GMAW) which the generation of slag should be avoidable.

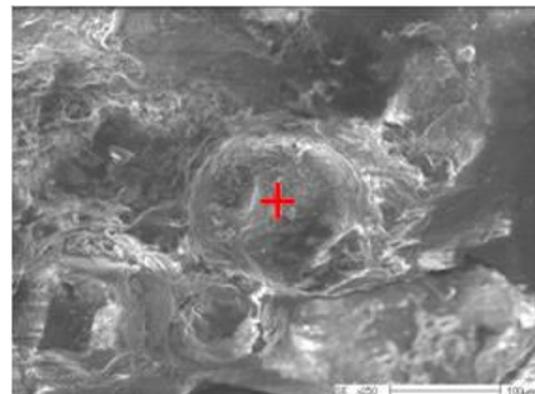
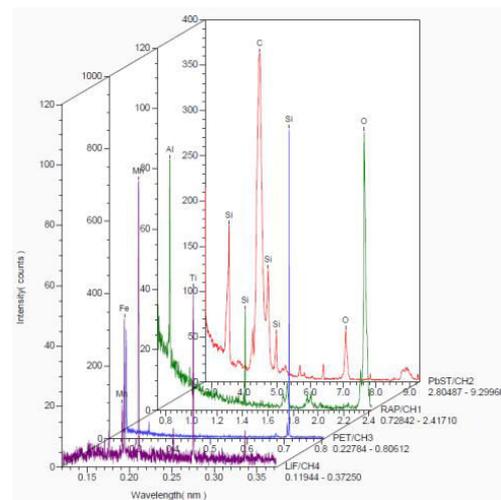
Fig. 5. Slag inclusion in fig. 4b and its EPMA WDS spectrum

Slag inclusions consist of nonmetallic materials trapped in the weld as a product of the slag reaction. Entrapment is the condition when slag mixing the weld pool or when surface slag is not removed completely and then buried by next weld passes. Slag may occur from an un-removed massive scale before welding. Slag inclusion can be located in the sub surface, inside of weld bead, or in the welding root like this case. Joining adapter use multiple-pass weld that is more prone to slag inclusion than single-pass weld joints due to slag may be entrapped in the weld between passed. Another common cause of entrapment is the incomplete removal of the slag from the previous pass. The higher rate of solidification/ cooling, lower temperature of weld pool, and undesired bead and joint shape are known as general factors triggering slag entrapment [12]. Image observation (Fig 5 & 6) and qualitative analysis (Table 1 & 2) of slag inclusion in Fig 4b and its cross-section conducted by EPMA. Dominant element contained in slag inclusion is Carbon (C), Oxygen (O), and Silicon (Si). Slag inclusion not only found in the initiation area but also in the filler metal with the similar dominant element.

No.	Element	Line	Crystal	Peak WL (nm)	K-ratio	Mass%
1	C	Ka	PbST/CH2	4.47249	0.14961	22.38
2	O	Ka	RAP/CH1	2.35952	0.53793	57.95
3	Al	Ka	RAP/CH1	0.83008	0.00410	0.28
4	Si	Ka	PET/CH3	0.71275	0.22874	14.14
5	Ti	Ka	LiF/CH4	0.27492	0.02572	1.64
6	Mn	Ka	LiF/CH4	0.21050	0.03587	2.41
7	Fe	Ka	LiF/CH4	0.19369	0.01803	1.20

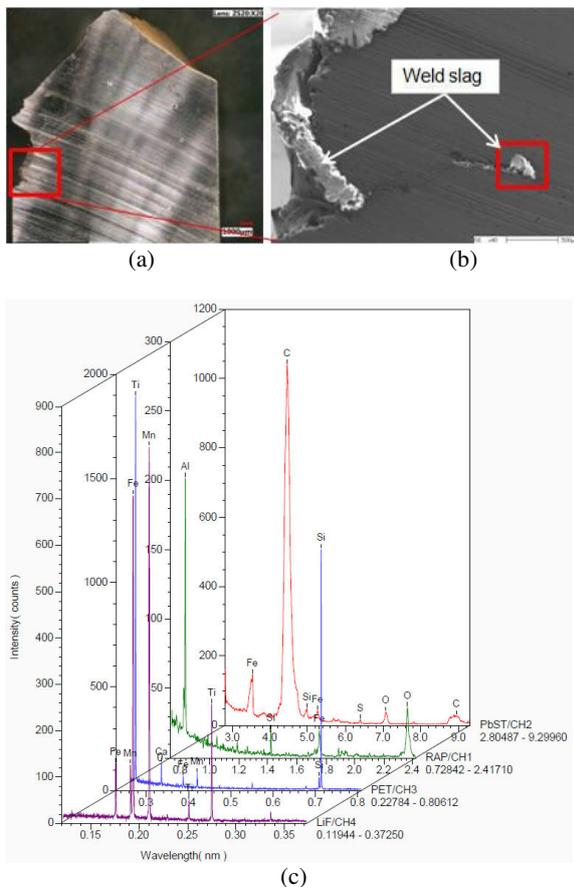
Fig. 6. (a) Cross section of initiation (b) Slag inclusion trapped in the weld metal. (c) EPMA WDS spectrum of slag inclusion

No.	Element	Line	Crystal	Peak WL (nm)	K-ratio	Mass%
1	C	Ka	PbST/CH2	4.46066	0.28238	41.34
2	O	Ka	RAP/CH1	2.36302	0.10429	16.67
3	Al	Ka	RAP/CH1	0.83162	0.00652	0.49
4	Si	Ka	PET/CH3	0.71288	0.18167	12.20
5	Ca	Ka	PET/CH3	0.33589	0.00449	0.27
6	Ti	Ka	PET/CH3	0.27472	0.06941	4.50
7	Mn	Ka	LiF/CH4	0.21038	0.18699	13.15
8	Fe	Ka	LiF/CH4	0.19386	0.16424	11.39

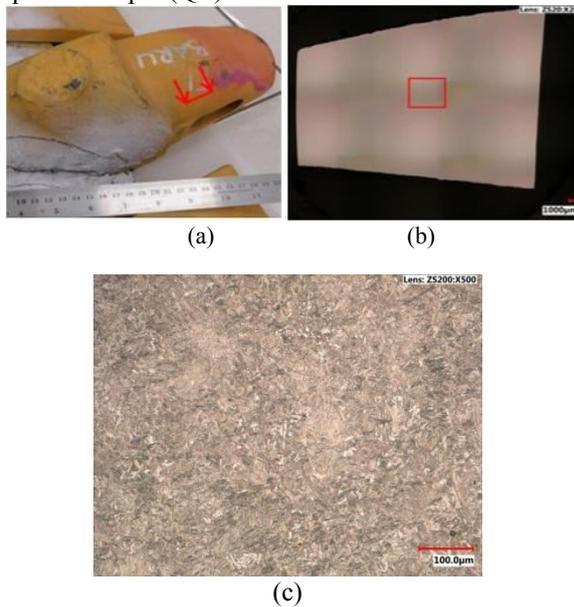
quenched steel must be tempered in the range 480-600°C or higher to obtain softer structure, i.e. tempered martensitic/ bainitic structure [16]. Martensite structure observed in the adapter casting (Fig. 7c), show that adapter had been treated by quench temper (QT).

Fig. 7. (a) (b) Location for taking a microstructure specimen and (c) microstructure of adapter casting

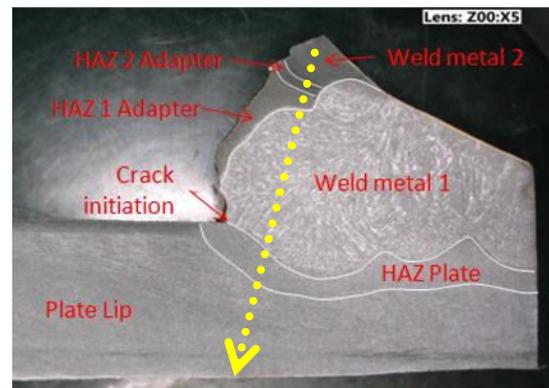
Hardness measurement through a cross-section of initiation area (Fig. 8) show fluctuation value with the abnormality occurred on the HAZ 2 adapter,

Fig. 8. Nital 30% macro etching on the cross section of initiation

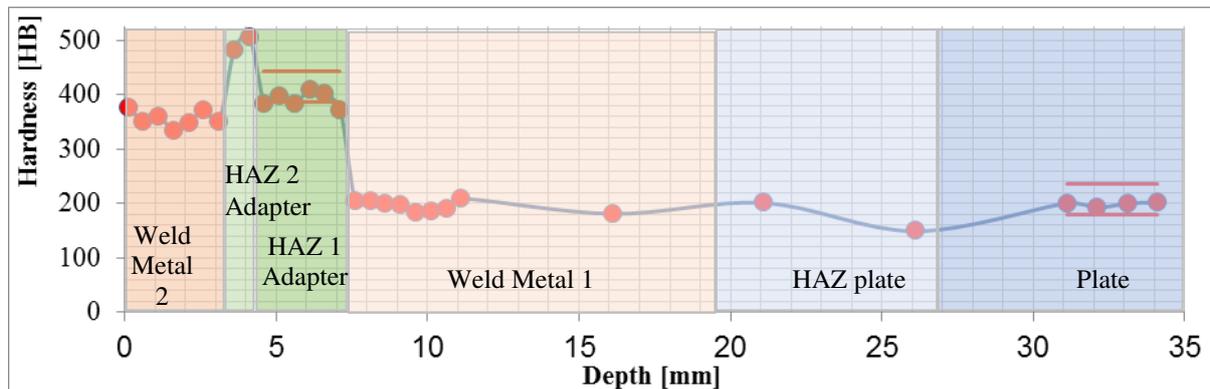
which is much higher than HAZ 1 adapter (Fig. 9). The lower hardness of HAZ 1 adapter due to post heat effect of multilayer welding. However, HAZ 2 adapter whose position above HAZ 1 did not get sufficient post heating that makes cooling rate at this section is higher. As the effect, hardness becomes higher and residual stress due to phase transformation and weld shrink also higher.

Fig. 9. Hardness value for location in fig. 8

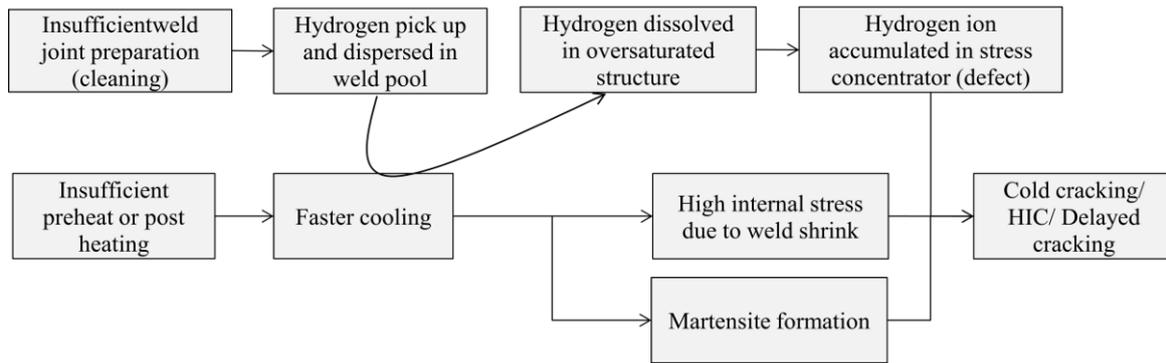
Fig 10. Estimation of failure mechanism

The failure of excavator bucket adapter is caused by cold cracking or delayed cracking. Crack initiated from slag inclusion in the root of weld metal caused by insufficient weld joint preparation and cleaning of the previous pass. The higher hardness of martensite structure in the heat affected zone (HAZ) of the adapter was due to a high cooling rate. High stress caused by insufficient post heating and inconsistency of controlling cooling rate triggered severe crack propagation.
