Prediction of shoreline change using a numerical model: case of the Kulon Progo Coast, Central Java

Abstract. Kulon Progo Airport is an airport development project located in the coastal area near Yogyakarta, Indonesia, which is expected to complete in 2019. With the increase in population, huge land acquisition will be difficult, so the development of coastal areas for the airport became inevitable. Kulon Progo is located in the disaster-prone zone area of the earthquake and tsunami, the airport design must consider the risk management and mitigation from tsunami and earthquake disaster. Although the airport is already calculated the danger of earthquake and tsunami, the development of the coastal area also needs to consider the danger of the natural coastal process itself such as sedimentation and erosion. Shoreline changes due to the new infrastructure in the coastal area can disrupt the equilibrium of coastal process especially the longshore sediment transport. A satellite image shows that Kulon Progo shoreline retreats over 60 meters due to the heavy sediment longshore transport in the past 10 years. Breakwaters in Tanjung Adikarto fishing port also made a great contribution

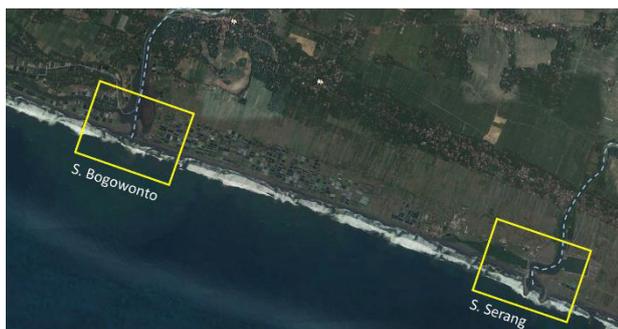
Fig. 2. River mouth location of Bogowonto and Serang Rivers

Serang river is seen to have built estuary protection by using a jetty on both sides of the river mouth. The effectiveness of the jetty viewed by satellite monitoring is not significant because in 2013, the sediment was still covering the estuary and caused the new river mouth formation. In the planning of coastal protection buildings, it is required a thorough analysis of the patterns of sediment movement, currents and waves. This analysis will be assisted by using numerical models to determine sediment movement patterns, so it can provide good recommendations to solving coastal problems in the coastal area of Kulon Progo.

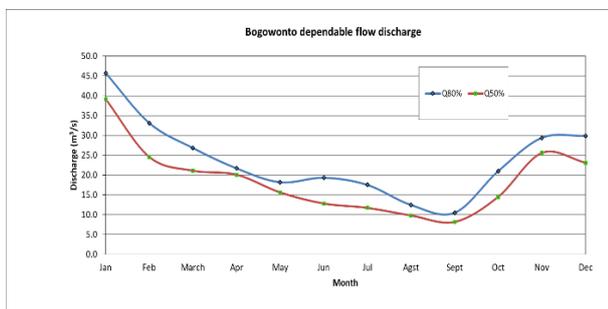
Fig. 3. Dependable flow Bogowonto river

Bogowonto River with the catchment of 291 km² has an average discharge of 20 m³ / s and for Serang River with the catchment of 195 km² has an average discharge of 9 m³ / s. The dependable flow of 50% and 80% can be seen on the figure 3 and 4. Dependable flow will be analyzed using F.J Mock method. F.J. Mock (1973) [12] proposed a monthly water balance simulation model for the drainage region in Indonesia, known as the Mock flow simulation. This model is specifically used for rivers in Indonesia [13]. The Mock method refers to the water balance in which the total water volume in the earth is fixed, only its circulation and distribution varies. Mock takes into account the volume of incoming (rain), out and stored water in the soil (infiltration, percolation and evapotranspiration) [14].

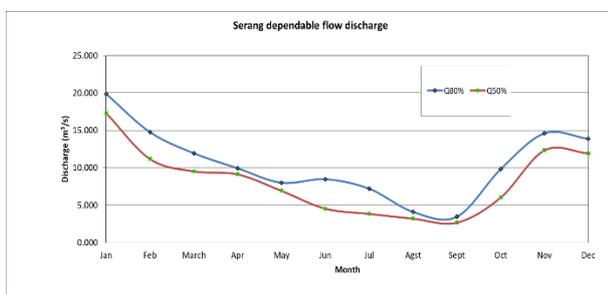
Fig. 4. Dependable flow Serang river

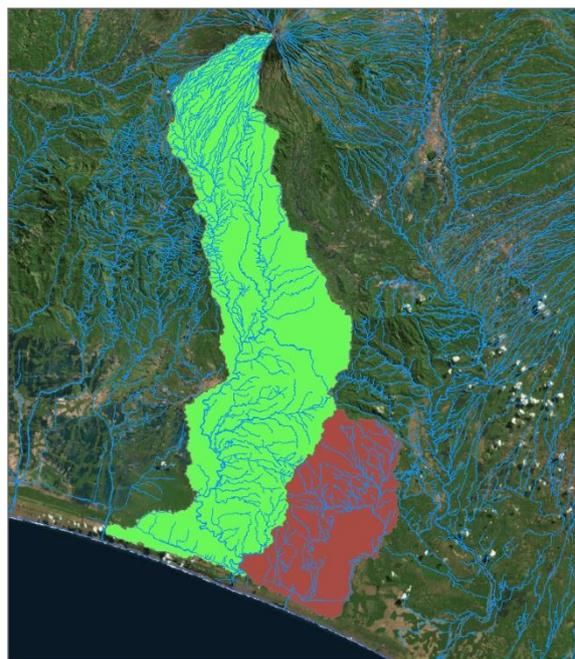
Fig. 5. Watershed of Bogowonto and Serang river

There are two major rivers at our study area, Bogowonto River on the east side of the coast and Serang River on the west side of the coast. The watersheds for both rivers can be seen in the figure 5. The Bogowonto River is seen to have a larger catchment area than Serang River catchment up to three times. Significant shoreline changes can be seen in the estuary of these two rivers. Where from year to year, river mouth morphology changes due to the high sediment transport and high wave propagation from the sea caused river mouth closure.

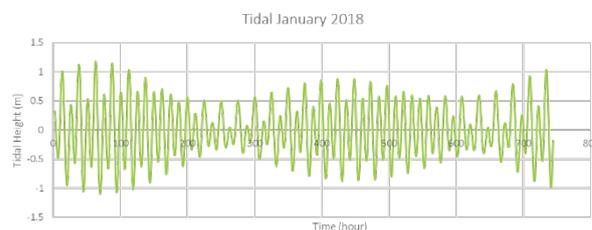
Fig. 6. Tides condition in study area

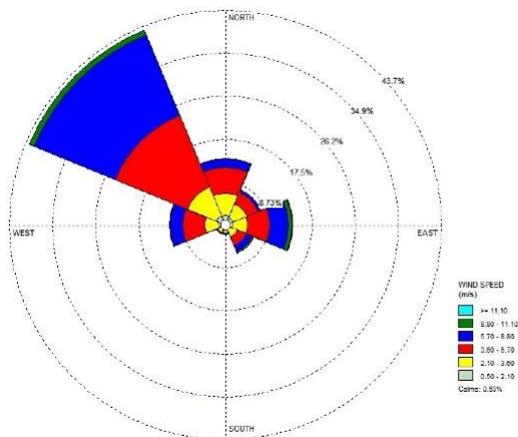
Wind data obtain for 12 years from 1 January 2006 until 31 December 2017. Data obtain from global data NOAA (National Oceanic and Atmospheric Administration) and predicted for 6 hours a day. From the wind rose generated from 12 years of data, dominant wind occurred from North-West with wind speed 5.7 – 8.8 m/s.

Fig. 7. Wind rose at Kulon Progo coast

From the dominant wind direction, we can see that the sediment transport tends to flow form east to the west, because wind from the east stronger ang more dominant than the wing from west. This assumption will be proven from satellite analysis at the estuary of Serang and Bogowonto River at figure 11 and 12.

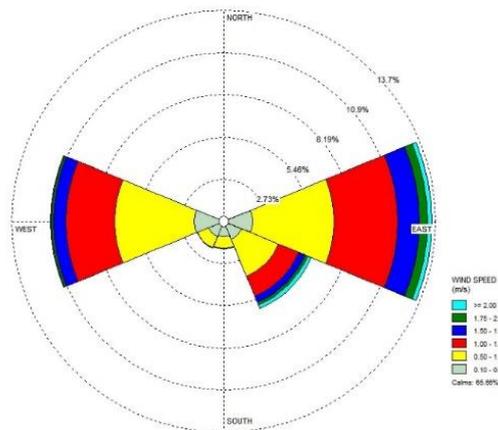
Wave direction and magnitude were obtained using wave hindcasting from wind data based on SPM (Shore Protection Manual, 1984). Wave hindcasting was carried out based on wind data and the effective fetch. The results are given in wave rose as follow in figure 8. The dominant wave direction is from the East and West. Significant wave height and period in Kulon Progo coast is 1.7 m with 5.7 second period.

Fig. 8. Wave rose from NOAA data at Kulon Progo coast

Wave generated from NOAA data produce a dominant wave from east and west direction. However, wave rose resulting from JICA analysis in 1989 dominant wave direction is coming from South. There is a significant difference dominant wave direction from both of wave rose. These significant differences may caused by the wave generation carried out on the deep sea.

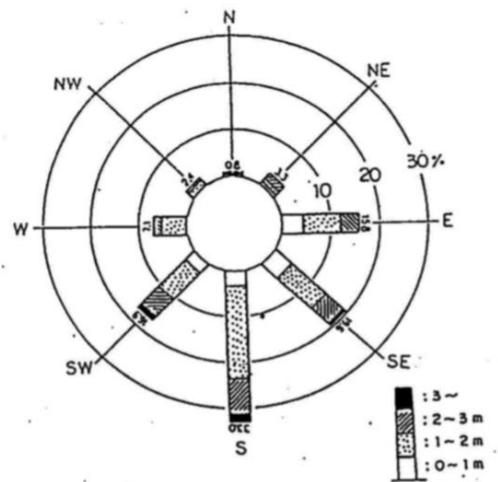
Fig. 9. Wave rose for Indian ocean, South of Bali (JICA, 1989)

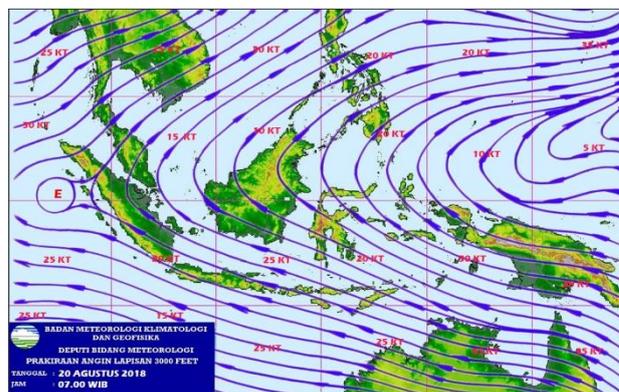
Fig. 10. Wind direction from BMKG

Wind prediction from BMKG also show that wind in the southern of Java flow from east to the west. Global data both the NOAA and BMKG shows similar pattern of dominant wind due to west monsoon and east monsoon and shows significant difference with the analysis from JICA. This is due to global data sense the direction of wind from the deep sea.

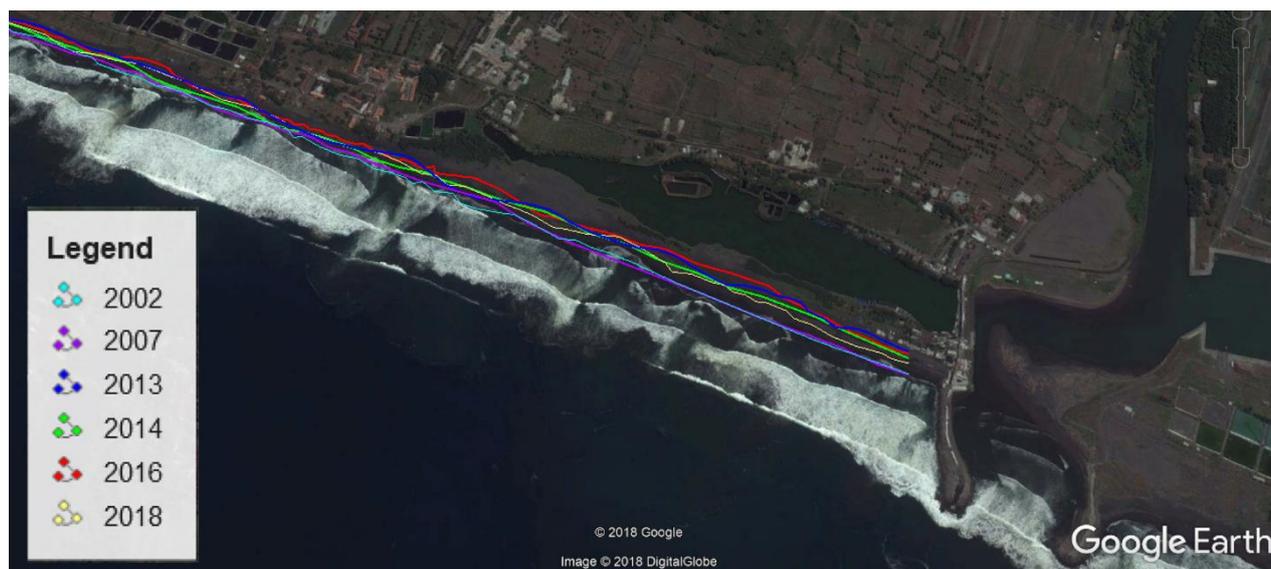
Fig. 10. Shoreline changes from satellite (Google earth)

These findings also beneficial on determining the mitigation strategy for disaster hazard especially to the new development of coastal infrastructure. From satellite images, we monitored the development of Kulon Progo coastline during 16 years (2002-2018). In this period, the coastline shifting up to 60 m. Satellite analysis is corresponding with the previous study where they conduct a survey by interviewing local people and gave a testimony where the previous Bugel beach has a length of 100 meters and now only 40 meters due to the abrasion [18].

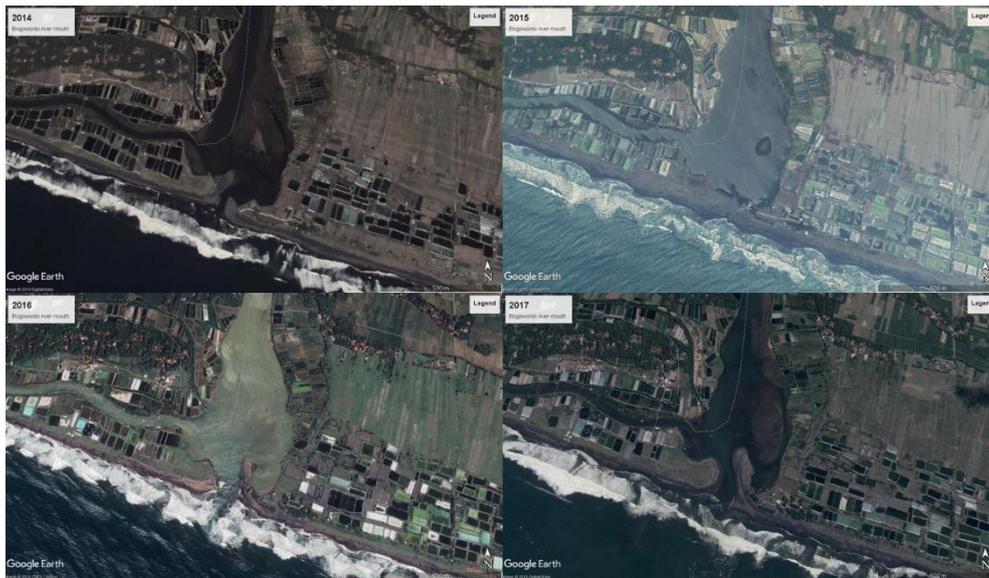
Fig. 11. Satellite photo of Bogowonto river mouth morphological changes (Google Earth)

The greatest impact of sedimentation and abrasion in this coastline can be seen in estuary of Bogowonto and Serang river. Detailed time-series satellite photo of each river can be seen in figure 11 and 12. we can observe that the morphology of the mouth of the estuary always changes significantly, the sedimentation transport tends to flow from the east and begins to cover the mouth of the estuary. Due to the large waves from the deep sea, the sand spits that cover the estuary will be pushed into the estuary and the sediment will form the island or a pile of sediment inside the estuary. Previous study conducted on Kuwaru coastline, Bantul Region, Province of Yogyakarta, analyze coastline change under wave attack. The study concluded that the erosion in Kuwaru beach happen due to the variation of wave steepness and lack of sediment supply from the river during dry season. The Kuwaru coastline shifted around 50 meters during 10 years (2008-2017). To reduce the risk of coastal disaster, especially against wave attack and erosion, the minimum width of Kuwaru setback zone should be 120 m [19].

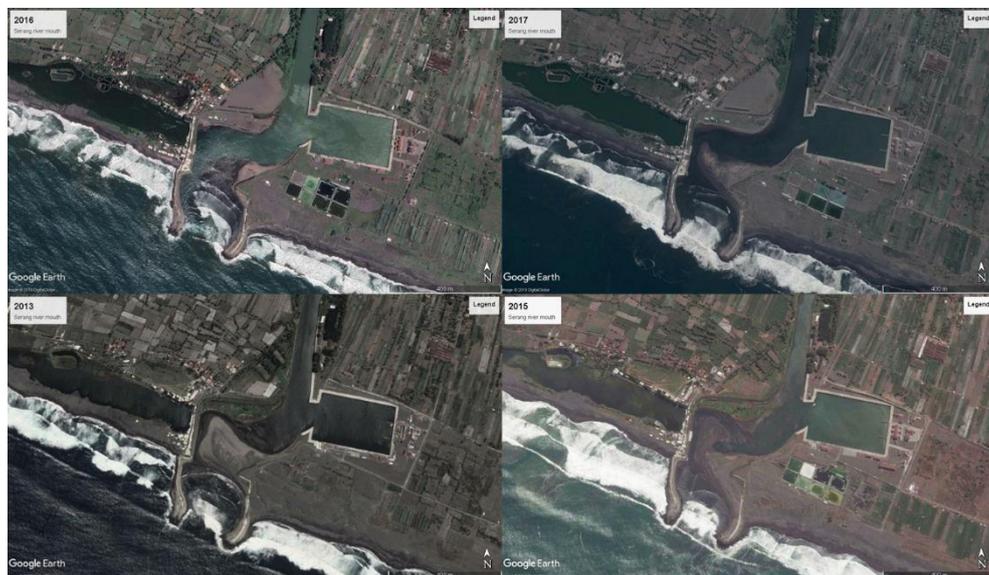
Fig. 12. Satellite photo of Serang river mouth morphological changes (Google Earth)

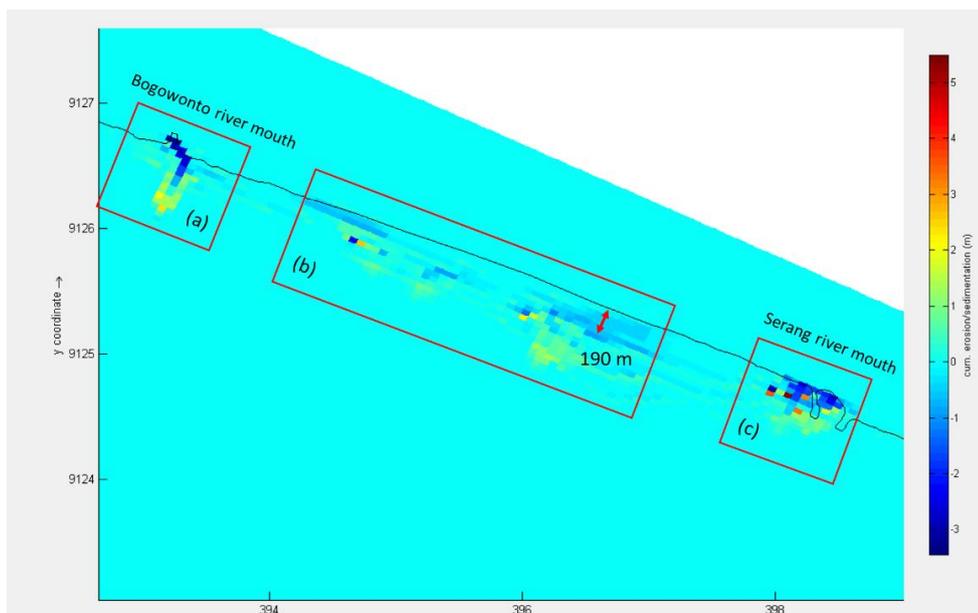
Fig. 13. Numerical model of Kulon Progo shoreline changes

Figure 13 (a) and (b) shows a high sedimentation rate at the river mouth of both rivers. High sedimentation rate can cause the possibility of silting in estuary. The silting can inhibit river flow to the sea, if the sedimentation keeps increasing in can leads to closure of estuary. The river flow will divert to a new river moth and change the river morphology just like Bogowonto rivers from satellite analysis at figure 11. The silting in estuary already happened frequently in Bogowonto rivers as we can see in figure 14, especially in dry season. High sedimentation rate and minimum flow rates from rivers resulting in sediment cannot be transported along the coast and deposit around the river mouth. The sediment transport process in general cannot be described well on this numerical model. Thus, a field data survey is needed so that the model can represent the field conditions well and have a better and more reliable model result.

simulation modeled for ten years, to know the sediment transport pattern in Kulon Progo coast. This simulation used secondary data for boundary condition, and bathymetry. The simulation will used flow simulation model by analyzing the process of tidal, discharges and wave interactions. Boundary condition in this research already describe at section two, with tidal and significant wave for open boundary and average flow for river discharge. The numerical model shows that the erosion and sedimentation occurred along the Kulon Progo coast due to the strong current especially between the two main rivers. We can observe in figure 13 (b), erosion occurred up to 2 meters along the coast and change the shoreline to set back up to 190 meters. This value is much higher compare to the previous analysis and satellite analysis with 60 meters shoreline set back. The sedimentation pattern from numerical model is in accordance with the satellite analysis. Heavy erosion in coastal zone without treated properly will become a serious damage to the infrastructure around coastal area. The infrastructure

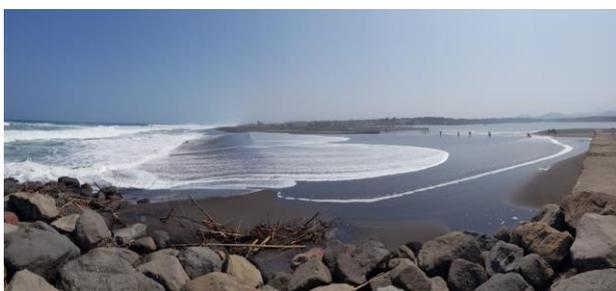
Fig. 14. Silting in Bogowonto rivers in dry season
