# Revitalization of historic railway bridges on the example of a structure in Łęknica (Poland)

**Abstract.** In the article, an attempt is made to describe the scale of the problem of the revitalization of railway bridges found on lines no longer in use. The issue of changes in use of historic railway bridges is considered on the example of a bridge in Łęknica built in the years 1897-1898. The described bridge is untypical due to the inverted parabolic truss girders and the placement of 9 spans in a horizontal arch of a small radius. The structural solutions of the railway structure as well as the scope of construction works carried out in an effort to adapt it for pedestrian and cyclist traffic have been presented.

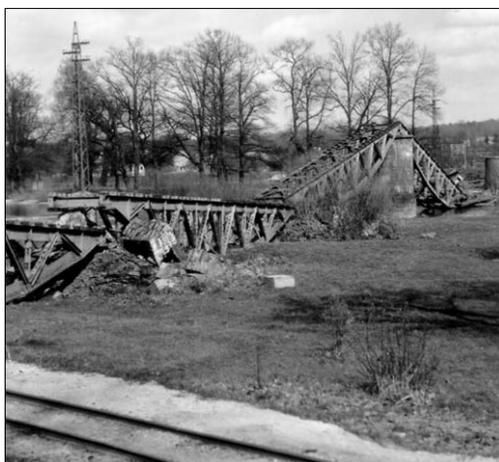
**Fig. 1.** View of destroyed bridge spans in 1945 [6].

The bridge over the Łysa Łużycka River, on a section of railway line No. 365 (Stary Raduszec – Bad Muskau) was built in the years 1897-1898 and used until the end of World War II. During the war, in February 1945, it was blown up by the German Army. The pillars and part of the steel spans of the bridge were destroyed, as seen in Figure 1. Upon drawing the Polish-German border along the Nysa River, it became a border bridge – with Poland responsible for the maintenance of its technical state according to an international agreement. In the years 1954-1955, the structure was rebuilt, though for the next half a century, the decision to open an international train connection was not made. It became a strategic bridge in military terms, as a result of which it was covered by ongoing technical supervision. In the 70s of the past century, its function was already purely fictitious, as the railway line on the German side had been closed down.

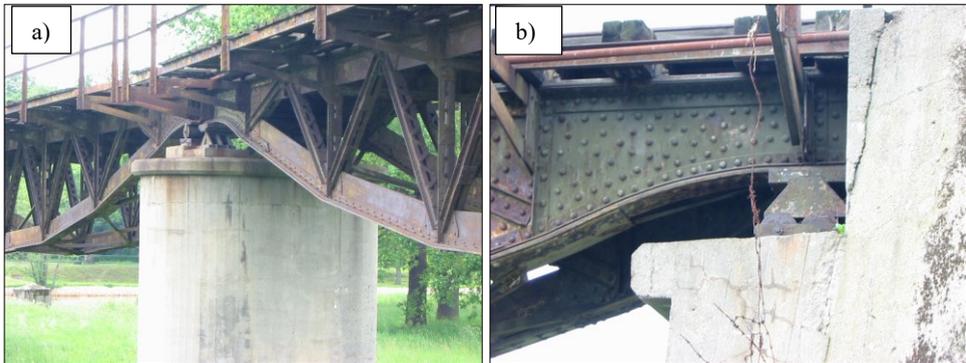
The technical state of the bridge prior to reconstruction can be assessed as adequate. All rivets in the connections of the truss girders as well as structural elements were complete. The steel spans were severely corroded. Wooden elements of the surface were incomplete and decayed. The bridgeheads were built from solid brick, whereas the intermediate supports of the bridge were made of concrete; moreover, the lower parts of the pillars were clad with stone blocks. The main damage to the supports is cracking and efflorescence on reinforced concrete elements, as well as missing mortar in the joints of the brick wall. Taking into account the age of the structure as well as its manner of use, it was characterized by typical damage described in literature [7]. Examples of the damage are shown in Fig. 2.

**Fig. 2.** Corrosion of elements of the Łęknica steel bridge prior to revitalization, a – in the region of a pillar, b – in the region of a bridgehead (photos by A. Juszczyk).

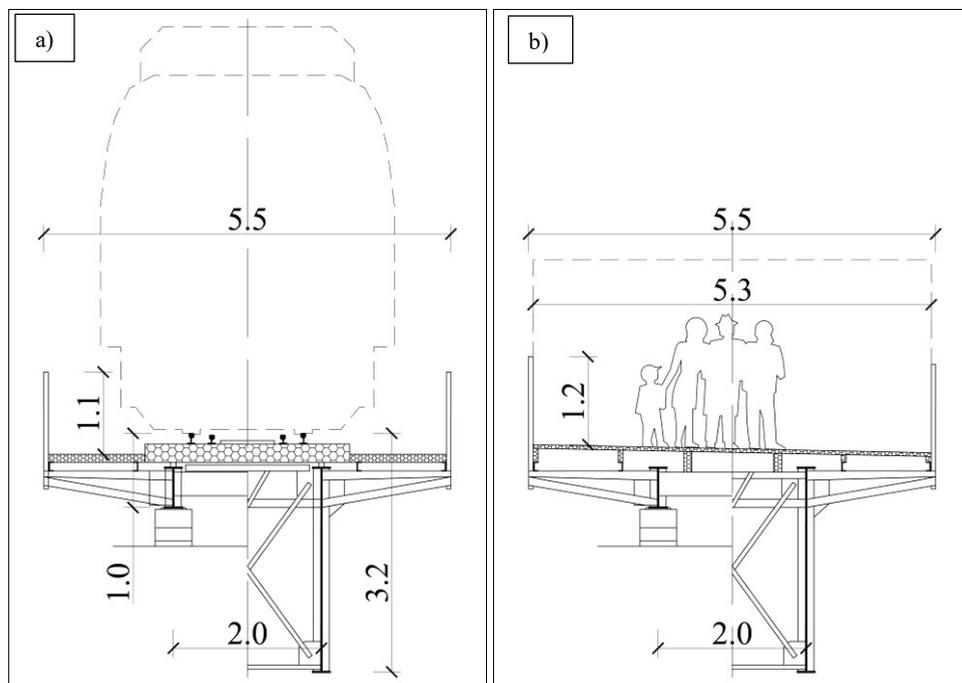
The railway bridge had an open deck with technical space on both sides, and it was thus necessary to prepare a new deck structure. The notion of revitalization called for preserving the historic geometry of the bridge, both in terms of its location on the plan as well as the

horizontal dimensions of the bridge. The dimensions of the horizontal cross-section of the railway bridge as well as the pedestrian-cyclist bridge are shown in Fig. 3.

**Fig. 3.** Horizontal cross section of the bridge in Łęknica, a – for railway traffic, b – for pedestrian-cyclist traffic (own study).

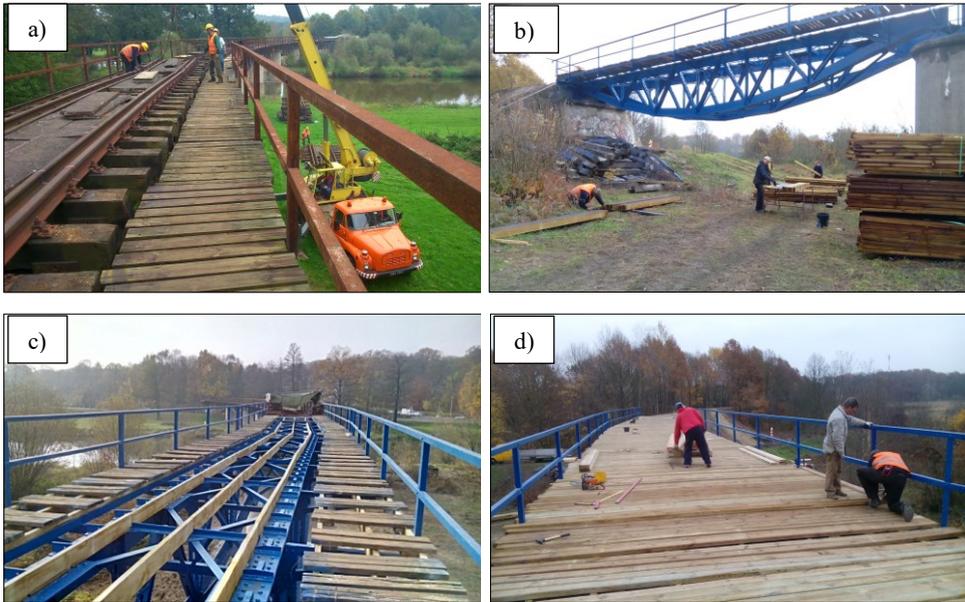
**Fig. 4.** Selected stages of the revitalization of the bridge in Łęknica, a – taking apart the railway surface, b-d – building the wooden deck, (photos by R. Woźniak).

Construction works in the framework of revitalization covered:

- taking apart the railway surface and elements of the deck,
- the cleaning of the steel structure,
- the anti-corrosion protection of steel elements by applying paint coats,
- building a wooden deck,
- installing road lighting,
- preparing the surface of the pedestrian-cycle path on access ways to the bridge.

Applying wood in the construction of the deck and surface allowed for shortening the realization time and ease of maintaining the curvilinear course of the entire structure. Ventilation spaces were left, which in connection with impregnating agents will extend the durability of the deck. Moreover, it was not necessary to install dilatation devices over each support.

The execution of construction works is present on the sample photographs below (Fig. 4).

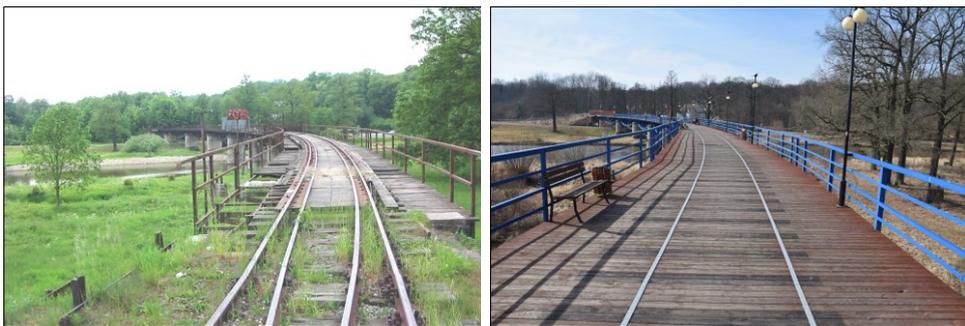
**Fig. 5.** General view of the railway bridge and pedestrian-cyclist bridge (photos by A. Juszczuk).

Elements imitating a railway surface in the form of steel flat bars as well as dark-coloured wood preservatives were introduced in an effort to highlight the original function of the bridge. A view of the surface of the structure is shown in Fig. 5.

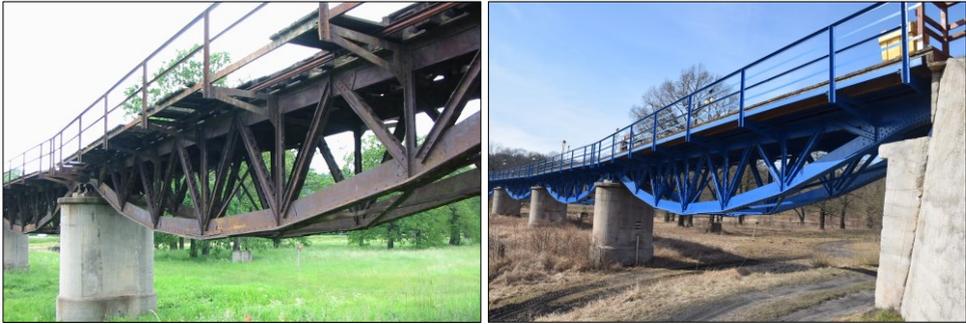
**Fig. 6.** Peripheral western span prior to and following revitalization (photos by A. Juszczuk).

The applied paint coats will ensure the protection of the steel structure against corrosion during subsequent years of operation. The view of the span prior to and after the revitalization is shown in Fig. 6. The colour of the steel structure and railings reflect those of railway structures.
