Improvement of the load capacity of the road overpass as a result of repairs after breakage caused by vehicle impacts

Abstract. Damages of spans of the overpass caused by impact of underpassing vehicles are relatively frequent. Objects that use prefabricated load-bearing elements that are not designed for such impacts are particularly exposed. After impact, such structural elements suffer extensive damage that must be repaired. Taking advantages of this recovery actions it is worth to perform strengthening that will protect object against possible future impacts. In this study the influence of the structural strengthening of the damaged overpass on its strength parameters is investigated. For this purpose the advanced computational model was created. The numerical model includes the response of the reinforcement and prestressing tendons. This model enables precise description of damage caused due to the vehicle's impact and further analysis of re-impact of the strengthened structure.

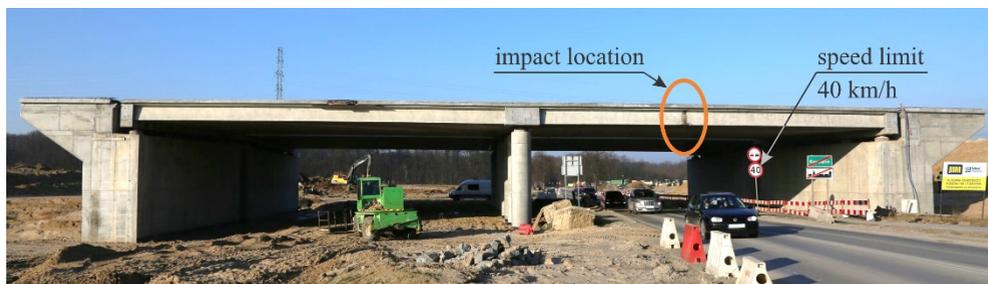
Fig. 1. Overall view of the bridge. The location of the impact is marked orange.

The considered WD-113 overpass (Fig. 1) is located along the S-6 expressway at km 2+842.39, near the Koszalin (Poland). Object consists of two independent structures, namely: WD-113L and WD-113P. They have been designed as a two-span concrete objects. The load-bearing elements are T-type prefabricated prestressed concrete beams (length 24.0 m, height 1.0 m) and a reinforced concrete slab over the T-beams (height 0.24 m). The crossgirders are located over the abutments and over the intermediate supports. The total length of the WD-113P object is equal to 48.90 m and the total width is 18.95 m.

During the inspection, the failure of the prestressing tendons was not confirmed. As a result of the second accident (01.12.2017) the bottoms of the girders were scratched which did not endanger the safety of the structure. Therefore, it was decided to only analyse the first collision event. The impact point is shown in Fig. 1 and the summary of the damage is given in Fig. 2.

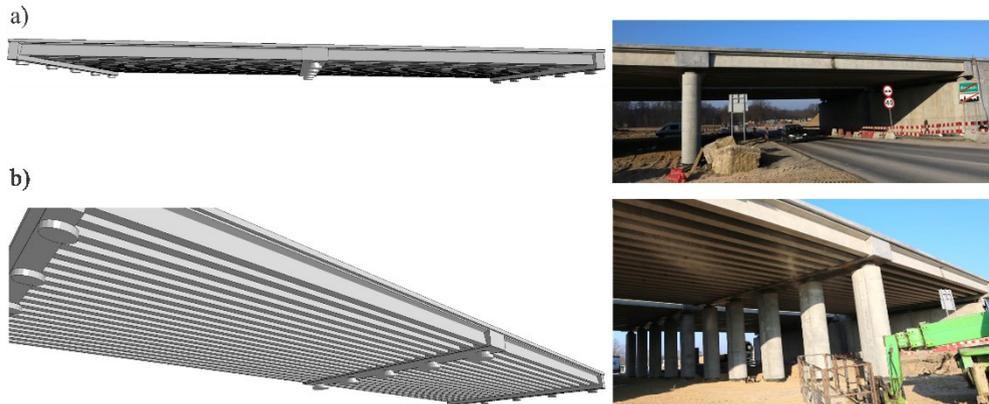
In order to assess the impact condition the computational model of the viaduct based on design documentation [8] was developed. The numerical model of the impact event consists of 1 312 278 nodes and 1 061 836 finite elements. Fig. 3 shows the comparison between the created model and the full-scale WD-113P object.

Fig. 3. The comparison of the computational model and real structure, a) side view, b) bottom view.
