Ventilated façade systems. Design and workmanship faults affecting the functionality and safe use

Abstract. Ventilated facade systems are increasingly used in modern construction industry. It is connected with a wide range of available wall claddings which allow to create distinctive architectural buildings (ventilated facade system made of fiber cement sheets won the prestigious European Prize for Urban Public Space 2016). If constructed properly, the ventilated facade systems have a positive effect on thermal insulation properties of building walls. With an increasing interest in this type of facade solutions, one can also notice an increased number of problems with the quality of the design documentation and construction works which affect the safe use of the building, thermal insulation properties of partition walls, the comfort of use. The paper presents basic faults found in the design and workmanship of the ventilated facade systems.

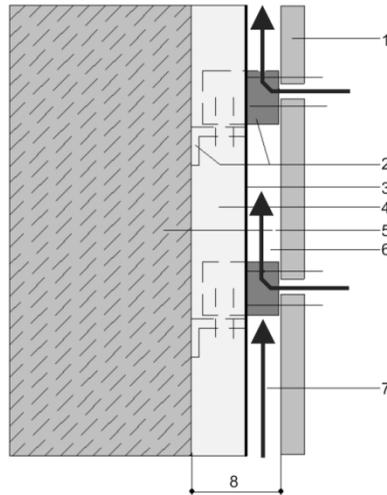
Fig. 1. Ventiladed facade system diagram: 1 – façade cladding, 2 – framework, 3 – air barrier, 4 – thermal insulation, 5 – external wall (Source [1]).

Recently investors and designers have increasingly used the ventilated facade systems in newly constructed and retrofitted buildings. The ventilated facade systems are the facade systems with air (ventilation) gap between the thermal insulation layer and the claddings where the air flows preventing moisture accumulation in this layer [1]. The principle of operation of the ventilated facade system is illustrated in Figure 1.

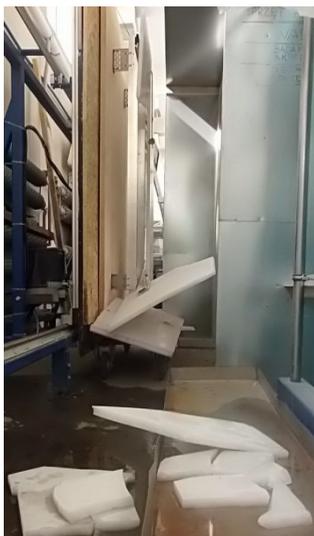
Fig. 1. The ventilated facade system damaged due to climate cycles.

When designing a ventilated facade system accompanied by the European Technical Assessment, it is necessary to pay special attention to technical and performance properties declared by the facade system manufacturer. Often the manufacturers of the ventilated facade systems from the southern Europe skip the climatic properties of the facade system, e.g. resistance to “heating–raining” or “heating–cooling” cycles. In the European Technical Assessments these properties are marked as not determined – NPD (No performance

determined). If the ventilated facade system with the above-mentioned properties not determined is used in the Polish climatic conditions, it may pose a risk of failure of the facade system when exposed to lower temperature or sudden weather breakdown (rain on a hot day). The effect of climate cycles on the ventilated facade system is presented in Figure 1.

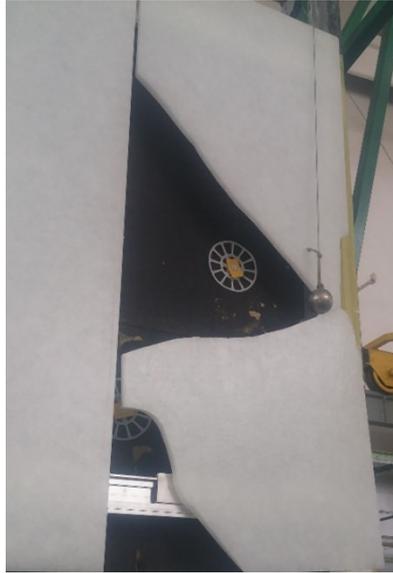
Fig. 2. Dangerous fragments of the ventilated facade system under hard body impact.

A very common fault in the design practices which affects the safe use of the building as a whole is the use of ventilated facade systems with claddings characterized by low resistance

to impact in areas available to passers who care very little about the property. Such claddings may break or fall off under impact. Falling fragments may lead to serious bodily injuries suffered by users (Figure 2).

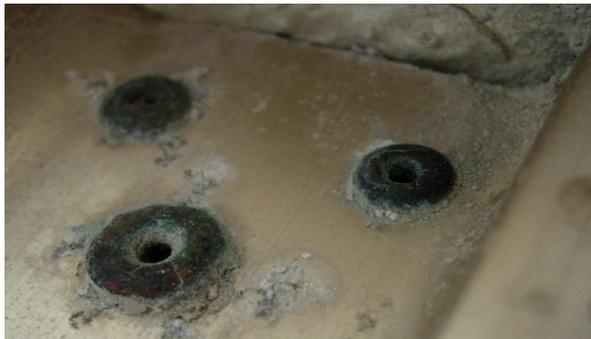
Fig. 3. Corroded rivets used to attach the ventilated facade system claddings to the framework.

A common design fault is to use the ventilated facade system in the corrosive environment which is more aggressive than provided for in NTA/ETA. The corroded parts of the ventilated facade system may lead to its damage (Figure 3).

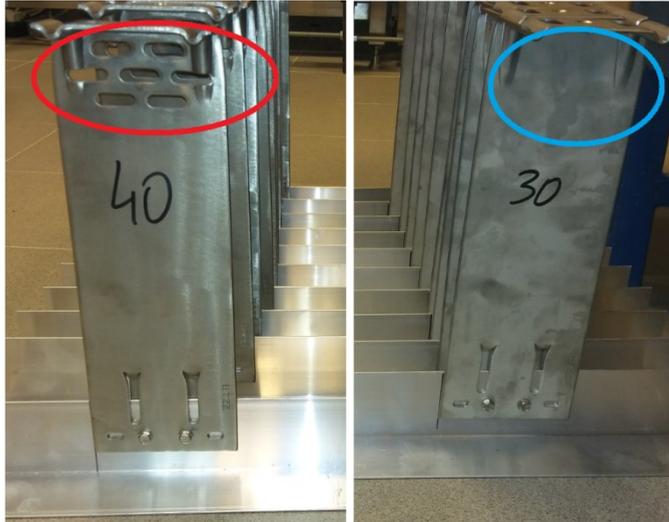
Fig. 4. Brackets for the ventilated facade system. The red circle is used to mark the solution which reduces the effect of thermal bridges.

The thermal insulation properties of space dividers may be reduced by the use of the ventilated facade system with brackets without thermal spacers or other solutions preventing the occurrence of thermal bridges (Figure 4). The Regulation of the Minister of Infrastructure on technical conditions to be met by buildings and their location [4] provides that: “the values of the heat transfer coefficient UC of the walls (..) for all types of buildings, which account

for adjustments made due to air gaps in the insulation layer, mechanical fixings penetrating the insulation layer (...), calculated according to the Polish Standards on calculation of heat resistance and heat transfer coefficient and heat transfer through soil, cannot be greater than $UC (max)$ ". Since 2017 it has been $0.23 \text{ W}/(\text{m}^2\text{K})$.

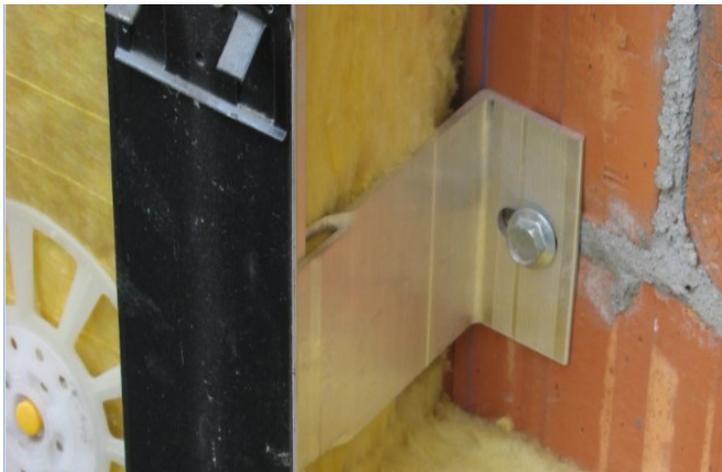
Fig. 5. The mechanical fixing of the ventilated facade system attached to the joint.

One of basic workmanship faults with effect on safe use of the ventilated facade system is the overlooking of the substrate strength before commencement of the works. The pull-out and shear resistance of the substrate (wall) for the mechanical fixings used to attach the substructure shall not be smaller than that provided for in the design. Often, when attaching the ventilated facade systems to masonry walls the contractors set the mechanical fixings not in the masonry unit (as provided for in the design), but in the joint which considerably reduces the safe use of the facade system (Figure 5).

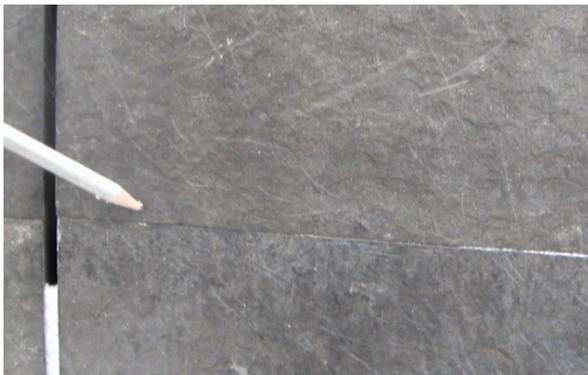
Fig. 6. Claddings of the ventilated facade systems subsiding as a result of reduced thickness of the walls of the substructure elements.

The strength properties of the ventilated facade system may be reduced by the use of substructure elements other than provided for in NTA/ETA. There are many instances of “leaning” the substructure, where the thickness of the bracket walls was changed to save the costs (Figure 6).

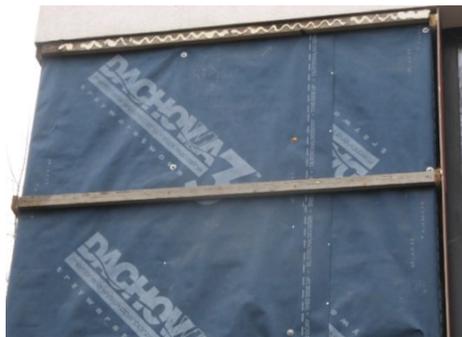
Fig. 7. The ventilated facade system cladding falling off as a result of disturbing the adhesive application method.

For claddings which are attached to the substructure with the use of adhesive, it is extremely important to use proper adhesive application method. Quite often the failure to comply with technical conditions for adhesive application is the cause of failure of the ventilated facade systems (Figure 7). Both the moisture content and air temperature at which the adhesive is applied have a very significant impact on the strength of the adhesive bond.

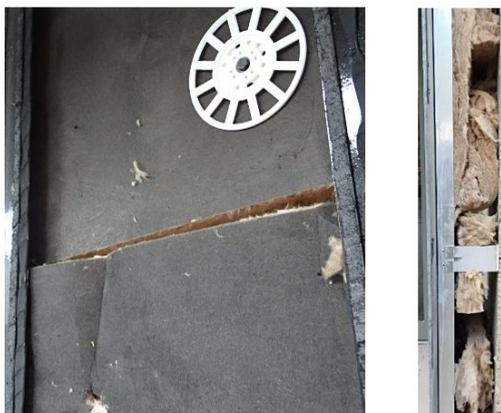
Fig. 8. Example of incorrect execution of thermal insulation.

The thermal insulation properties of the ventilated facade system are weakened by improper execution of the thermal insulation layer, e.g. by clogging the ventilation gaps between the thermal insulation and the claddings which prevents air circulation or leaking connection of individual thermal insulation units which lead to occurrence of thermal bridges (Figure 8).
