Safety assessment of strengthened floor slab structures in a historic department store in Wrocław

Abstract. The subject of the paper are existing intermediate steel/ceramic ceiling structures on four levels from "-1" to "2" in a remodelled historic department store in Wrocław, which are reinforced with an extra concrete flooring slab cast on a trapezoidal sheet in the post-war period. The purpose of this work is to check the possibility of leaving in these reinforced brick slabs with Förster's clay block, ceiling structures, as part of the reconstruction of this building after 2005. The scope of work includes the diagnostics of structural elements for these floor slabs with material tests.

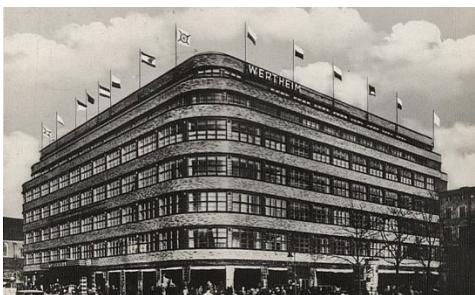
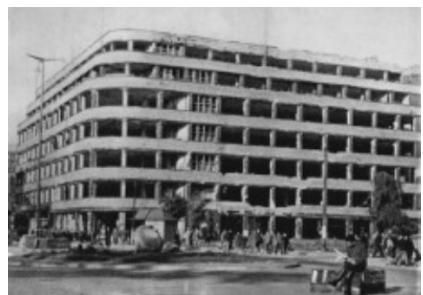
The monumental, seven-storey building of "Renoma" department house, formerly called "Wertheim", was built in 1930 (Fig. 1a). At the end of The Second World War, on March 12, 1945, it was bombed and was being engulfed in flames for several days (Fig. 1b). It was reopened after three years in 1948, during the Regained Territories Exhibition as the largest Department Store in Poland - Fig. 2a.

Fig. 1. a) The building of the pre-war "Wertheim" department store - 1932-1934 [source: Public domain: <https://polska-org.pl/612875,foto.html>], b) Burnt department store after the Second World War [source: Public domain: <https://polska-org.pl/photo/file.action?thumbFit300x180=&id=930818>].

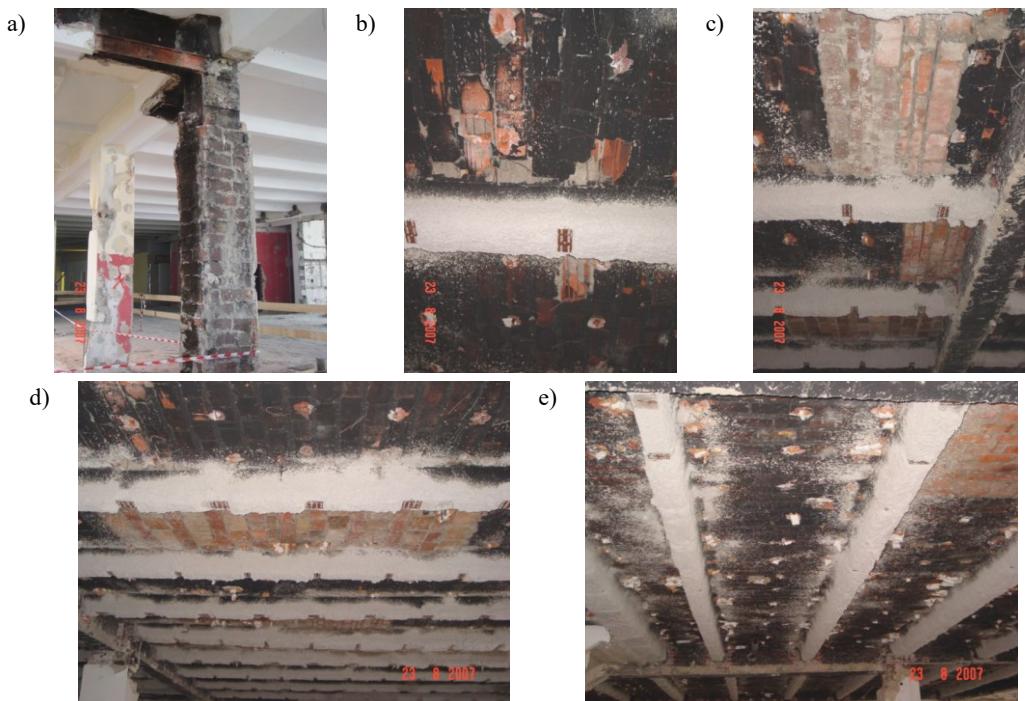
Fig. 4. a) ÷ e). Technical condition of Förster type ceramic blocks based on steel ceiling beams. Visible smoke covered surfaces of ceramic ceilings and column damage.

The following typical damages to the filling of the ceilings - ceramic hollow bricks have been found:

- a) 1st level (evaluation from the bottom of the ceiling) - about 25% of Förster type hollow bricks suffered damage of various sizes in their bottom parts. Some of the holes in the hollow bricks have been filled with polyurethane foam or insulation. The smoke covered bricks were observed -Fig. 4. The ceramic floor slab above the ground floor level showed the highest number of hollow brick damages among the assessed ceilings. A random lack of mortar in the joints between the blocks was

observed. The stratification of the ceiling layers was not visible. However, when tapping randomly selected unbroken blocks, some of the hollow bricks made a hollow sound, which indicated internal cracks;

- b) 2nd level - significant smoke covered bottom surfaces of the hollow bricks as well as local damage of the slab was observed.

Due to these fire damages, the inter-story floors have been strengthened by the use of an additional floor layer of the concrete slab on a T55 / 188 trapezoidal sheet. In this way, the Förster ceramic blocks were partially de-stressed. As a result of the inspection holes made in-situ, it was established that the sheet together with the concrete slab lied directly on the levelling layer of the ceramic plate.

It should be emphasized that in accordance with the Article 5(1) of the Polish Act – Construction Law, "*a building together with associated installation should have been designed and constructed in the manner specified in the technical regulations, including technical and construction knowledge.*" In addition, according to above mentioned regulations, it was necessary to additionally ensure that fulfilment of the basic requirements concerning, among others, the safety of the building. This means that during conducting the safety analysis and calculations of the load-bearing structure of the inter-floor ceilings of the building, it was necessary to possess full knowledge about the built-in construction materials, the applied construction technology and solutions as well as the geometry of the element's profiles in the entire structure. In addition, in order to ensure the safe operation of damaged brick floor slabs (ceilings), it was necessary to strengthen their bottom surfaces - Förster brick blocks, e.g. by using expanded metal mesh with sprayed plaster.

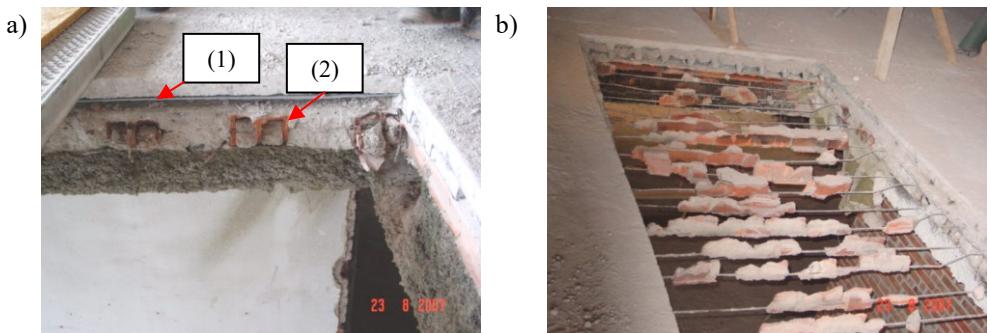
The concrete slab was made on a T88 / 188 trapezoidal sheet, 0.88 cm thick. When carrying out inspection holes pits (e.g. in the ceiling at the "2" level), some areas where the sheet was incorrectly arranged were found - folds parallel to the steel floor beams - Fig. 5.

Fig. 5. Examples of a parallel arrangement of trapezoidal sheets (1) to steel ceiling beams (2). There are visible There are visible reinforcing steel bars of the ceramic plate reinforcing steel bars of the ceramic plate – see Fig. b).

The reduced thickness h_p of the concrete floor slab laid on a trapezoidal sheet below the assumed 6 cm caused exceeding the SLS (the Serviceability Limit State) of this basic load-bearing element of inter-story floors at many measuring points. Particularly, the fields where profiles of these sheets are parallel to steel ceiling beams (perpendicular to steel binding joists) could be observed. This unfavourable static scheme, which was not considered by the designer of the reconstruction and modernization of the department store, is documented in the results of the inspection holes made in many check points - see Fig. 4.

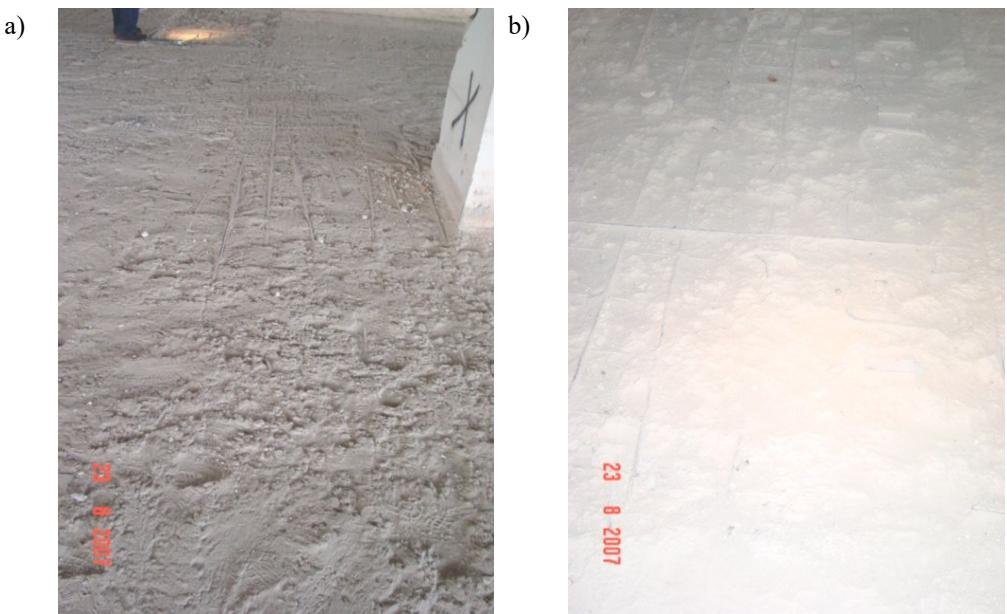
Moreover, in the inspection holes made, a large dispersion in the measured thicknesses of the concrete slab over the trapezoidal sheet was found - from 3 cm to 9 cm. The average thickness of the concrete slab was estimated at about 5 cm. The top surface of the slab was not leveled and showed significant irregularities - Fig. 6. At about 10% of the surface, the top surface of the concrete slab was spalling, exposing the reinforcing bars around the entire circumference - Fig. 7.

Fig. 6. Technical condition of the top layer of the concrete slab on the trapezoidal sheet.

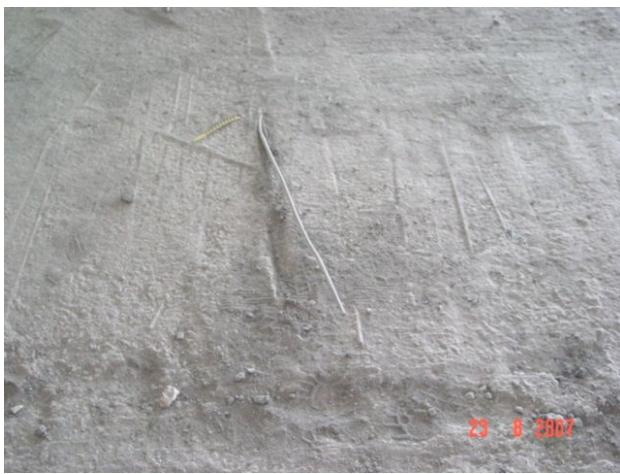
Fig. 7. Technical condition of the reinforcement of the upper concrete slab.

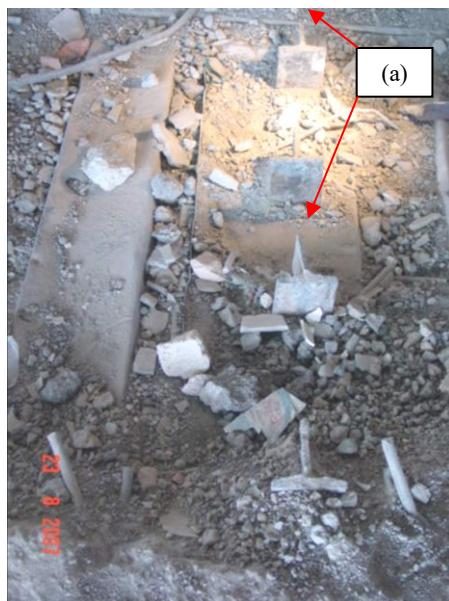
Joints connecting the concrete floor slab with steel ceiling beams were made in various ways (Fig. 8):

- on the 2nd level: as vertical, vertically welded sections of a T-65 profile (a), with a length of 80 mm and a spacing of 25 cm,
- on the 1st level: as sections of the L40 x 40 x 8 profile, welded horizontally with one edge, at a spacing of about 1.0 m or vertical bars Ø 10 from steel 34 GS welded to the reinforcement;
- on ground level: as vertically welded sections of T-50 profile, with a length of 50 mm and a spacing of 50 cm.

Fig. 8. Welded concrete slab joints and steel ceiling beams.

The location of the joining connectors using Profoscope was not possible due to the presence of surface reinforcement of this panel. Their inventory would require removing the entire surface layer of concrete above the joists. It should be noted that due to the presence of joining connectors, the trapezoidal sheet had not been placed on the joists.

The testing on the properties of joints (abovementioned connectors) was carried out by the Welding Institute in Gliwice [2]. It showed that "due to the heat affected steel zone from 1929 (steel floor beams), the connectors do not meet the requirements as for a JRG1 steel quality group according to PN-EN 10025-2: 2002 *"this steel should not be combined using welding with other steels"*". This means that the existing and applied welded joints connecting the concrete slab with the steel ceiling beams had a reduced load-bearing capacity for shearing.

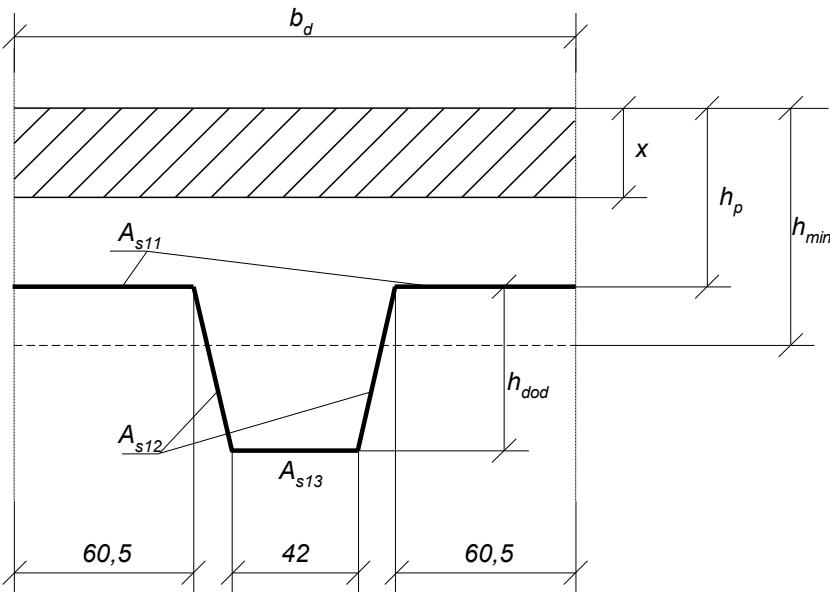
In the inter-storey ceilings, there were ceramic Klein type slabs (Förster block), which carried only their own weight were situated. These slabs, due to their long service life and due to war damage, were found in a very bad technical condition. Hence, the subject of further standard verification calculations and analysis was a monolithic concrete floor slab with ribs laid on T55/188 trapezoidal sheet and a thickness of 0.88 cm (Fig. 9). It was the basic structural element of the floor layers of the building.

- h_p – the assumed thickness of the concrete slab above the profile of the trapezoidal sheet: 6.0 cm (when carrying out the local inspections the various values of the slab thickness were measured, reaching in some measuring points up to 3 cm),
- b_d – the slab section width used for calculations: 18.8 cm – see Fig. 9,
- h_{min} – the distance of the centre of gravity of the trapezoidal sheet from the upper compressed fibres of the concrete slab: 7.95 cm,
- h_{dod} – the height of the trapezoidal sheet: 5.5 cm,
- A_{s11} – the area of the top surface of the trapezoidal metal sheet: 1.06 cm^2 ,
- A_{s22} – the area of the web of the trapezoidal metal sheet: 1.03 cm^2 ,
- A_{s33} – the area of the bottom surface of the trapezoidal metal sheet: 0.37 cm^2 ,
- x – the height of the compression zone of the concrete slab.

Fig. 9. The geometry of the concrete floor slab with ribs, made on a trapezoidal sheet. Dimensions in mm.

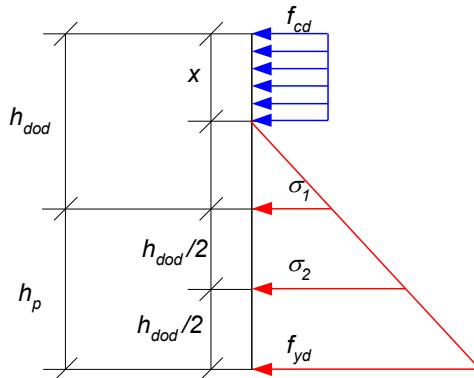
The values of stresses in the steel sheet were determined in accordance with the scheme shown in Fig. 10 continue preliminary estimation of the cross-section bearing capacity.

Fig. 10. Distribution of stresses in the cross-section of the concrete floor slab made on the trapezoidal sheet.

$$\sigma_1 = \frac{(h_p - x)f_{yd}}{h_p - x + h_{dod}} = 73.24 \text{ MPa} \quad (6)$$

$$\sigma_2 = \frac{\left(h_p - x + \frac{h_{dod}}{2}\right)f_d}{h_p - x + h_{dod}} = 141.62 \text{ MPa} \quad (7)$$
