# The diagnosis of the technical condition of buildings as an indicator of the scale of needs for the revitalization on the example Koźuchów

**Abstract.** In the revitalization process, the scope of work to be done depends on the technical condition of a particular historical site. Any activities should be preceded by a diagnosis of its technical condition in terms of changes which have taken place so far. The diagnosis of particular buildings will make it possible to determine the scope of needs to be included in the revitalization plan. The paper presents technical issues occurring in residential and commercial buildings and the problem of protection of cultural heritage as exemplified by the historical urban complex in Koźuchów.

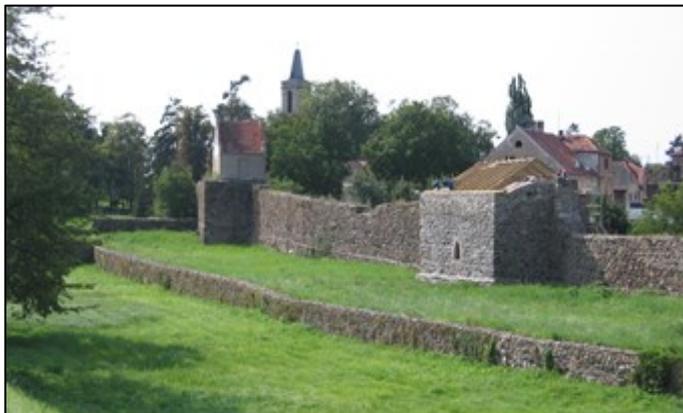
**Fig. 1.** The fortifications, a segment. The defensive walls have almost entirely been preserved; the moat, the outer ring of walls (photo by B. Nowogonska).

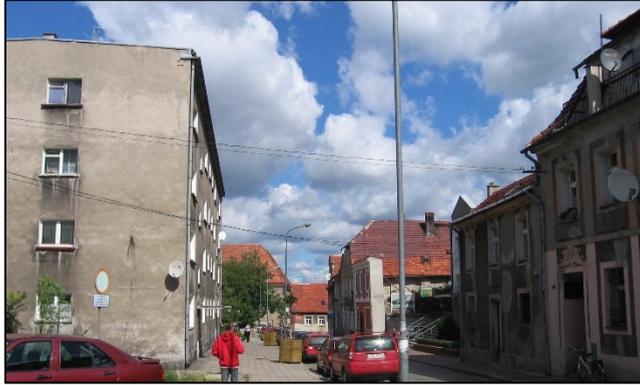
In the twentieth century, three four-storey blocks of flats were built in the complex of old architecture (in the streets: Rynek, Klasztorna and Mickiewicza). They disturb the former spatial arrangement, visually overwhelm the nearby castle and spoil the panorama of this historical town. The buildings are located near the castle and their walls completely block the view. The original scale is also disturbed, because according to the widely known principle for complexes of old architecture, the highest and most impressive buildings were located in the market square in the centre, and the height of buildings decreased with the distance from the town centre. Four-storey buildings were built next to the three-and two-storey ones.

**Fig. 4.** A building from the 1970's (photo by B. Nowogonska).

It is also postulated that some buildings should be expanded, and that their architectural line should follow the original medieval pattern. It is also recommended that the four-storey buildings should be modernized, and that their architectural line in Klasztorna Street should be corrected. It is necessary to expand the commercial buildings in Daszynskiego Street to restore the original medieval building line in the street [11].

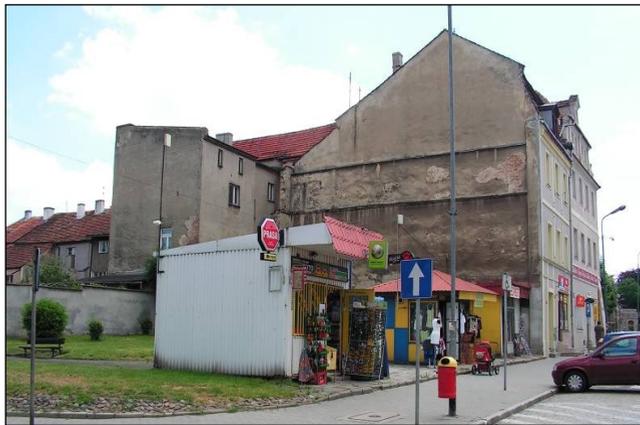
There are voids in the spatial composition of the complex. Therefore, there is a need to integrate the existing buildings into a compact and complete urban complex by filling the voids with modern buildings, which would match the surrounding architecture. It is postulated that the complex should be restored to a form as close to the original as possible in order to preserve the historical character of the whole place.

**Fig. 5.** Voids in the spatial composition, part of the eastern façade (photo by B. Nowogonska).

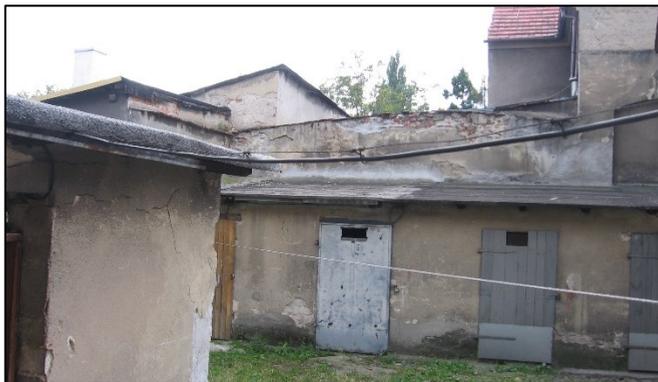
**Fig. 6.** An outbuilding planned to be demolished (photo by B. Nowogonska).

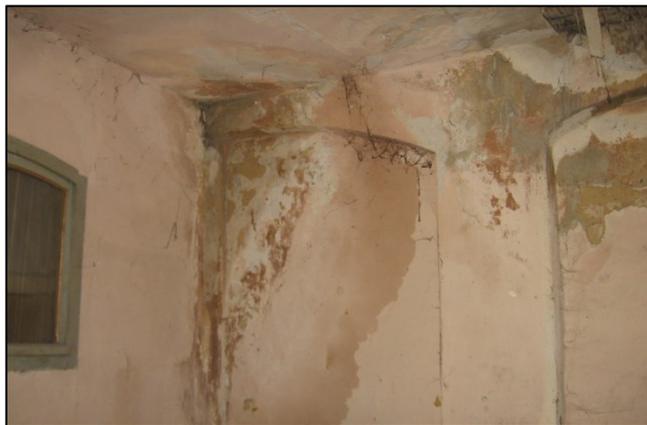
**Fig. 7.** Detail of the wall on the first floor in one of the houses. The dampness on the walls and the ceiling is due to the leaking roof valley. (photo by B. Nowogonska).

The flashings are made of galvanized steel sheets. The corroded roof valleys, the lack of gutters, and missing down pipes allow rain water to penetrate into the interiors, damage the exterior plaster and dampen the walls.

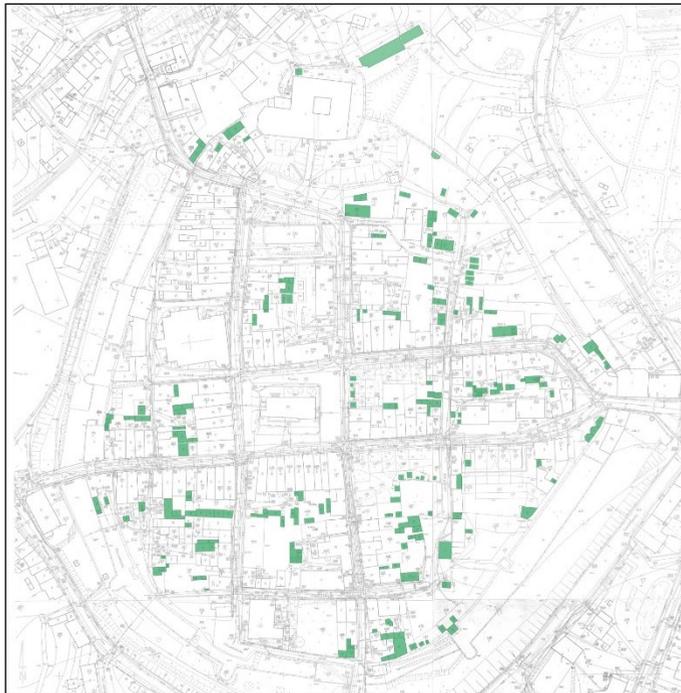
**Fig. 8.** The buildings planned to be demolished.

The guiding principle of the revitalization should be to preserve the historical arrangement of the land plots, urban quarters and streets within the fortification walls. In order to properly direct the necessary transformation and modernization work, it is planned to remove elements of low historical and compositional value. It is postulated that the general plan of the area should be cleaned up by demolishing temporary objects, back-buildings, garages and outbuildings (in the following streets: Mickiewicza, Koscielna, Legnicka, Glogowska, Limanowskiego, Obywatelska, and Daszynskiego) [11]. However, a number of back-buildings, especially the ones that are intended to be modernized (in Krzywoustego street), should be preserved. In order to reproduce the spatial model of the Old Town, it is proposed to demolish the buildings which are disharmonious with the medieval layout of the streets (buildings at 19 Legnicka Street, 12 Mickiewicza Street and 2 Glogowska Street) [11].

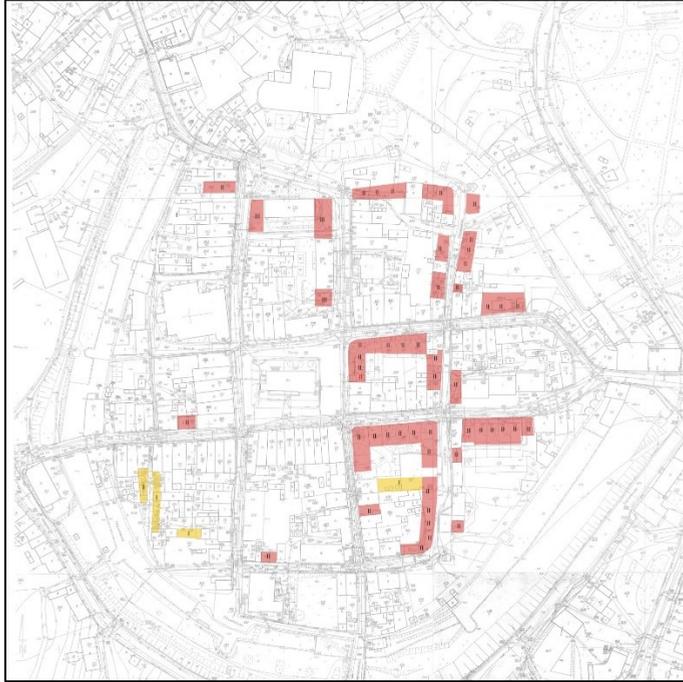
**Fig. 9.** Newly designed buildings.

While shaping urban landscape, it is necessary to be careful that the new infill buildings should be in harmony with the buildings that have been preserved [13-15]. In order to regain the historical urban arrangement, it is necessary to restore the historical look of the streets, squares, axes of view and the scenic routes of the town. Therefore, it is recommended to introduce a compact arrangement of buildings, to keep a suitable scale and dimensions, to use steep roofs, and to maintain the historical outlines of former structures. The proposed additions must not change the former, historical character and should avoid the falsification of history. It is recommended that the reconstruction of the historical Old Town should involve searching for contemporary architectural forms which will harmonize with the historical urban surroundings. Newly constructed buildings should not exceed the height or dimensions of the existing buildings. They should be built with the same spatial assumptions as the historical urban complex.
