Degradation of architectural precast concrete elements on the facade of St. Michael the Archangel church in Warsaw

Abstract. The paper presents the case study of the degradation of architectural precast concrete elements on the facade of St. Michael the Archangel church in Warsaw. The background of the contemporary precast non-standard prefabrication was presented with the examples of polish recent applications. The GPR (ground penetrating radar) method was used in determining the location of reinforcement in the precast elements in the degraded façade. The conceptions of repair were analyzed and the reasons of the destructions of the precast elements.

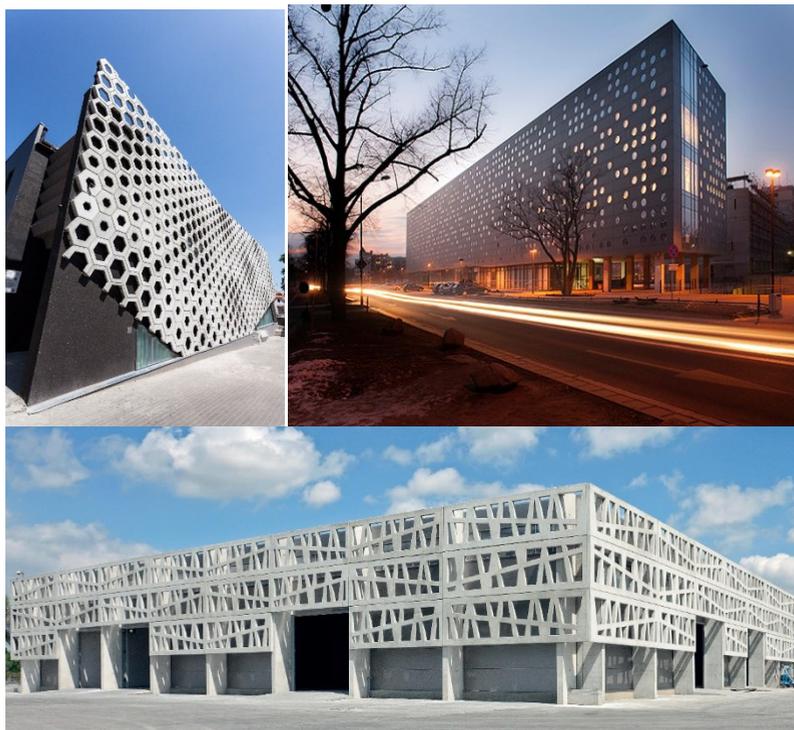
Fig. 1. Non-standard elevations in public buildings [1].

Concrete prefabrication gives wide possibilities for shaping the structure, spatial form and aesthetics. This allows to create objects in accordance with the vision of architects and the expectations of investors and users. Wide use and recognition of investors find non-standard individually designed elevations, especially public buildings (Fig. 1). Wall elements of atypical shapes and openwork can also be used as internal partitions allowing to arrange interesting interiors [1].

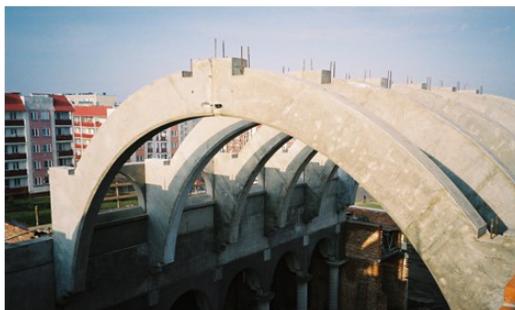
Fig. 2. Prefabricated elements in the church construction [1].

The precast technology is also used in the implementation of non-standard structures such as churches. An example of the construction of prefabricated structures is, for example, the construction of a neo-Baroque church (Fig. 2). In the aforementioned case, prefabricated reinforced concrete girders with a span of up to 12 m were made. For technological reasons, the largest element (32 tons) of the nave has been divided into two elements. The construction of the church also used prefabricates of a different type, including the covering of the arched ceiling. The vault was made as a composite slab prefabricated-monolithic in the form of filigree ceiling shells. The use of prefabricated elements in sacred building has a long tradition in Poland. The post-war example of the use of prefabricated elements for the implementation of the church facade is the church of St. Michael the Archangel in Warsaw, which is the subject of this publication (Fig. 3).

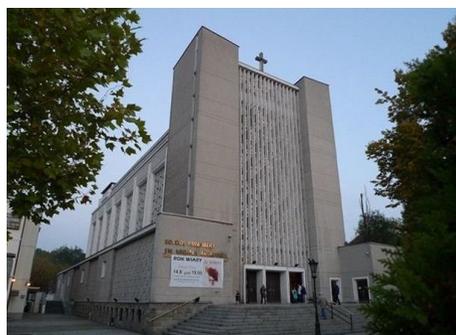
Fig. 3. Church of Saint. Michael the Archangel in Warsaw (<http://archwwa.pl/parafie/warszawa-sw-michala-archaniola/>).

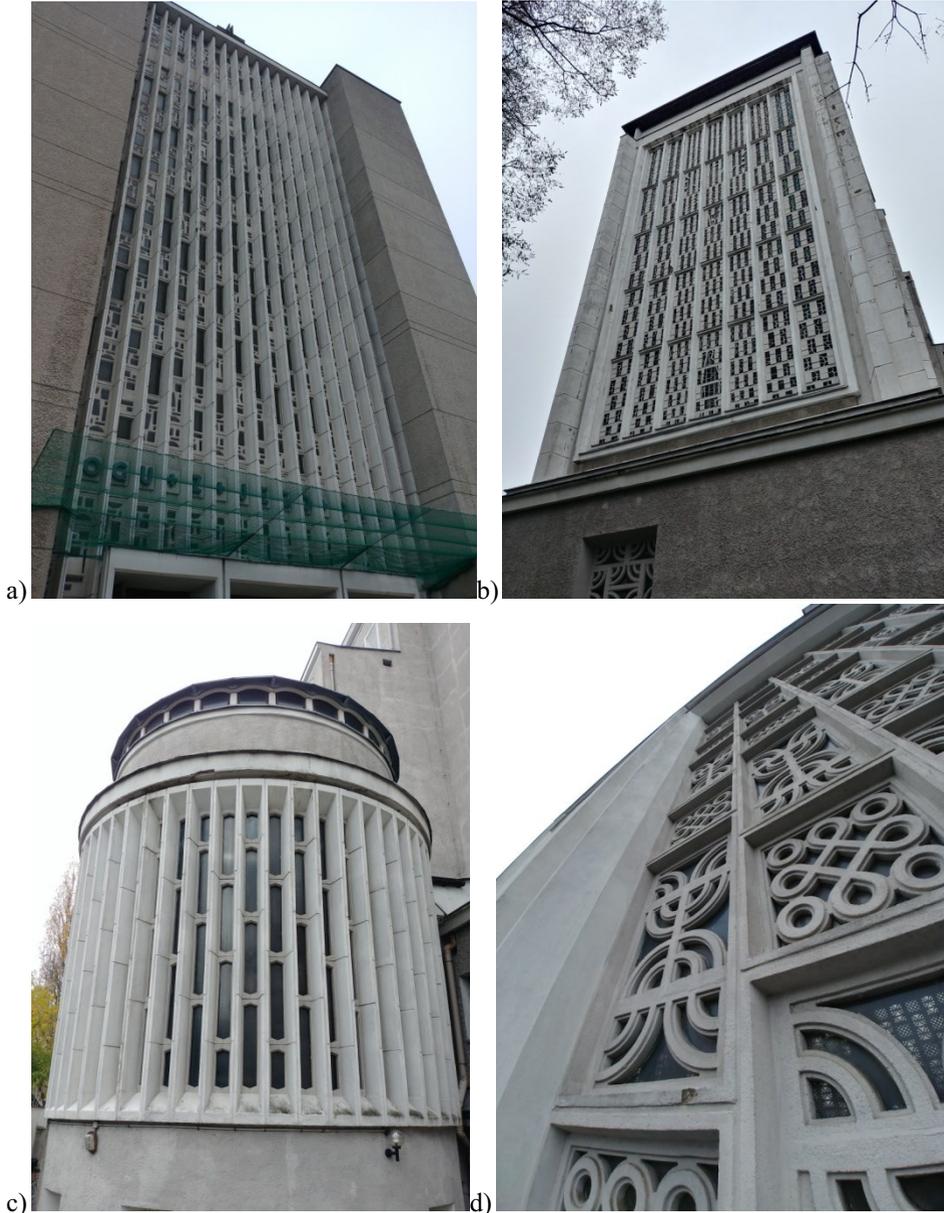
Fig. 4. Prefabricated elements of the church on the front façade (a) and on the other façades (b, c, d).

The church was erected in the 50/60 of the last century, in a mixed technology, using numerous prefabricated elements that constitute architectural elevation elements (Fig. 4).

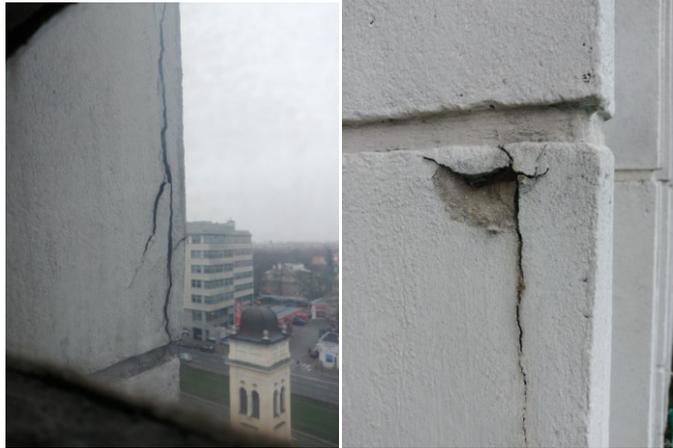
Extensive damage to façade elements has been found. They include the detachment of the outer vertical edges of the elements (Fig. 5) and the horizontal cracking of the elements from the inside. Cracks in the inside usually run horizontally around the height of the element (Fig. 6). Separation from the outside applies to virtually all elements on the entire height of the façade (Fig. 7). Damage to the elements from the outside runs along the reinforcing bars and applies to the entire thickness of the reinforcement cover (Fig. 8).

Fig. 5. Delaminations of the outer edges of the elements.

Repair of elements should be made on the basis of a repair project prepared by the selected contractor (design and build) using an effective concrete repair technology. The state of destruction of the outer surfaces of the façade indicates that all elements should be covered by the repair. The scope of the repair should include restoring the load-bearing capacity of the elements as well as restoring the appearance of the façade and ensuring the durability of the elevation. In addition, the following aspects of implementation should be noted:

- removal of loose and loose parts of concrete elements on the entire height of the façade,
- thorough cleaning (e.g. by abrasive blasting) of the exposed reinforcement surfaces of the elements to obtain the cleanliness effect of Sa 2.5 steel; in areas where a significant reduction of reinforcement sections may be found, it may be necessary to restore or reinforce the element, e.g. with carbon fiber tapes,

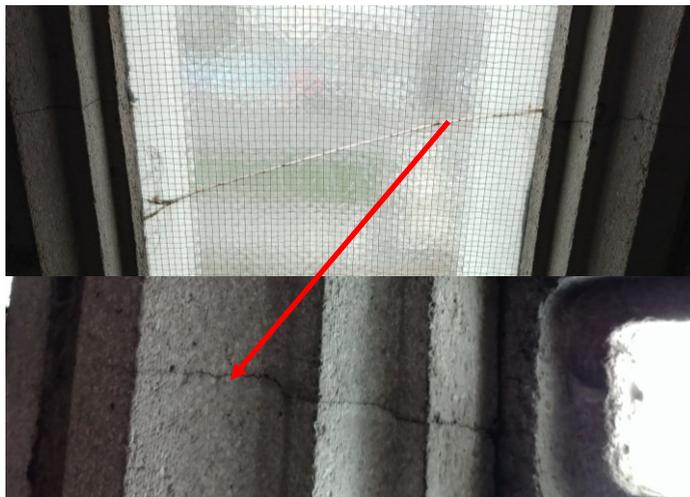
Fig. 6. Cracks from the inside in the middle of the span of the element.

The concrete used in the elements was characterized by very fine graining and probably a relatively low cement content. The cover made in the case of the side surfaces of the elements was even only a dozen or so millimeters. The reinforcement of the elements is made of smooth bars Ø6 mm. These material characteristics would be unacceptable in the light of current prefabrication design standards. Accepted materials of low quality and a small degree of reinforcement of elements also affected their general stiffness while working in a self-supporting facade wall - this was reflected in the regular arrangement of cracks running horizontally, usually at the height of individual elements.

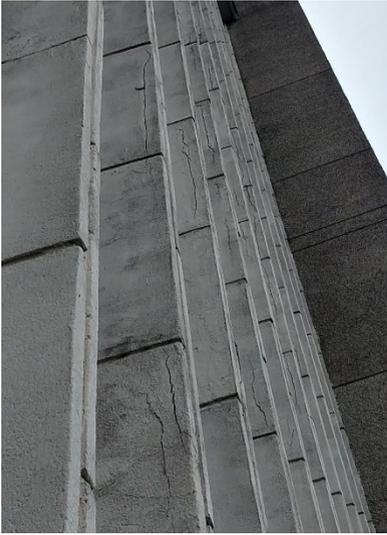
Fig. 7. Extensive damage to façade elements.

In the case of the forge shown in Fig. 7, another material - presumably used for local repair - is also visible - also freshly grained, but with a clearly visible fine aggregate 2/4 mm. This material is also carbonated but to a limited extent: approx. 20 mm from the external surface and approx. 7 mm from the lateral surface. The difference probably arises from a different exposure to the atmospheric conditions of both surfaces and the associated different durability of the painting trip on the surface of the element. The corrosion condition of the rod visible in Fig. 7 is probably the pre-repair situation, but in the present situation the carbonation stability of the repair layer is also depleted and further progress of corrosion of the reinforcement is to be expected.

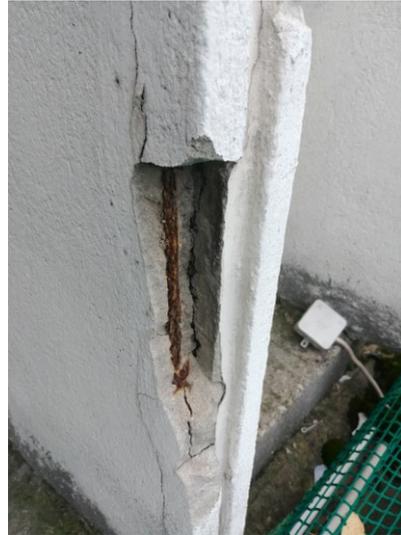
Fig. 8. The insulation of the reinforcement cover.

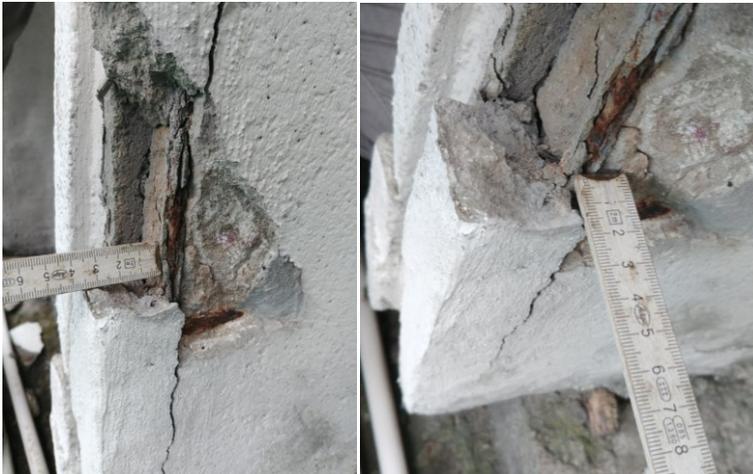
In the first stage of the diagnostics, the thickness of the reinforcement cover from the outer side of the façade was evaluated in two planes, by open-pit method in several places. Example of measurements in a plane perpendicular to the façade (Fig. 9a) and in a plane parallel to the façade (Fig. 9b). The thickness of the concrete cover from the outside surface fluctuated within the limits of 35-40 mm, while from the side surface - 15-17 mm.

Fig. 9. Estimated thickness of the concrete cover: a) from the outer surface (edge of the element) approx. 30-40 mm; b) from the lateral surface approx. 15-17 mm.

The difference in the result is visible in both cases documented in the pictures. In the photo 6b probably the primary material of the prefabricated element (sand concrete) is visible and there is no untreated, i.e. unfinished, area on the surface of the forging. This explains the strong corrosive state of the visible rod and a significant loss of its cross-section as a result of the separation of mechanically weak corrosion products.

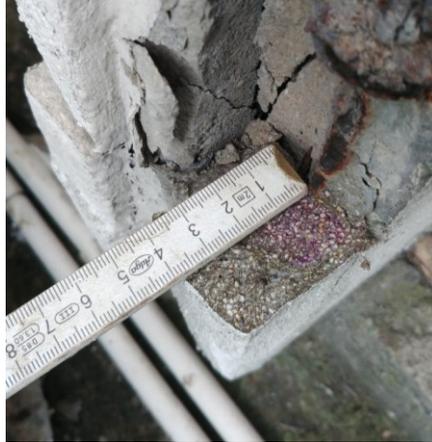
In the second stage of diagnostics, carbonation depth tests were carried out. These tests were performed on fresh (made just before the test) forgings of structural elements using phenolphthalein indicator, which allows to determine the pH front limit equal to 8.3. The procedure for making the marking was in accordance with the PN-EN 14630 standard and included: making the forging, wetting its surface with distilled water, applying a

phenolphthalein solution, measuring the depth of the carbonation front. An example of the test result is shown in Fig. 9 b and 10.

Fig. 10. Range of the carbonated zone.

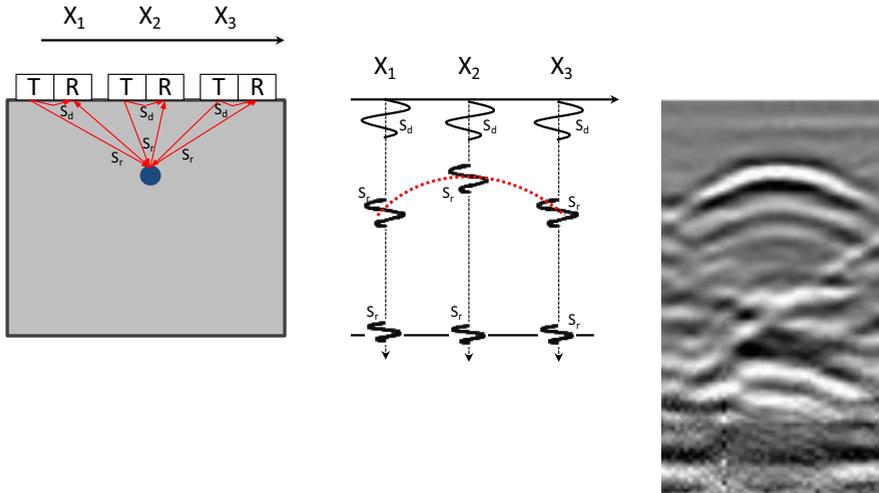
The aim of the study was to determine the location of reinforcing bars. The tests were carried out using the Ground Penetrating Radar (GPR) method [2, 3] and the execution of local opencasts from the self-supporting lagging of the rods. The GPR method is a non-contact technique, the operating principle of which is very similar to the echo method most often used in ultrasonic flaw detection, but instead of elastic waves, electromagnetic waves are used. The difference in the dielectric properties of the two materials determines the amount of reflected wave energy that is recorded by the antenna (Fig. 8).

Fig. 11. Principle of GPR testing.

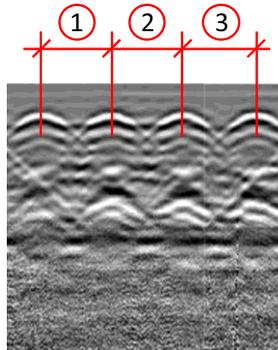
In typical construction applications, the radar is used to detect delamination and defects and the location of reinforcing bars in reinforced concrete elements (Fig. 12).

Fig. 12. Location and determination of spacing of reinforcing bars in a reinforced concrete element.

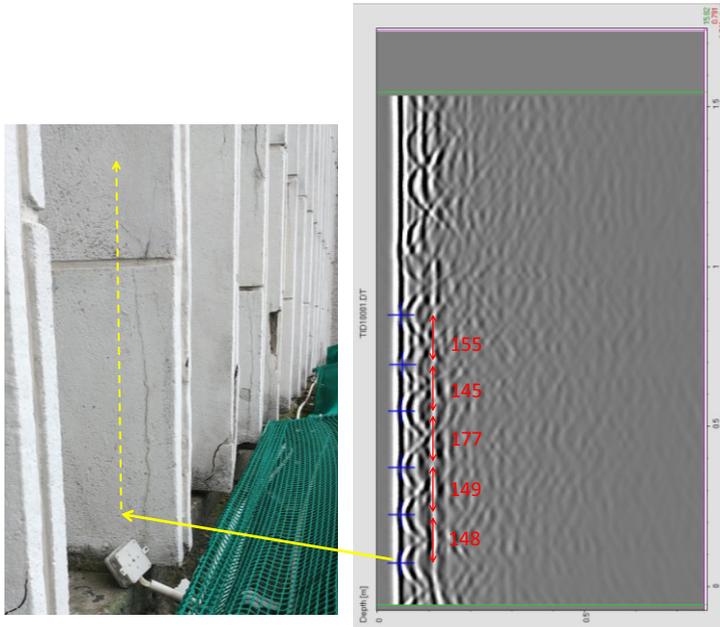
Fig. 13. A radar image made along the side surface of the element - identification of reinforcing bars.

The radar images indicate a horizontal spacing of bars of the order of 150-170 mm and a vertical spacing of bars of 100-120 mm. The made opencasts indicate that the reinforcement of prefabricated elements was made of $\phi 6$ mm bars. It should be assumed that adjacent prefabricated elements are connected with each other by horizontal steel connectors placed on one side at the height of the element, and on the other - at the contact of adjacent vertical elements. The exact identification of the connectors is only possible in an invasive way when disassembling or deep excavation.

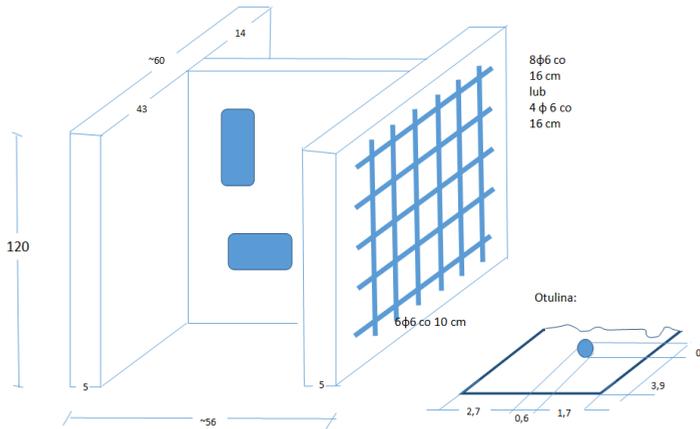
Fig. 14. Sketch of the probable arrangement of reinforcing bars in the element.

The sketch of the probable arrangement of reinforcing bars in the element is shown in Fig. 14. The height of all elements is 120 cm, except for the "half" elements occurring in a given vertical section on the top or bottom edge of the façade.
