# Evaluation of the condition of the external layer of walls in the national technological system "S-Sz" (Szczecin System) of large-panel prefabricated construction

**Abstract.** The condition of the texture layer of external walls directly affects the durability of a large panel building. The results presented in the article are the result of an inventory and a number of studies carried out in 2018 on selected residential buildings in a local variant of the Szczecin Large-Panel System. Both in situ tests (layer thickness measurement, reinforcement location, determination of lagging thickness) and laboratory tests (strength test, carbonation range) were carried out. Significant deviations of the examined wall elements from the design assumptions were proved. Moreover, it was found that the carbonated concrete of the external layer does not adequately protect reinforcing steel. With the use of so-called sandwich samples, the compressive strength of the concrete was confirmed. A favourable ratio of specimen dimensions was established for the results of lightweight concrete strength tests.

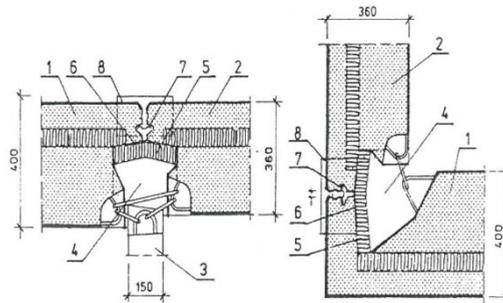
Wall elements of the analyzed buildings were three-layer: 36 cm and 40 cm thick (Table 1). The load-bearing layer consisted of expanded clay concrete with a thickness of 220 mm and 260 mm, respectively. Thermal insulation in the form of 60 mm thick wool was covered with a 80 mm thick expanded clay concrete external layer (Fig. 3).

**Fig. 3.** Vertical joints of layered external walls made of expanded clay concrete "S-Sz" (modernisation). 1 - gable wall T, 2 - curtain wall Z, 3 - internal wall, 4 - concrete B15, 5-foamed polystyrene 60 mm, 6 - isofoil, 7 - profile insert, 8 - zinc coated sheet [4].

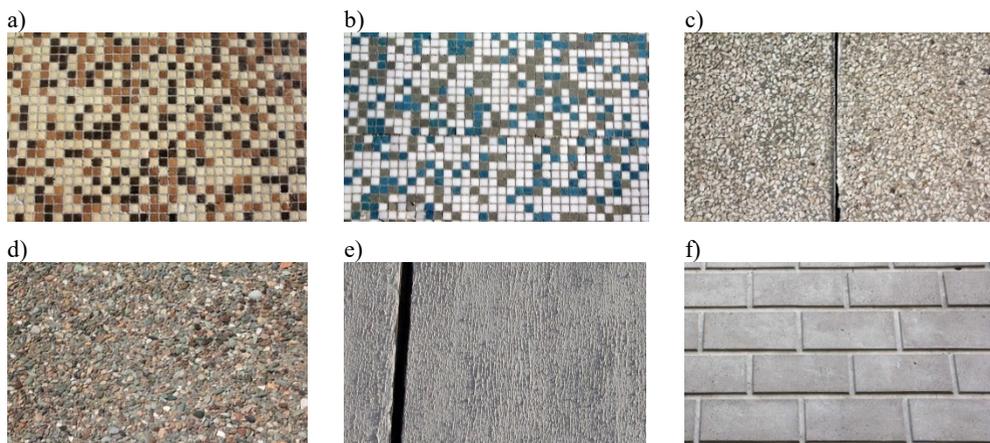
The elevations in the housing estate in question were finished off in various ways-as shown in Fig. 4. All the panels selected for the study had a finish in the form of a glass mosaic, which, for technological reasons, was made first, at the bottom of the structure – in a wall of this type the external layer was usually done first.

**Fig. 4.** Texture of external walls: a), b) stained glass mosaic, c) grit, d) washed stone, e) thin-coat plaster, painted, f) imprint in concrete.

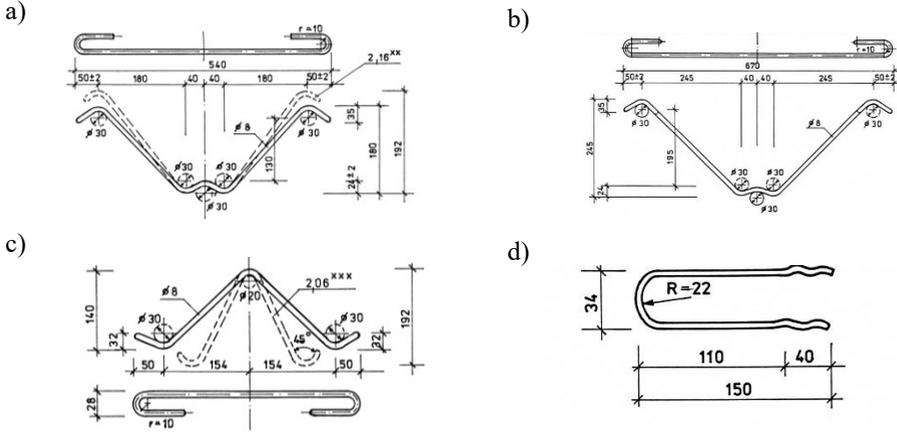
Hangers  $\varnothing 8$  mm and pins  $\varnothing 3$  mm made of steel rods are responsible for the connection of the load-bearing layer with the external layer - in accordance with the assumptions of H13N4G9 grade (stainless steel and acid resistant, point weldable). The system provided for the use of both single and double-bent hangers (Fig. 5) - depending on the order of created layers and the local variety.

**Fig. 5.** Connectors used in three-layer walls: a) hanger type 2.16, b) hanger type 2.17 c) hanger type 2.06 (single-bent), d) pin [4].

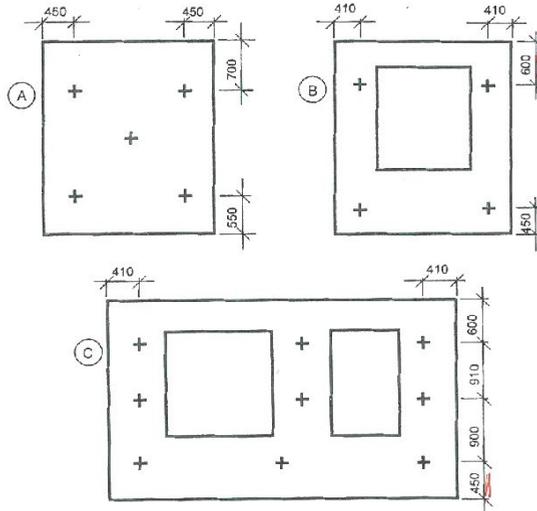
Fig. 6 shows a diagram of the arrangement of hangers in the wall element depending on the type of element.

**Fig. 6.** Diagram of the arrangement of hangers in the walls of the Szczecin System [3].

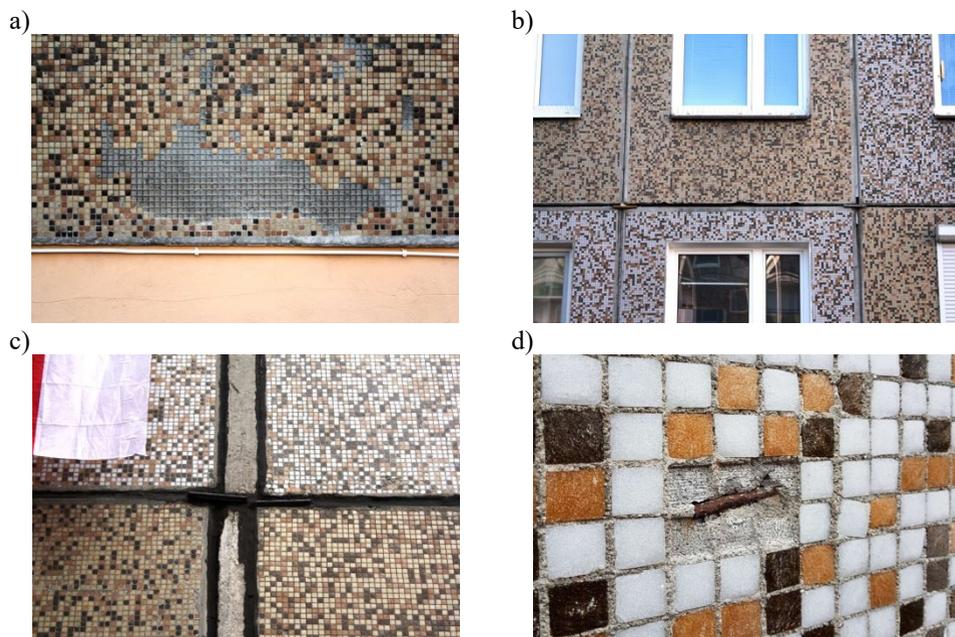
The problem of leaking joints also needs to be emphasized - in many places, exposed joints as wide as 4-5 cm do not have a filling on the thickness of both the external layer and thermal insulation. Therefore, these are potential thermal bridges and places of rainwater penetration. Selected damages are visible in Fig. 7.

**Fig. 7.** Damage to the outer layer: a) detachment of the stained glass mosaic, b) chipping of the edges / leaking joints, c) lack of fitting of elements, d) detachment of the covering.

Therefore, actions should be planned to strengthen the anchoring of the external layer and at least to protect the current damage and to supplement the thermal insulation and waterproofing in the joints. This will protect the curtain walls against further degradation caused by atmospheric factors.

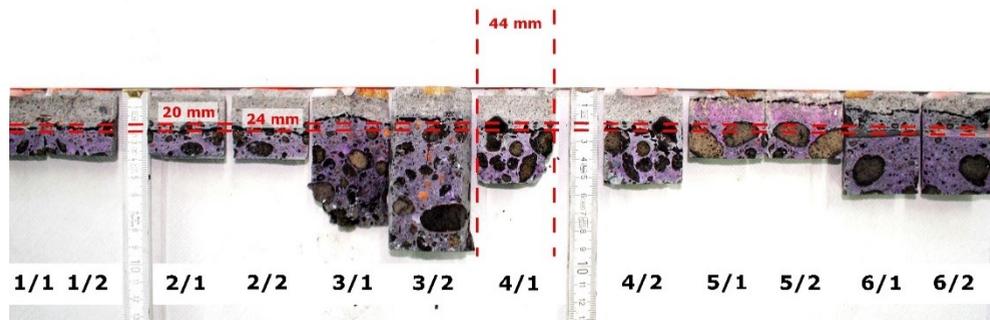
The measurements were carried out on core boreholes taken from the elevation of the building. The diameter of the samples is 44 mm. The boreholes were split using a hydraulic press. The fracture surfaces were cleaned of loose particles under the influence of compressed air. The samples were laid down taking into account the position of the outer layer in one line. After the application of 2% phenolphthalein solution and after approximately 30 seconds, a measurement was taken. In order to better illustrate the range, the discoloration limit was indicated with a marker, several photos were taken showing changes on the surface of the rupture (Fig. 8).

**Fig. 8.** Graphic analysis of the range of carbonation of concrete of the external layer

The maximum range of carbonation (24 mm) was measured and an attempt was made to determine the average range. The results for individual samples differ significantly, therefore the mathematical mean (19.9 mm) was assumed. Of course, the range of  $\text{pH} \geq 11.8$  (causing passivation of the reinforcement) will be smaller than the discoloured areas that indicate  $\text{pH} \geq 9.0$ . The measured thicknesses of the covering (varying between 8 and 48 mm) as well as the 6/1 rebar (Fig. 9) visible on the sample at a depth of 22 mm allow us to believe that hangers and pins are exposed to corrosion initiation processes.

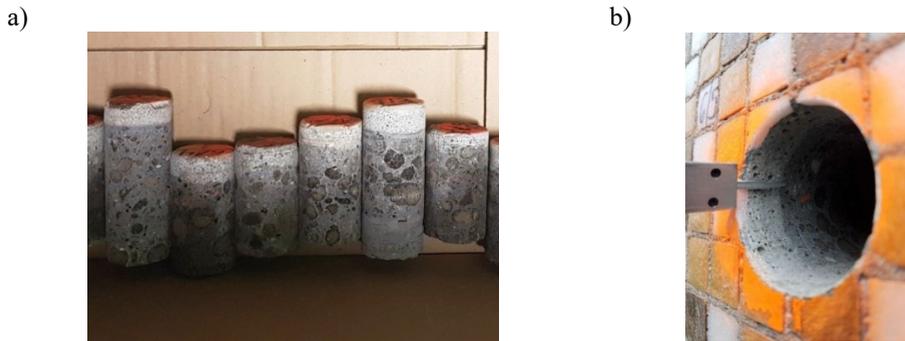
In addition, it is worth emphasizing that in many cases the carbonation range coincides with the colour change of concrete visible on the boreholes and in the holes (Fig. 9). Due to the fact that the slabs were made with an external layer downwards and the use of lightweight expanded clay aggregate, it was possible to segregate the concrete.

**Fig. 9.** Visible segregation of concrete mix: a) on boreholes b) in the hole

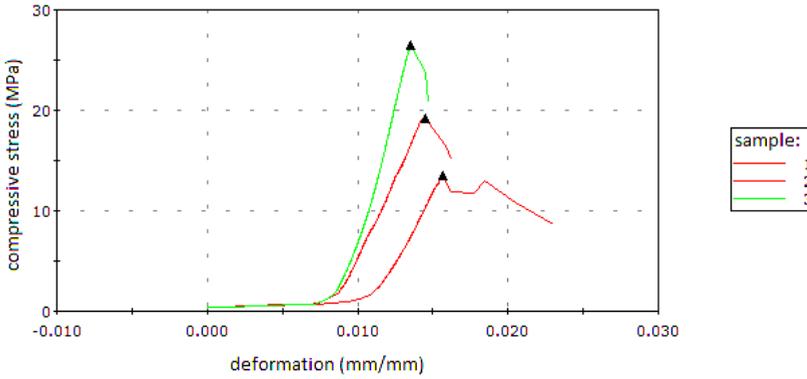
After the first series of tests, it turned out that the measured compressive strength, reaching even 35.7 MPa, is significantly too high in relation to the design requirements (the assumed concrete class is B20) and material capabilities (expanded clay aggregate). The results were partially too high for the six tested samples, but also very divergent (10.1 - 35.7 MPa). It was decided to change the  $l/d$  ratio and to try to get close to the proposed  $l/d \leq 2$ . Three samples were selected, the length of which fulfilled these assumptions and another series was carried out. The results are shown in the graph (Fig. 10). The maximum compressive stress of 26.5 MPa (before taking into account the correction factor) is still significant.

**Fig. 10.** Compressive strength curve of a series of samples  $l/d \leq 2$

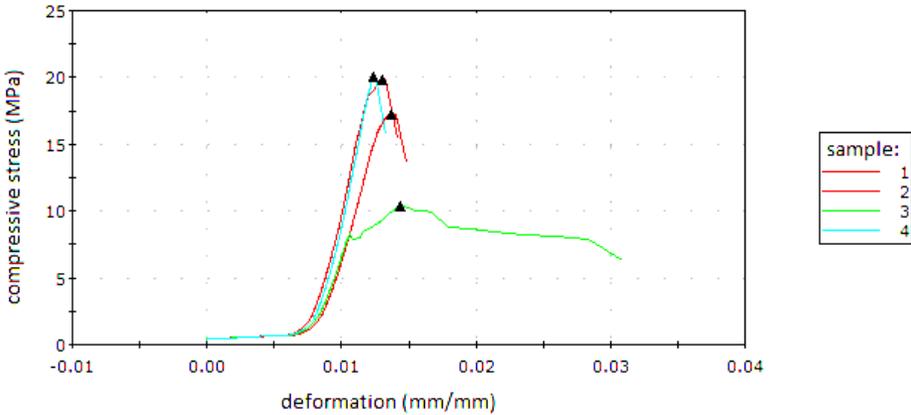
According to the assumptions, the sample was glued with vikol wood adhesive and after the binding time declared by the manufacturer, another series of tests were carried out. Eight cylindrical specimens  $l/d = 1$  were used to obtain 4 specimens meeting  $l/d \leq 2$  ratio condition. In Table 3 the results of compressive strength after the series with original specimens  $l/d \leq 2$  and glued specimens (sandwich) are presented. A graph of the sandwich samples is shown in Fig. 11.

**Fig. 11.** Compressive strength curve of a series of sandwich samples

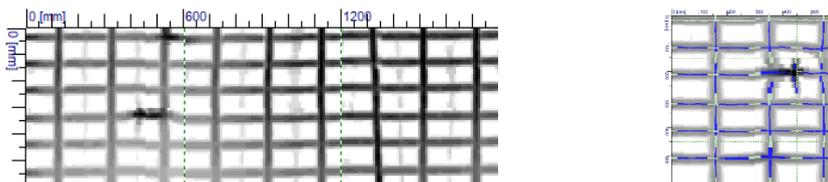
Both 60x180 cm blocks and 60x60 cm images were scanned in order to determine the characteristic reinforcement points, including the location and anchoring of the steel hanger (Fig. 12).

**Fig. 12.** Scanned block of 60x180 cm and a picture of 60x60 cm with a visible hanger.

The analysis of scanned images indicates the use (in the external layer) of reinforcement grid with equal spacing of 10x20 cm (laid horizontally or vertically) and the diameter of reinforcement rods of 4.5 mm (samples of rods were taken). The diameter of the hanger could not be verified. Samples of reinforcement bars confirm the use of smooth steel A0.

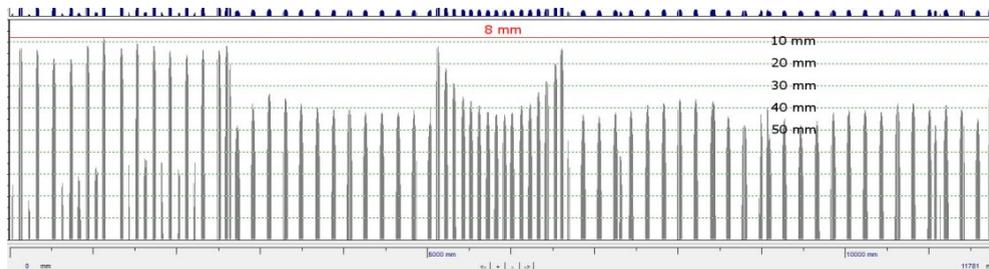
The 60x60 peel in Fig. 13 shows the element of the hanger and its shift in relation to the design assumptions - the measurement field was arranged in such a way that - taking into account the design assumptions - the hanger was in the middle. The shift is therefore 15 cm horizontally and 10 cm vertically.

Next, the thickness of the covering was measured in detail along the entire length of the selected gable wall (Fig. 13), i.e. 11.80 m. The horizontal and vertical displacement of the hanger is 15 cm.

**Fig. 13.** Measurement of covering thickness over the length of the gable wall (11.8 m)

In the drawing it is possible to unambiguously separate five individual façade panels, it is also visible that the central one has a 10x20 cm vertical reinforcement grid and the rest of the panels a horizontal one. The covering on the measured elements varies between 8-48 mm (design assumptions are 15 mm). Undoubtedly, the reinforcement nets moved during concreting, probably due to incorrect fixing.
